SERVICE DIRECTIVE BULLETIN

SERVICE DIRECTIVE BULLETIN NO. T-055

1. SUBJECT: Tail Rotor Rotating Controls Installation Inspection
2. MODEL: 480 and 480B
3. EFFECTIVITY: All S/N
4. BACKGROUND:

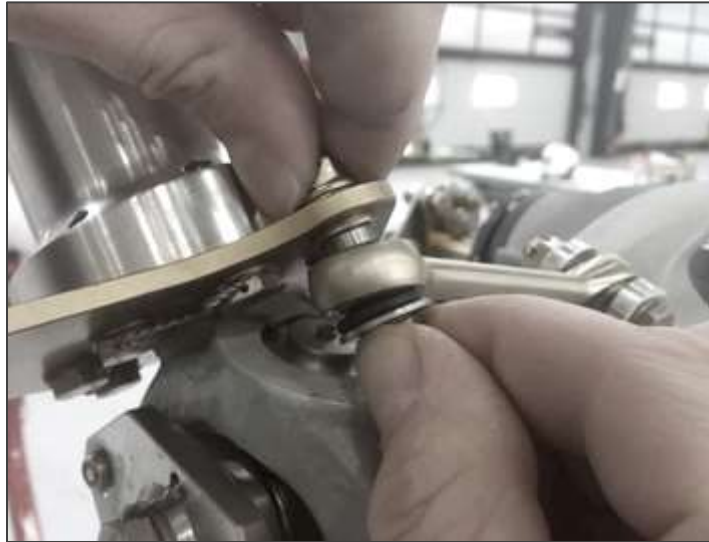
Figure 1. Check for Loose Hardware

Enstrom has received a report of severe deterioration of the blade grip pitch horn at the point of attachment for the tail rotor pitch change link assembly. Further findings indicated that a lack of washers may have initiated the deterioration as evidenced by the wear exhibited on the damaged pitch horn plate. In addition, Enstrom has received reports of loosened hardware even after proper torque procedures were followed.

5. COMPLIANCE:
 - 5.1 Before each flight, perform a pre-flight check for loose, turning hardware.
 - 5.1.1 Using both hands, firmly grasp the bolt head and nut and attempt to turn the bolt in the pitch change link rod end (Figure 1).
 - 5.1.1.1 If the hardware is tight, no further action is required.
 - 5.1.1.2 If the hardware is loose and/or wear is detected, contact authorized maintenance personnel to check the installation and re-torque (reference SIL T-027 (latest revision)) as soon as practicable.

- 5.2 At the next 50-hour service, modify the hardware requirements in accordance with SIL T-027 (latest revision) (refer to Figure 1, items (6) and (7)).

- 5.2.1 Replace AN960-416 washers (cad plated carbon steel) with NAS1149C0463R/NAS1149C0432R washers (passivated stainless steel).
 - 5.2.2 Each AN960 washer is to be replaced with its equivalent size NAS1149C04XXR washer.
