ENSTROM HELICOPTER CORPORATION

SERVICE DIRECTIVE BULLETIN

SERVICE NOTE NO. 0008

SUBJECT: Main Rotor Control Pitch Link

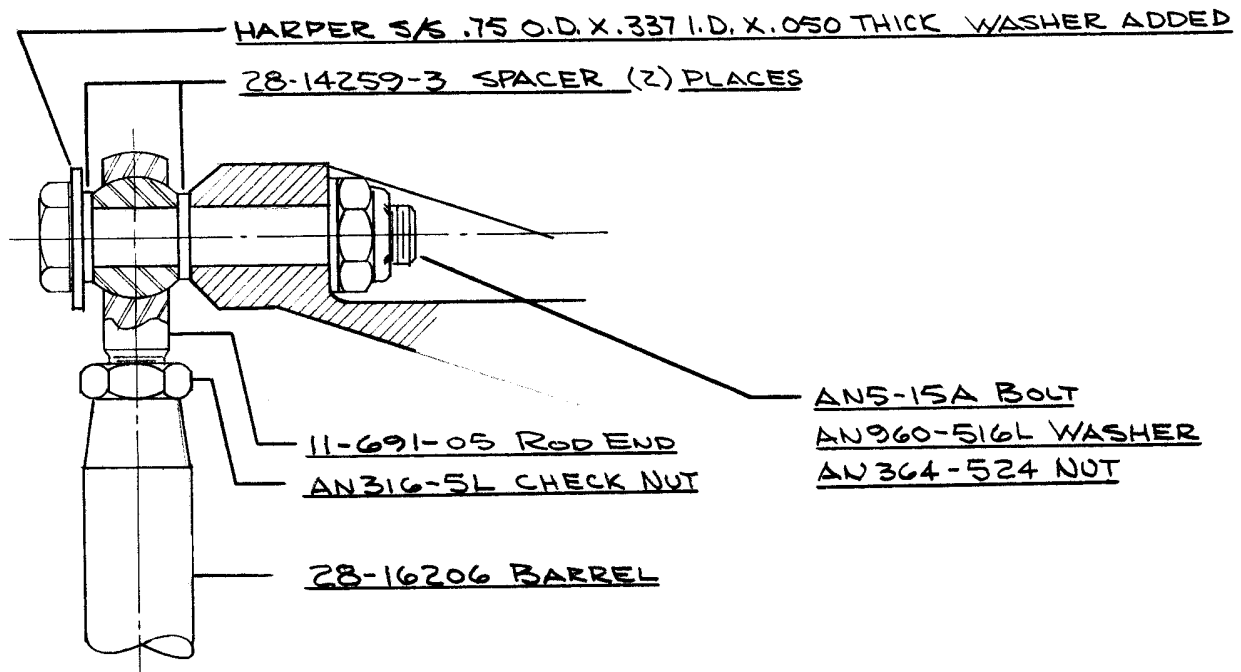
One occurrence has been noted of an improperly manufactured Fiberglide uniball rod end. The defect noted was an improperly swaged uniball bushing to the rod end housing, the result being movement of the uniball bushing within the housing.

To reduce the possibility of the rod end housing slipping off the uniball bushing and over the retention bolt head, we recommend the installation of a Harper stainless steel washer under the head on the inboard side of each lower pitch link rod end at the rotor blade pitch arm. The washer installed is a Harper S/S .75 O.D. x .337 I.D. x .050 thick and can be obtained locally or from the Enstrom Corporation.

Install Harper washer as indicated by drawing below. Special attention should be given to attach bolt - a minimum of 1½ threads should be exposed after installation of AN960-516L washer and AN364-524 nut. If the attach bolt AN5-15A does not meet this requirement, an AN5-16A bolt should be substituted. This problem may arise due to tolerance variation.
