SERVICE DIRECTIVE BULLETIN

SERVICE DIRECTIVE BULLETIN NO. 0064

SUBJECT: Collective Friction Usage

MODELS: F-28A, 280, F-28C, 280C, F-28F and 280F

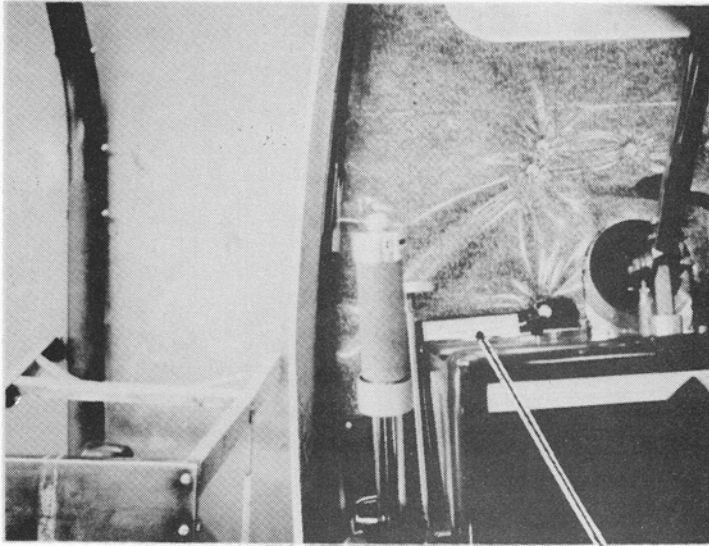
Current production Enstrom helicopters are placarded "COLLECTIVE FRICTION TO BE USED FOR GROUND OPERATION ONLY" on the fiberglass seat flair near the collective friction handle (refer to picture). Included with this bulletin is the placard which must be installed, as shown, on all Enstrom helicopters. Additional decals can be obtained from Enstrom Helicopter Service Department by ordering P/N 28-16296-11.

NOTE: Placard to be positioned even with edge of seat cover and inverted to facilitate reading by pilot.
