SERVICE DIRECTIVE BULLETIN NO. 0113

DATE: September 27, 2011

1. SUBJECT: Cyclic Trim Actuator Switch Assembly Inspection
2. MODEL: F-28A, 280, F-28C, 280C, F-28F, 280F, and 280FX
3. EFFECTIVITY: S/N 828 and prior; S/N 2133 and prior
4. BACKGROUND:

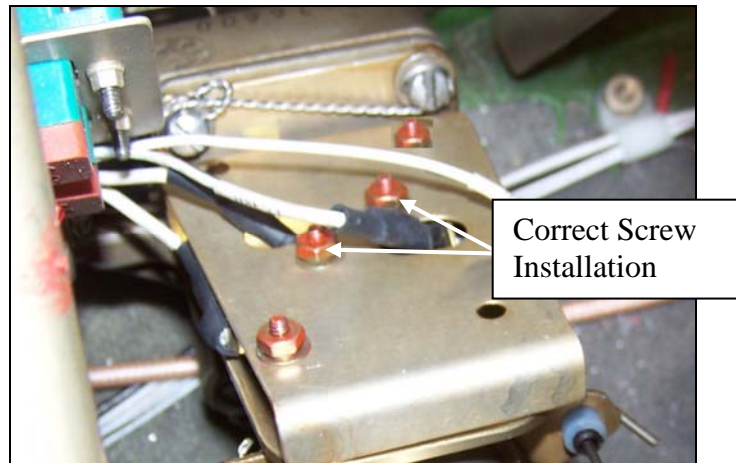
- 6.1 Locate the trim actuator assemblies by removing the seat deck.
- 6.2 Inspect the lateral and longitudinal trim switch assemblies for the proper screw orientation. The screw shanks and nuts should be visible on the wiring side of the switch assembly (*Figure 1 and Figure 2*). The heads of inner screws should be facing the spring capsule.

Figure 1. Properly Installed Screws – The heads of the inner screws face the spring capsule.

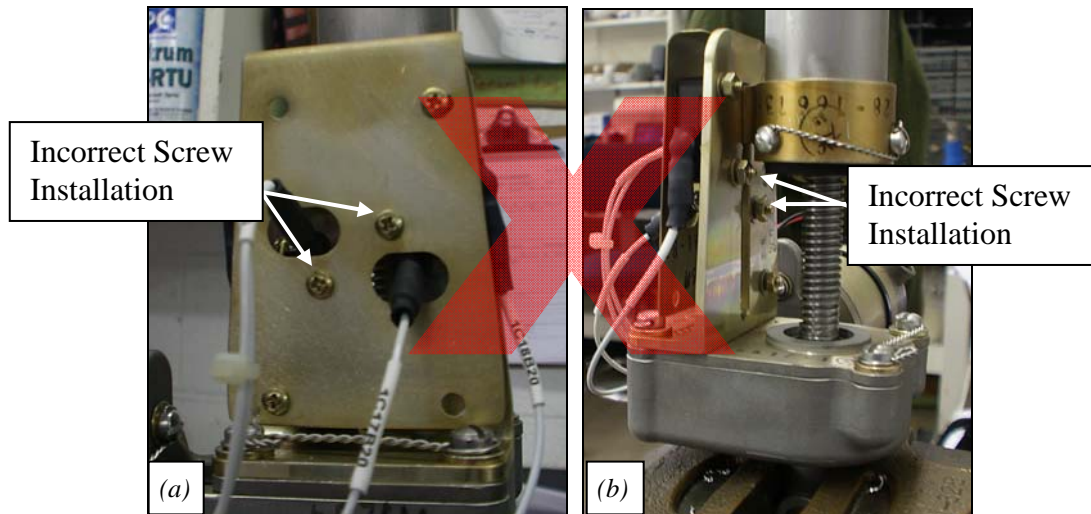
Enstrom has received a report of an incorrectly assembled trim actuator switch assembly used in the cyclic trim system. The screws that assemble the switches to the bracket were inadvertently installed in the opposite direction. This is a concern for the screws adjacent to the bracket slot, as the protruding shanks could interfere with the spring capsule travel and possibly compromise the performance of the cyclic trim system.

Figure 2. Improperly Installed Screws (a) (b) – The shanks of the inner screws face the spring capsule (b). (The trim actuator is removed from the aircraft.)

- 6.8 Remove the inner screws (3), washers (4) (5), and nuts (6) from the switch assembly. Re-install the inner screws (3), washers (4) (5), and nuts (6) such that the screw heads face the spring capsule. Use care to avoid moving the position of the switches when installing the screws.
