SERVICE DIRECTIVE BULLETIN NO. T-047

DATE: September 25, 2014

1. SUBJECT: Tail Rotor Drive Shaft Bearing Assembly
2. MODEL: TH-28, 480, and 480B
3. EFFECTIVITY: S/N 5140 and prior
4. BACKGROUND:

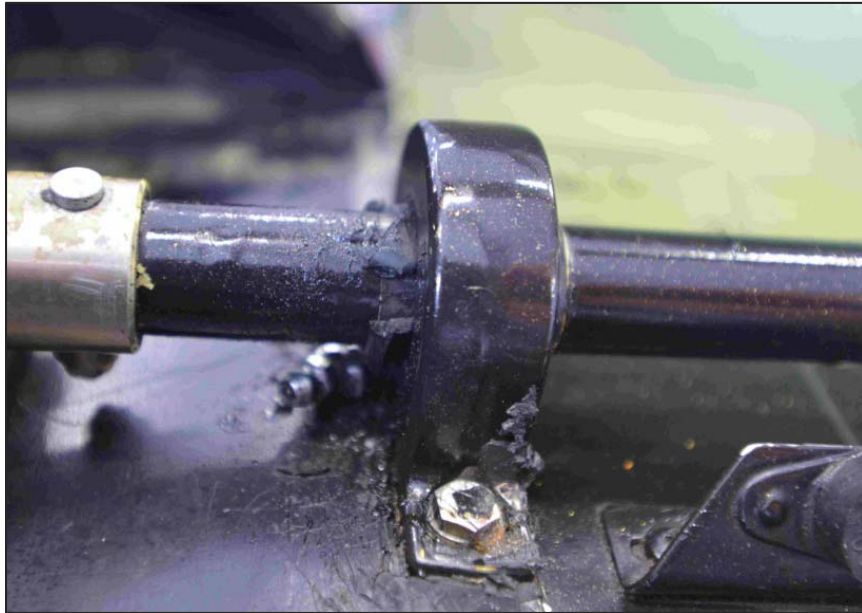
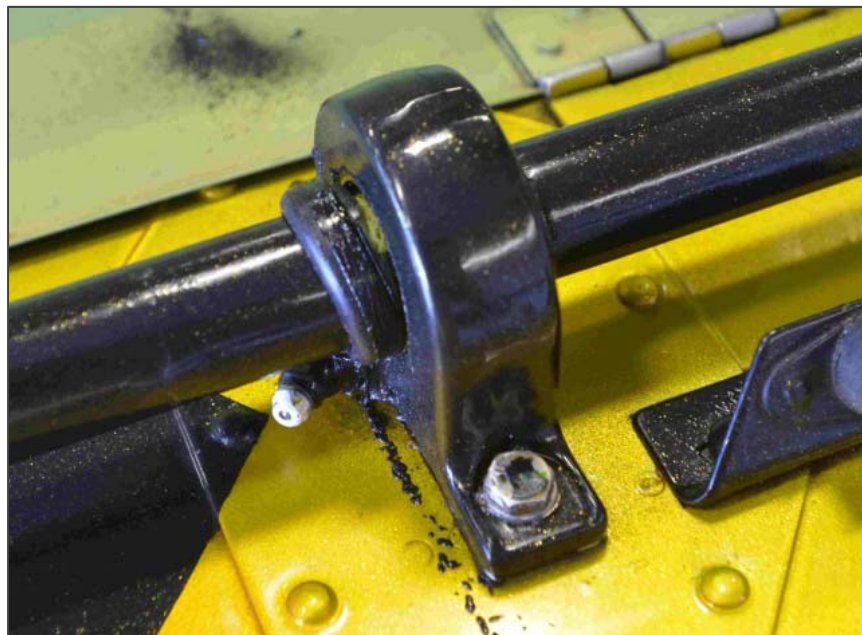
Enstrom has received a report of deterioration of the rubber bushing in tail rotor drive shaft bearing assembly caused by interference of the bushing with the bearing housing. This interference is possible if the bushing, P/N 4136002-15, is installed with an incompatible bearing housing or if the bushing is installed backwards.

Figure 1. Bushing Deterioration (forward side shown)

- 6.2 Inspect the bushing for interference with the bearing housing (Figure 1).
 - 6.2.1 If tears or deterioration is detected proceed to step 6.3.
 - 6.2.2 If no tears or deterioration is detected, no further action is required. Reinstall the aft tail rotor drive shaft cover and remaining covers.

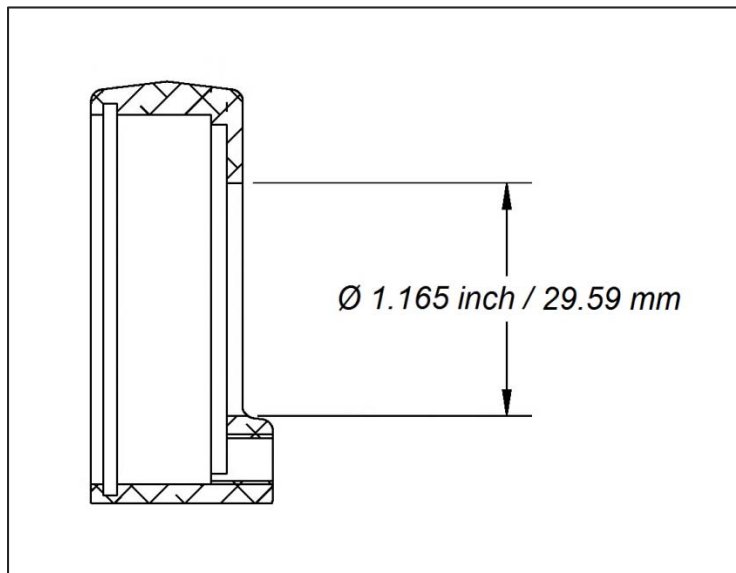
Figure 2. Bearing Housing Modification

- 6.3 Inspect the bearing housing:
- 6.3.1 Inspect the condition of the bearing housing in accordance with paragraph 11-76, A of the TH-28/480 Series Maintenance Manual.
 - 6.3.2 Measure the smaller hole opening. If less than 1.16 inch/29.46 mm, open the hole diameter to 1.165 inch/29.59 mm (Figure 2) or install new bearing housing 28-13611-15 (refer to Figure 3).
 - 6.3.3 Refer to step 6.4 for proper bushing installation.
