SERVICE INFORMATION LETTER NO. 0189

- DATE: February 4, 2019
1. SUBJECT: Magneto Retard Terminal P-Lead Insulator
2. MODEL: F-28C, F-28C-2, F-28C-2R, F-28F, F-28F-R, 280C, 280F, and 280FX
3. EFFECTIVITY: F-28F S/N 832 and prior; 280FX S/N 2158 and prior; any F-28C, F-28C-2, F-28C-2R, F-28F, F-28F-R, 280C, 280F, and 280FX that may have had the P-lead insulator changed in the field
4. BACKGROUND:

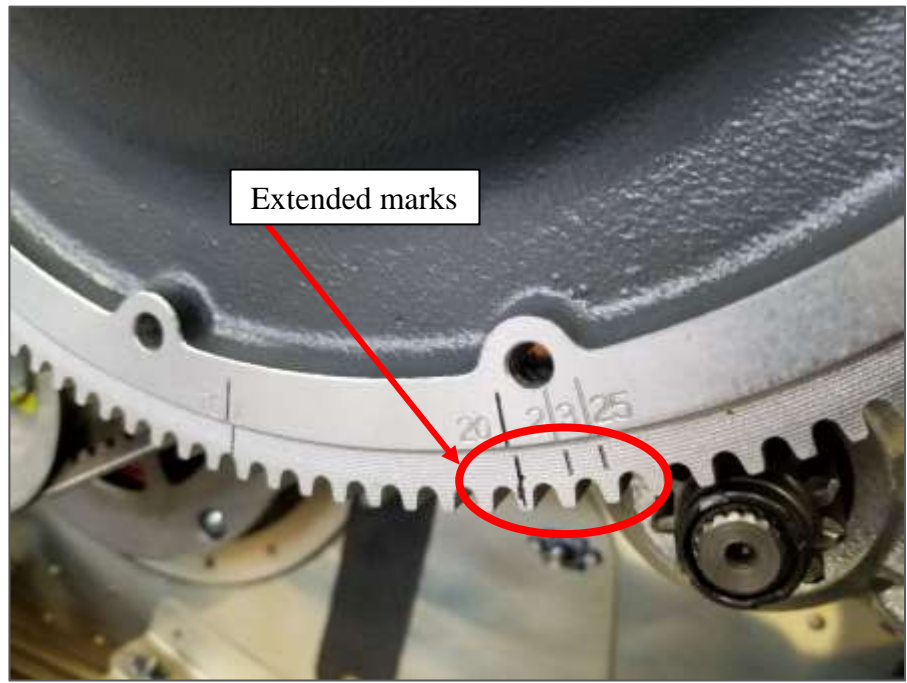
Figure 1. Timing index marks extended onto the ring gear

NOTE: The ignition timing marks are stamped into the starter ring gear support assembly and not actually on the ring gear. To aid in setting the magneto timing, it may be advisable to extend the marks onto the ring gear using a fine Sharpie® or similar marker (Figure 1).

- The retard timing is set too advanced, at TDC (top dead center). For proper operation of the shower-of-sparks starting system, the retard contact (points) must be set to open half tooth on the starter ring gear after TDC. Refer to the Enstrom F-28F/280F Series Maintenance Manual, Section 13-9, paragraph E, item (2) for steps for setting the proper timing,
- Or the soft rubber retard terminal P-lead insulator is installed.

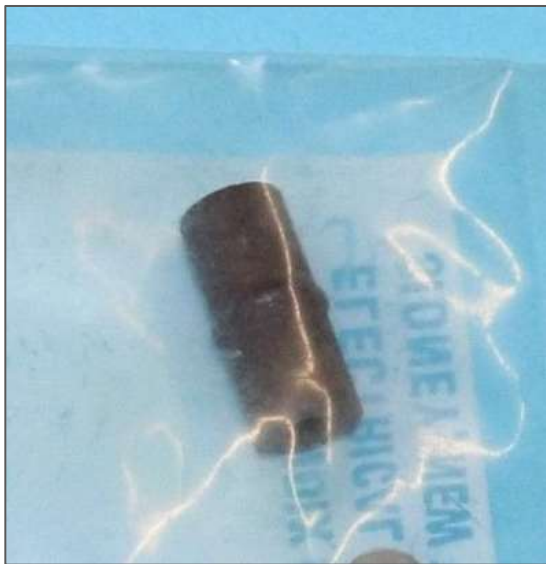
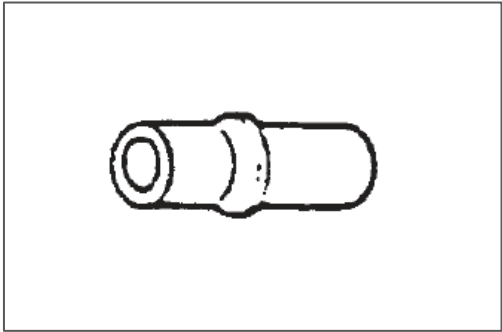
Figure 2. P/N 10-382812 Rubber Insulator

The magneto retard terminal insulator may be either phenolic or soft rubber. The soft rubber insulator is generally used in pressurized magnetos. It forms a tight seal but the compressed insulator may hold the wire insulation and prevent the lead from seating on the terminal and making proper electrical contact. The phenolic insulator will not trap the wire insulation so the lead will make better contact with the terminal. The aircraft with the serial numbers listed above were assembled with a soft rubber insulator (Figure 2). Enstrom recommends checking for this rubber insulator and, if installed, replacing with a phenolic bushing to allow the lead to seat properly.

At the next 100 hr/annual inspection, determine if the P-lead insulator is rubber. If so, replace P/N 10-382812 rubber insulator with P/N 10-157212 (Kit P/N 10-157208) bushing in accordance with paragraph 6.

6.6 Slide the rubber P-lead insulator (P/N 10-382812) (Figure 2) off of the wire and slide the phenolic insulated bushing (P/N 10-157212) (Figure 3) onto the wire.

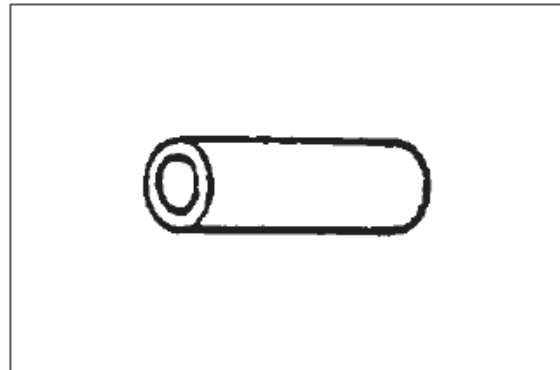
Figure 3. 10-157212 Phenolic Bushing

The magneto retard terminal bushing (P/N 10-157212) is similar to right and left P-lead connection bushings (P/N 10-382697), but is shorter in length. Ensure the correct bushing is being installed on the retard terminal P-lead wire. Installing the incorrect bushing will cause improper magneto operation.
