SERVICE INFORMATION LETTER (SIL) NO. T-073

DATE: October 13, 2020

1. SUBJECT: Pylon Reinforcement Doubler Installation
2. MODELS: 480, 480B
3. EFFECTIVITY: S/N 5254 and prior
4. BACKGROUND:

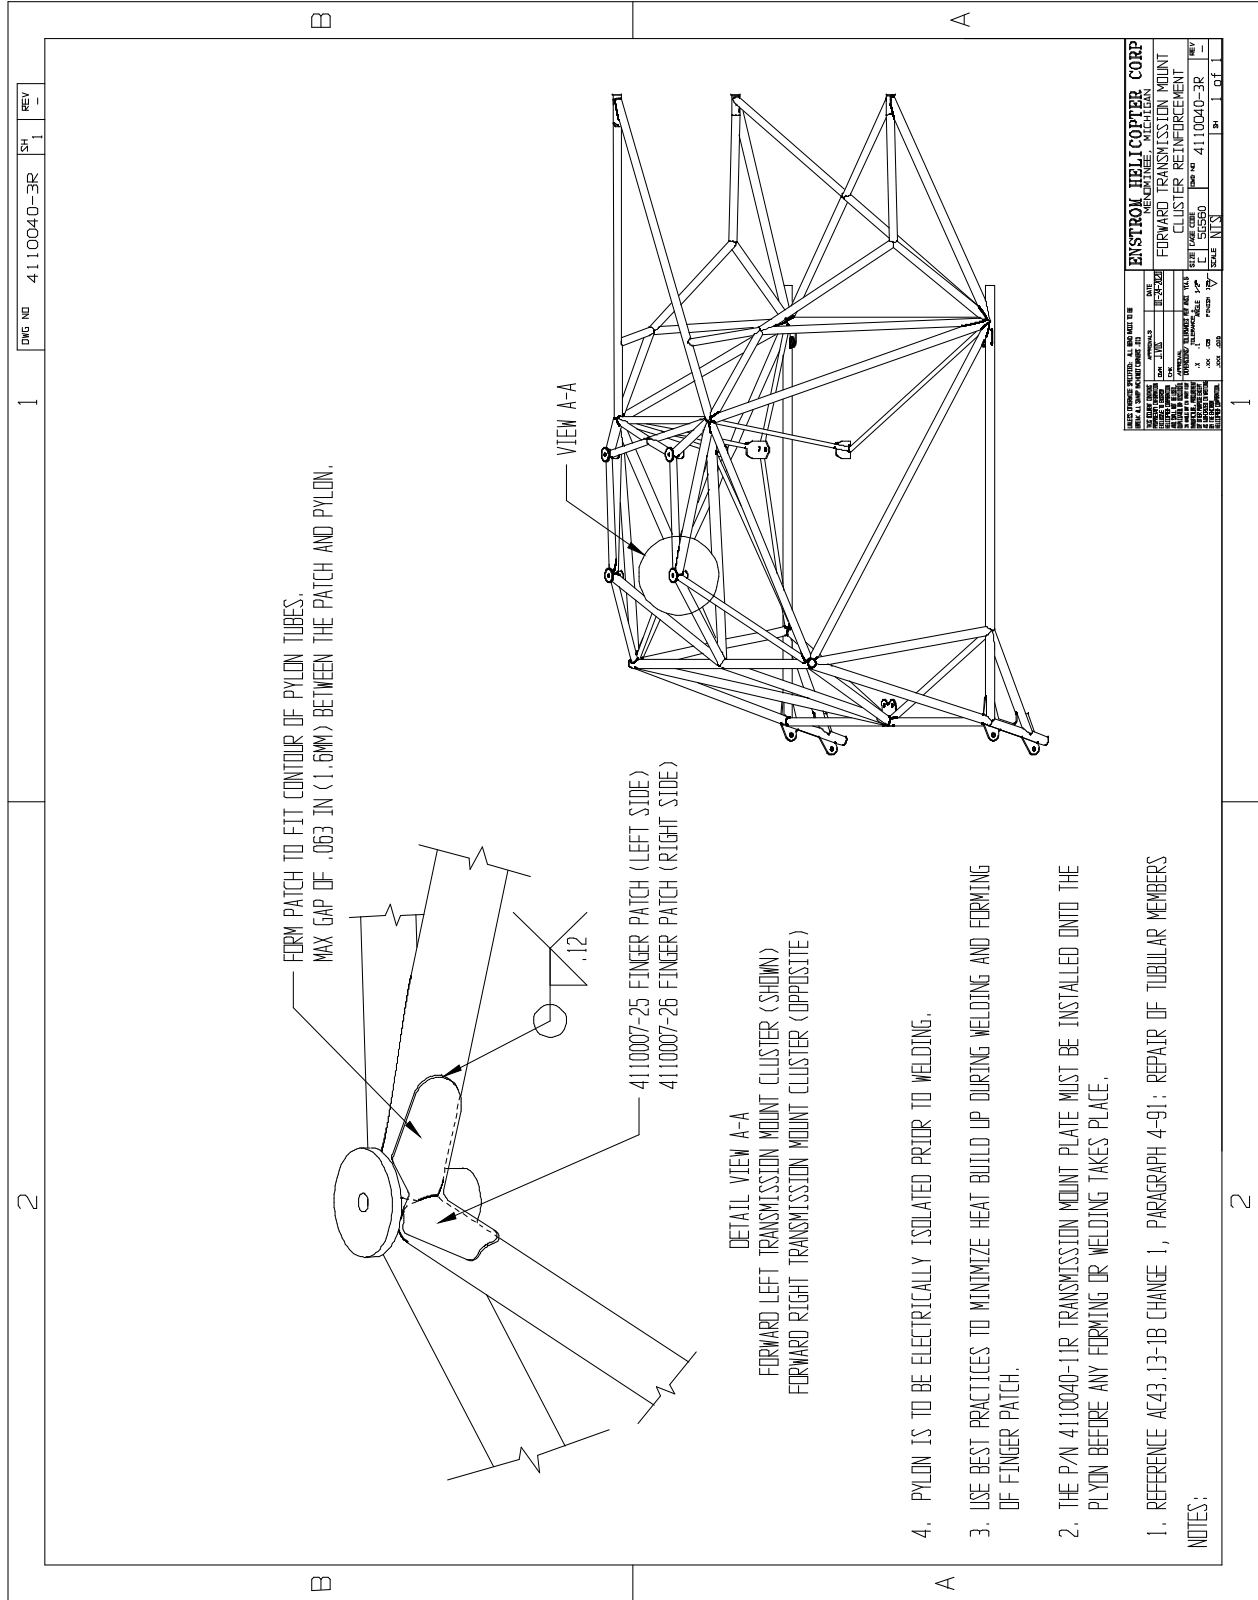
Figure 1. Drawing 4110040-3R – Forward Transmission Mount Cluster Reinforcement

Enstrom received reports of cracks in the pylon joint under the forward left and/or right transmission mounts of three aircraft used in training operations. Enstrom issued Service Directive Bulletin (SDB) T-065 requiring inspection of the pylon for cracks.

- 6.5 Clean the pylon tubes and welds in the area of the transmission mount using a suitable solvent (refer to paragraph 7.2).
- 6.6 Using chemical paint remover, remove epoxy primer from the finger patch area (reference Figure 1 and paragraph 7.2).

- 6.8 Weld P/N 4110007-25 and P/N 4110007-26 finger patches to the pylon joints (reference Figure 1).
 - 6.8.1 Form the patch to fit the contour of the pylon tubes. It is permissible to heat the finger patch to assist in forming. The maximum gap between the patch and pylon is 0.063 in/1.6 mm.
- 6.9 Once the welds have cooled, remove P/N 4110040-11R pylon repair fixture.
- 6.10 Apply epoxy primer (reference paragraph 7.2) to the finger patch and welds.
- 6.11 Install the fuel cell support structures and fuel cells (MM paragraph 8-76).
- 6.12 Install the engine (MM paragraph 13-7).
- 6.13 Install the main rotor transmission (MM paragraph 11-37).
- 6.14 Install airframe grounded instruments and avionics (MM paragraph 7-14 and TH-28/480 Series Maintenance Manual Supplement 5 or applicable manufacturer installation manual of relevant installed equipment, as applicable).
