SERVICE INFORMATION LETTER NO. 0096

Subject: Inspection of P/N 28-12462 Fuel Lines

Model: F-28C and 280C

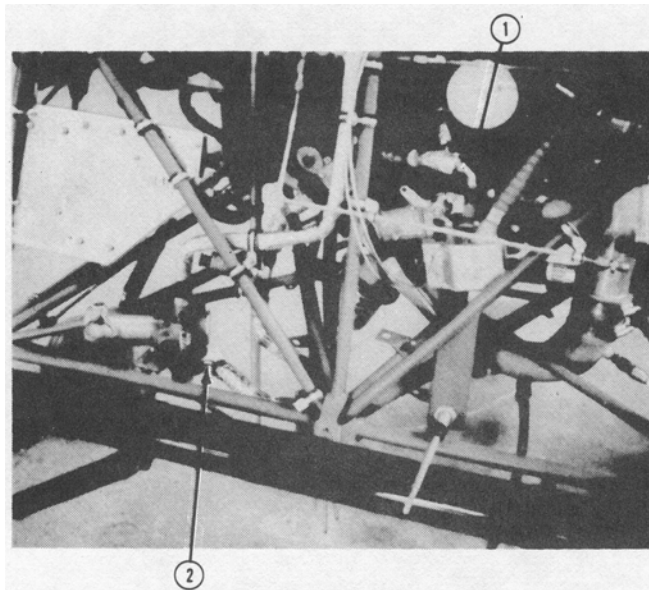
There have been reports of failures in the MS 87020-6 tubular elbow fitting on the Enstrom P/N 28-12462 fuel line assembly. The failures may have been caused by improper maintenance procedures on installation or removal of lines equipped with aluminum MS tubular elbow fittings. In the event of such failure, a potential fire hazard may exist. These fuel lines are installed in two (2) locations:

1. From the engine driven fuel pump to the injector
2. From the fuel strainer to the boost pump.

To eliminate the possibility of reoccurrence of this problem, the fitting material has been changed to steel. Aluminum tubular elbow fittings are identified by their BLUE color, and if found on these fuel lines, for improved safety, it is recommended that at the next 100 hour inspection the aluminum lines be replaced with those having a cad plated steel elbow.
