SERVICE DIRECTIVE BULLETIN NO. 0125

Revision 1

1. SUBJECT: Tail Rotor Rotating Controls Installation Inspection
2. MODEL: F-28C, F-28C-2, F-28C-2R, F-28F, F-28F-R, 280C, 280F, and 280FX
3. EFFECTIVITY: All S/N
4. BACKGROUND:

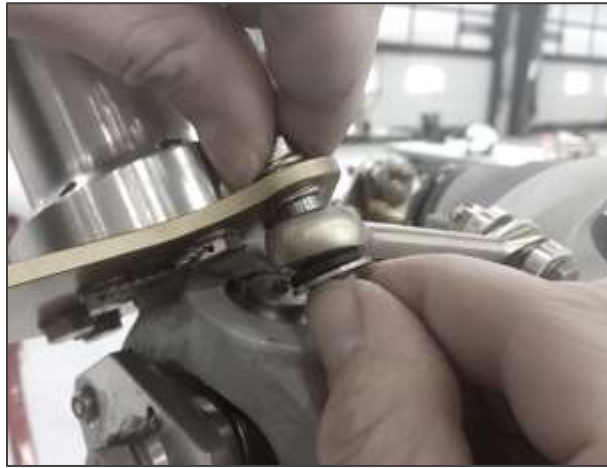
Figure 1. Check for Loose Hardware

Enstrom has received a report of severe deterioration of the blade grip pitch horn at the point of attachment for the tail rotor pitch change link assembly. Further findings indicated that a lack of washers may have initiated the deterioration as evidenced by the wear exhibited on the damaged pitch horn plate. In addition, Enstrom has received reports of loosened hardware even after proper torque procedures were followed.

5. COMPLIANCE:
 - 5.1 Before each flight, perform a pre-flight check for loose, turning hardware.
 - 5.1.1 Using both hands, firmly grasp the bolt head and nut and attempt to turn the bolt in the pitch change link rod end. (Figure 1).
 - 5.1.1.1 If the hardware is tight, no further action is required.

- 5.1.1.2 If the hardware is loose and/or wear is detected, contact authorized maintenance personnel to check the installation and re-torque (reference SIL 0165 (latest revision)) as soon as practicable.

- 5.2 At the next 50-hour inspection, modify the hardware requirements in accordance with SIL 0165 (latest revision) (refer to Figure 1, items (6) and (7)).

- 5.2.1 Replace AN960-416 washers (cad plated carbon steel) with NAS1149C0463R/NAS1149C0432R washers (passivated stainless steel).
- 5.2.2 Each AN960 washer is to be replaced with its equivalent size NAS1149C04XXR washer.
