SERVICE DIRECTIVE BULLETIN NO. T-008

Revision 3

1. SUBJECT: Cracked Oil Cooler Blower Short Shaft, P/N 4129102
2. MODEL: TH-28, 480, and 480B
3. EFFECTIVITY: All S/N equipped with P/N 4129102, multi-piece shaft
4. BACKGROUND:

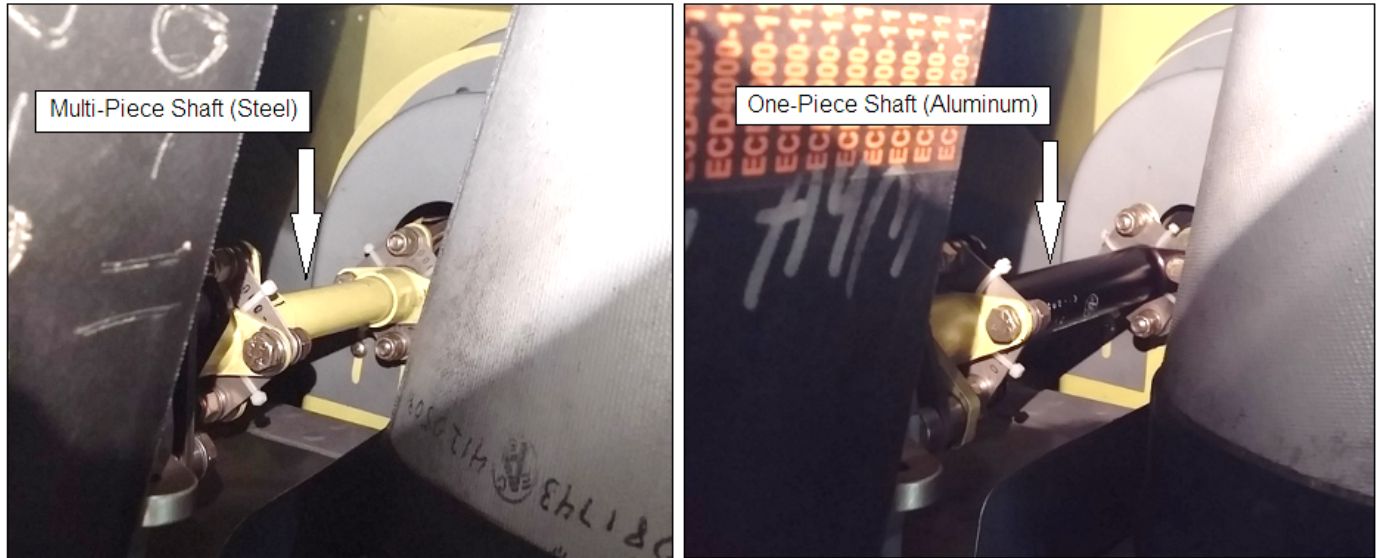
As a result of two incidences involving cracked shafts (plug welded), Revision 1 requires inspection of the brazed or welded shafts for cracks. If the inspection reveals a cracked shaft, the shaft must be replaced with the one-piece shaft. If the shaft is airworthy, it may remain in service until the next annual or 100-hour inspection at which time the shaft must be replaced with the one-piece shaft.

- 6.1 Determine whether the multi-piece or the one-piece shaft is installed. The multi-piece shaft (steel) consists of couplings brazed or welded to the ends of the shaft; it may exhibit a yellow epoxy primed surface. The one-piece shaft is solid construction (aluminum) with a uniform diameter between the flanges; it has a black hard coat anodized surface (Figure 1).

Figure 1. P/N 4129102 shaft as viewed through the left side engine access panel. Multi-piece shaft shown on left; one-piece shaft shown on right.

- 6.4 If no crack is detected, the aircraft may be returned to service. However, the multi-piece shaft must be replaced with a solid, one-piece shaft (see paragraph 7) at the next annual or 100-hour inspection, whichever occurs first.

- 6.5 If the shaft is cracked, replace the short shaft (see paragraph 7).
 - 6.5.1 Perform a limited alignment check of the blower assembly to the lower drive pulley.
