SERVICE DIRECTIVE BULLETIN NO. T-020

1. SUBJECT: Inspection of Pylon Assembly for Cracks
2. MODEL: TH-28, 480, and 480B
3. EFFECTIVITY: All Serial Numbers
4. BACKGROUND:

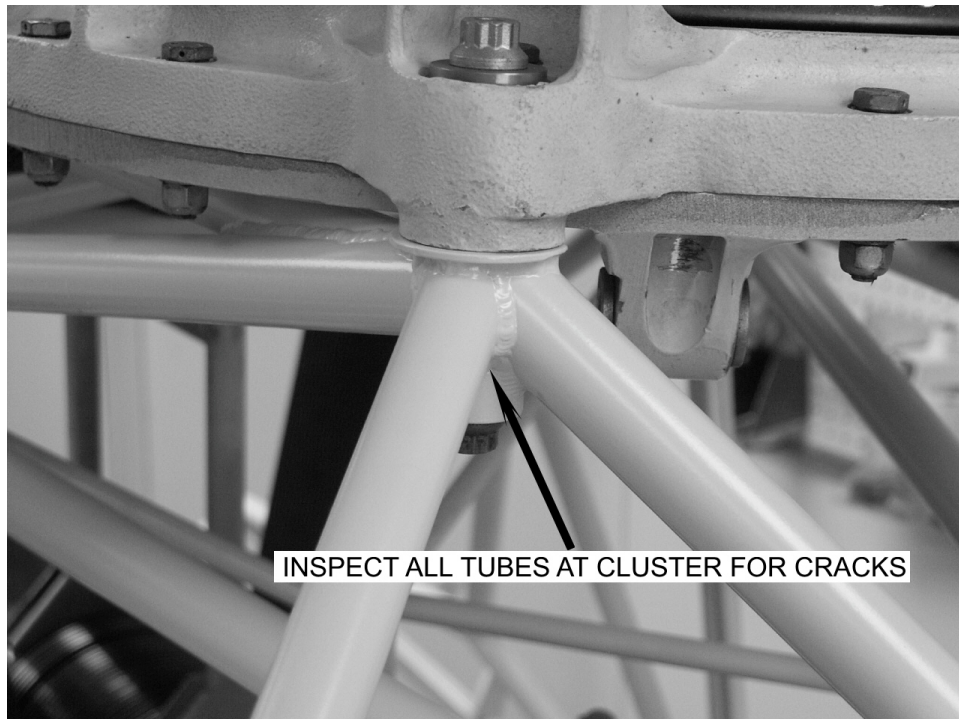
Figure 1. Right, Front Main Rotor Transmission Mount Cluster

- B. Using a suitable light source and an inspection mirror (as required), visually inspect the areas of the pylon assembly shown in Figures 1 through 8 for cracks. If a suspected crack is found, use a dye penetrant inspection to determine if the pylon assembly is cracked.

- A. Repair cracked pylon assembly tubes in accordance with AC 43.13-1B, Change 1, *Acceptable Methods, Techniques, and Practices - Aircraft Inspection and Repair*. Contact Enstrom Helicopter Corporation for specific repair instructions and repair material requirements if required.

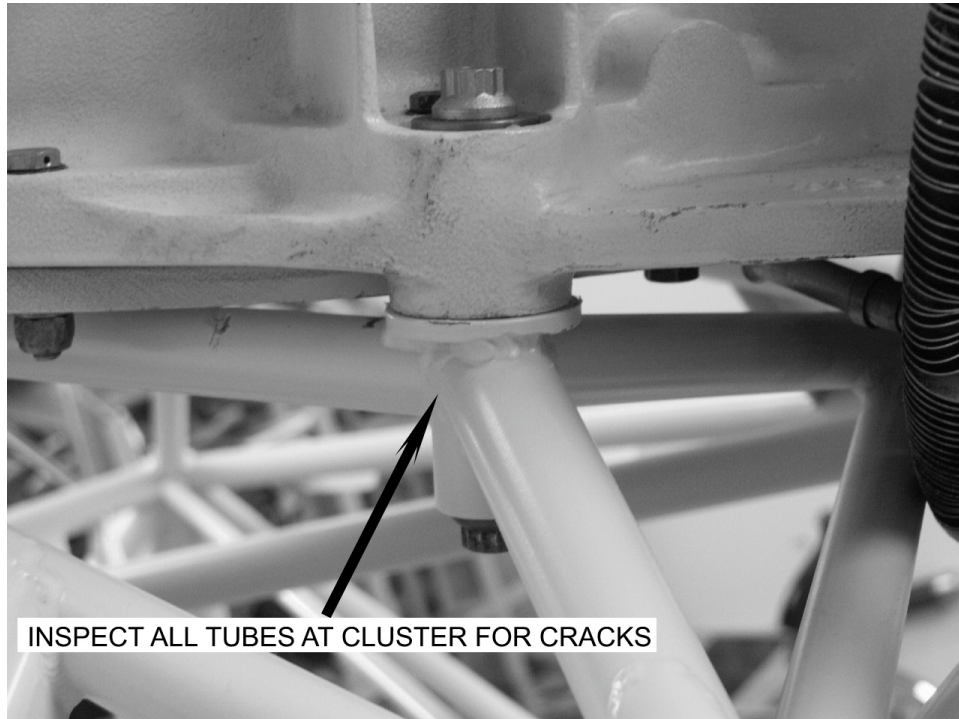
Figure 3. Left, Rear Main Rotor Transmission Mount Cluster

During investigation of a 480 accident, a broken pylon tube was found in the area of the left, rear main rotor transmission mount. It has not been determined, at this time, if the failure occurred before the accident or was a result of the accident.
