SERVICE DIRECTIVE BULLETIN

SERVICE DIRECTIVE BULLETIN NO. T-064

DATE: August 25, 2020

1. SUBJECT: Tailcone Bulkhead Inspection
2. MODEL: 480, 480B
3. EFFECTIVITY: All S/N
4. BACKGROUND:

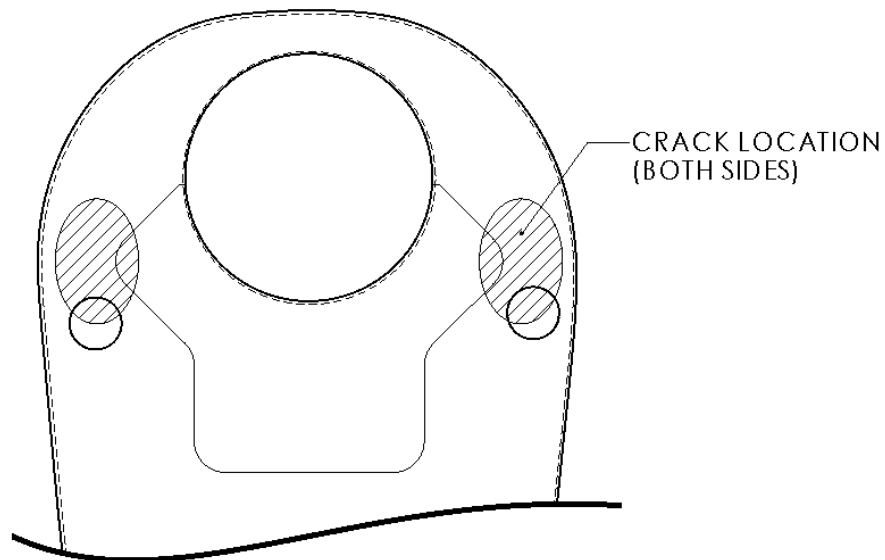
Figure 1. Crack Inspection Areas

Three instances of cracks in the tailcone bulkhead have been reported during field inspections. The cracks are located in the aft bulkhead near the right side lobe of the lower clamp assembly.

- 5.1 Within the next 10 flight hours, perform a visual inspection of the bulkhead.
 - 5.1.1 Using a suitable light source, inspect the bulkhead in the areas shown in Figure 1.

5.2.3 Using a suitable light source and a mirror as required, inspect the interior surface of the bulkhead for cracks in the areas indicated in Figure 1.

5.2.4 Using a 10-power magnifying glass and a suitable light source, inspect the exterior surface of the bulkhead for cracks in the areas indicated in Figure 1.

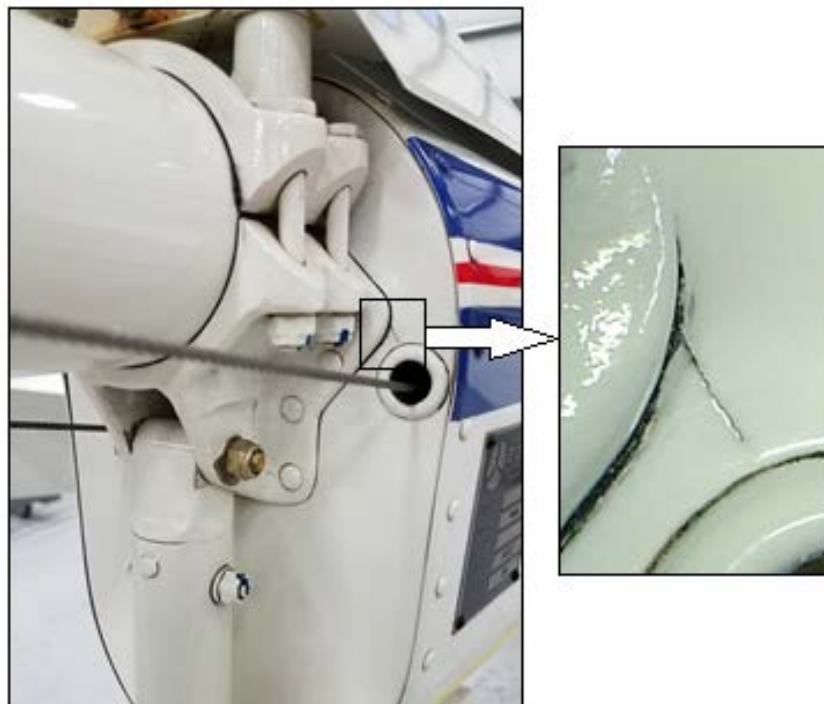
Figure 2. Crack in Aft Tailcone Bulkhead (Example 1)

- 5.1.2 Examples of a cracked bulkhead are shown in Figure 2 and Figure 3. In both examples, there is a crack on the right side near the lobe of the lower clamp assembly.

- 5.1.4 If a crack is detected, stop drill ($\varnothing.094$ through the bulkhead) both ends of the crack. If one end of the crack is obscured by the grommet, there is no need to stop drill the hidden end of the crack. The bulkhead must be inspected and repaired in accordance with paragraphs 5.2 and 6 at or before the next 100 hour/annual inspection.
