ENSTROM HELICOPTER CORPORATION

SERVICE DIRECTIVE BULLETIN

SERVICE NOTE NO. 0004

DATE: May 10, 1968
SUBJECT: Tail Rotor Blade Life - Part No. 28-15100
MODEL: F-28, All Serial Numbers
COMPLIANCE: Before Further Operation of the Helicopter

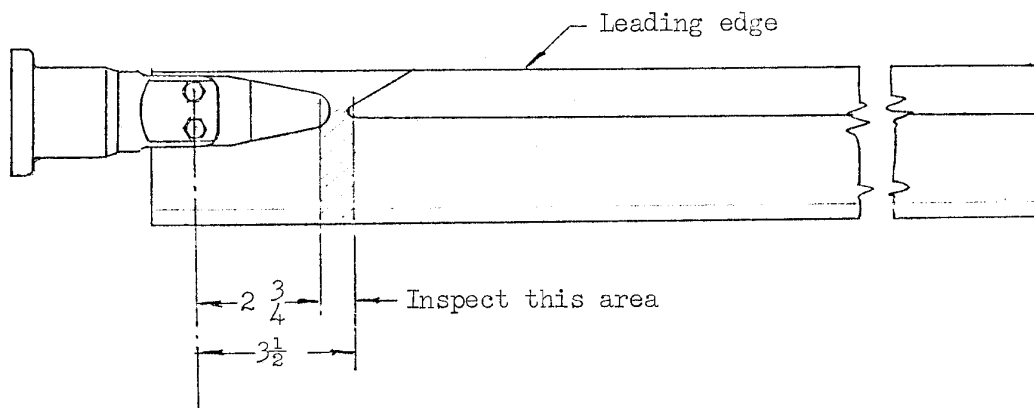
A retirement life of 200 hours has been established on the tail rotor blades, Part No. 28-15100, in view of one occurrence of a crack in service at 400 hours total time. Therefore, all tail rotor blades having a total time of 200 or more hours are to be removed from service, tagged with total number of hours, and stored for possible future use.

In addition, daily inspection of the blade skin for cracks in the chord-wise direction is required in an area $2 \frac{3}{4}$ to $3 \frac{1}{2}$ inches outboard of the retention bolts. (See sketch)

Should a crack be found, the blade must be retired from service, and we request that the Enstrom Corporation be advised of the defect.
