## SERVICE DIRECTIVE BULLETIN

SERVICE NOTE NO. 0005

SUBJECT: Belt Drive Support Strut P/N 28-13227

MODELS AFFECTED: F-28A, All Serial Numbers

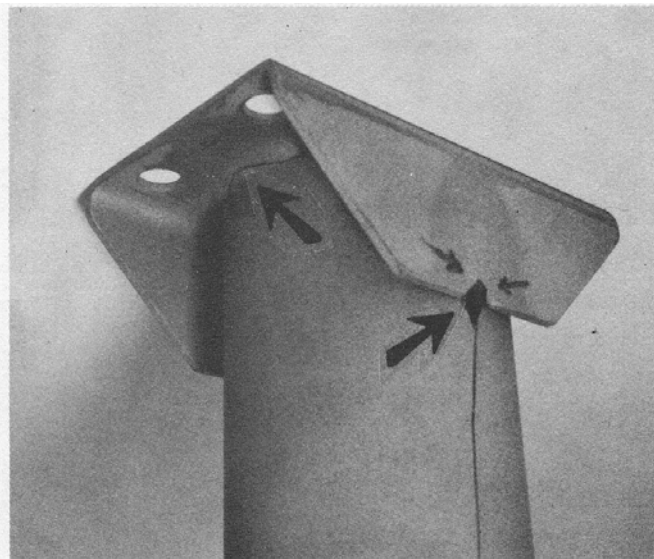
A few instances have been reported of cracks developing in the upper end of the belt drive support strut, Part No. 28-13227. The cracks have developed in the welded joint in the mounting bracket and outer sleeve assembly, Part No. 28-13225. The figure below shows the locations of where the cracks occur.

The cracks, in most probability, will occur on the aft side of the mounting bracket; however, a visual inspection must include both the forward and aft sides of the bracket.

A static visual inspection with the belt tightening mechanism fully engaged is mandatory every ten (10) flight hours. This inspection interval is to be completed until the belt drive support strut is replaced. The replacement strut will include a redesigned mounting bracket.

The replacement of the strut must be done at the earliest convenient time to the customer or within one hundred (100) flight hours from the time of this service note. The replacement should be coordinated with the Service Department of the Enstrom Corporation. With this service note, the Service Department will include complete instructions and procedures to replace the strut.
