SERVICE DIRECTIVE BULLETIN

No. 0021C
Supersedes 0021B
Page one of two

Date: April 2, 1982
Subject: Main Rotor Spindle P/N 28-142 82
Model: F-28A
Effectivity: As Noted

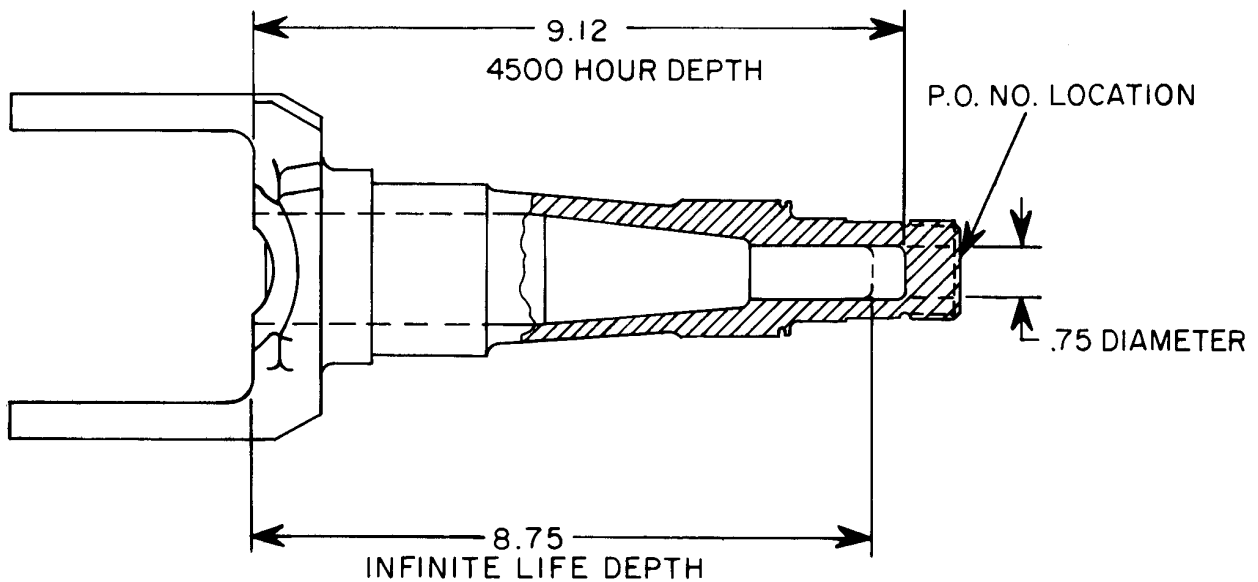
FIG. 1
TOP VIEW OF 28-14282 SPINDLE

These spindles are identified as shown in Figure 1.

The possibility exists that one or more of these defective spindles may be in service. These suspect spindles are from one manufacturing lot and can be identified by a purchase order number etched on the end of the spindle (see Figure 1). The end of the spindle can be exposed by removal of the rotor blade and Lamiflex dust cover. The suspect spindles will have P.O. 21300 etched on the end. All spindles bearing this identifying purchase order number must be inspected for proper depth of the .75 inch bore.

It will be required that all helicopters listed be inspected for limited life spindles (P/N 28-14282) from P.O. 21300 lot at the next 100-hour inspection in accordance with Airworthiness Directive 75-22-01 unless previously accomplished, and a proper log book entry of this inspection be made.
