SERVICE DIRECTIVE BULLETIN

SERVICE DIRECTIVE BULLETIN NO. 0051

Subject: Main Rotor Transmission Mounting Hardware

Models: All

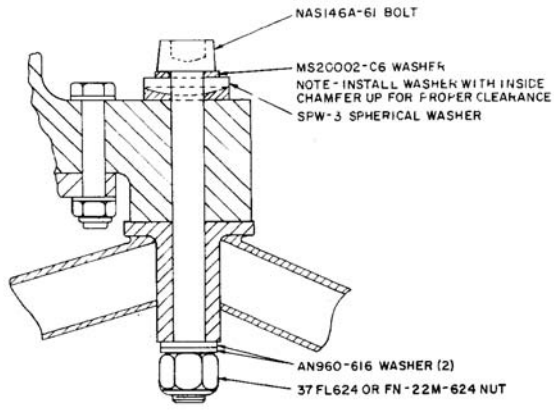
FIGURE 1

1. Main rotor transmission S/N 42-006-76PS and below, which have not been previously machine spot faced on the upper side of the mounting pad, as shown in fig. 2, have previously been retrofitted with bolts and hardware installed as called for in Service Information Letter No. 0057. The Service Information Letter No. 0057 configuration is to be modified by removing the cotter pin and nut (P/N AN 310-6) from each mounting bolt and replacing with either nut P/N 37 FL 624 or FN-22M-624. Refer to figure 1.

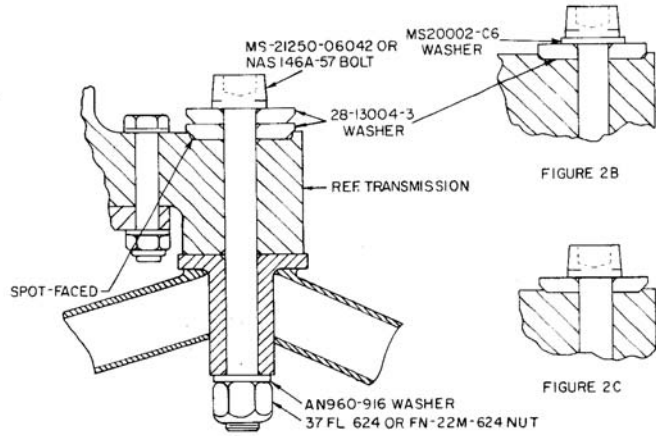
FIGURE 2

2. Main rotor transmission S/N 42-007-76PS through S/N 46-182-79C, have spot faced mounting pads. These transmissions may require a variety of washers as the dimension of the mounting pad thickness may vary. Acceptable bolt installation and spacing is shown in figure 2, parts A, B, and C. Because of the potential interference of a pylon tube, the left aft mounting bolt may require shimming under the bolt head and chamfered washer.

RETENTION BOLT INSTALLATION SHOWING
 ACCEPTABLE WASHER CONFIGURATIONS

NOTE: Care must be taken that only a chamfered washer be placed under the head of the bolt and required shims of “AN” washers to complete spacing be placed between the chamfered washer and the transmission lug. The part number for these washers are also called out in figure A and B.

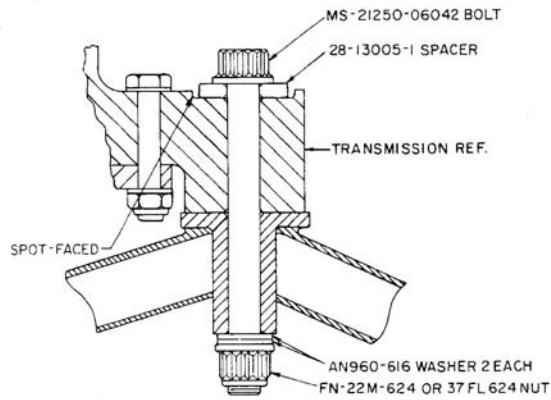
FIGURE 3

3. Main rotor transmissions S/N 46-182-79C and up, have spot faced mounting pads of a controlled dimension and mounting bolts have been installed per figure 3. No change is required. This configuration of bolt and nut is satisfactory for all prior transmission serial numbers provided that the self aligning washer configuration of Service Information Letter 0057 is used with non-spot faced transmission mount as shown in figure 1 and the proper spacing of figure 2 is maintained with spot faced transmission mounts.

TYPICAL GEAR BOX TO PYLON ATTACHMENT
