SERVICE DIRECTIVE BULLETIN NO. 0057

Subject: Periodic Inspections of Lamiflex Bearings and Shims in Main Rotor Blade Retention Assembly

Models: F-28A, F-28C, F-28F, 280, 280C, 280F

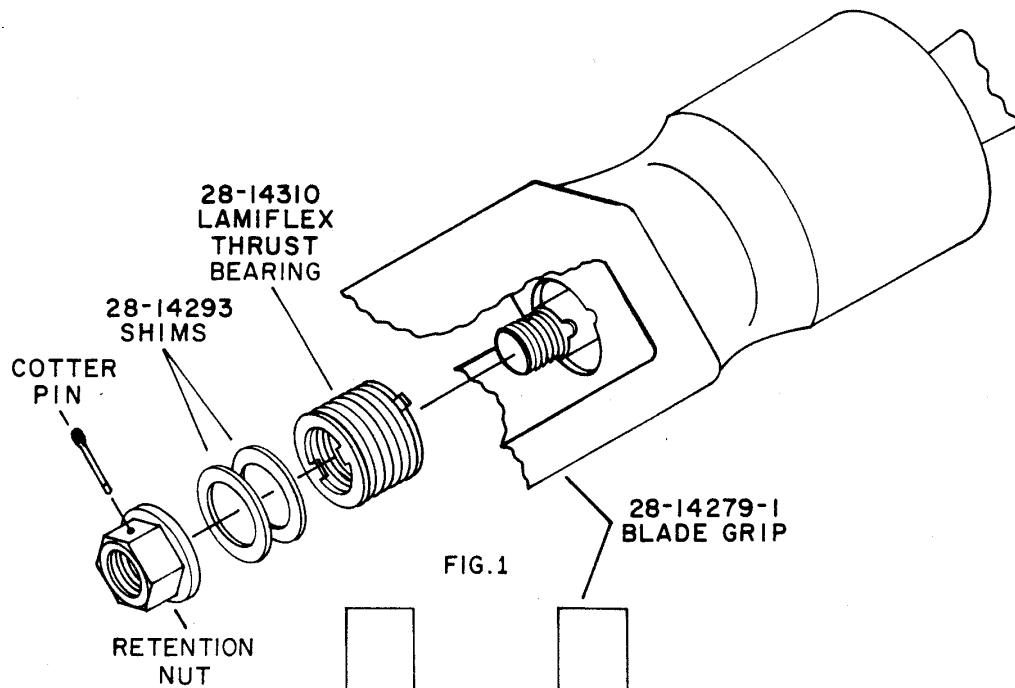
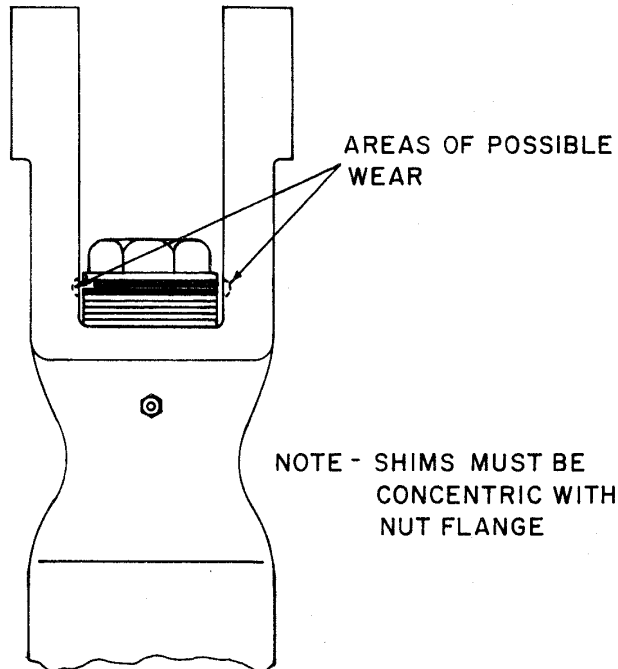
There have been two reports of misalignment of the nylon shims, P/N 2 8-14293, located immediately outboard of the Lamiflex thrust bearing, P/N 28-14310, in the main rotor blade retention assembly. These misaligned shims have worn grooves in the inner surfaces of the blade grip, P/N 2 8-14279-1 (Ref. Fig. 2).

If a groove is worn in the surface of the grip, blend it smooth over a circular area having a diameter equal to worn groove length. DO NOT remove excessive material such that the concave surface extends beyond the cover, P/N 2 8-14239-1, allowing it to leak. Grip is to be replaced if groove is over .125 in. deep.

If the shim is misaligned, remove the cotter pin, P/N AN380-4-8, and the retention nut, P/N 28-14335. Realign the shim(s) with the Lamiflex bearing, or replace the shim(s) if damaged with new shim(s) of equal total thickness. Ensure that the replacements are concentric with the thrust bearing (Ref. Fig. 2). Reassemble per instructions in Section 6 of the Maintenance Manual.
