SERVICE DIRECTIVE BULLETIN NO. 0082

1. SUBJECT: Inadvertent Trim Motor Operation on 24 Volt D.C. Systems
2. MODELS: All F-28F, 280F and 280FX models equipped with 24 volt D.C. electrical systems and any F-28C, F-28C-2, or 280C models that have been converted to a 24 volt D.C. system
3. EFFECTIVITY: Prior to the next flight and as noted under compliance.
4. BACKGROUND:

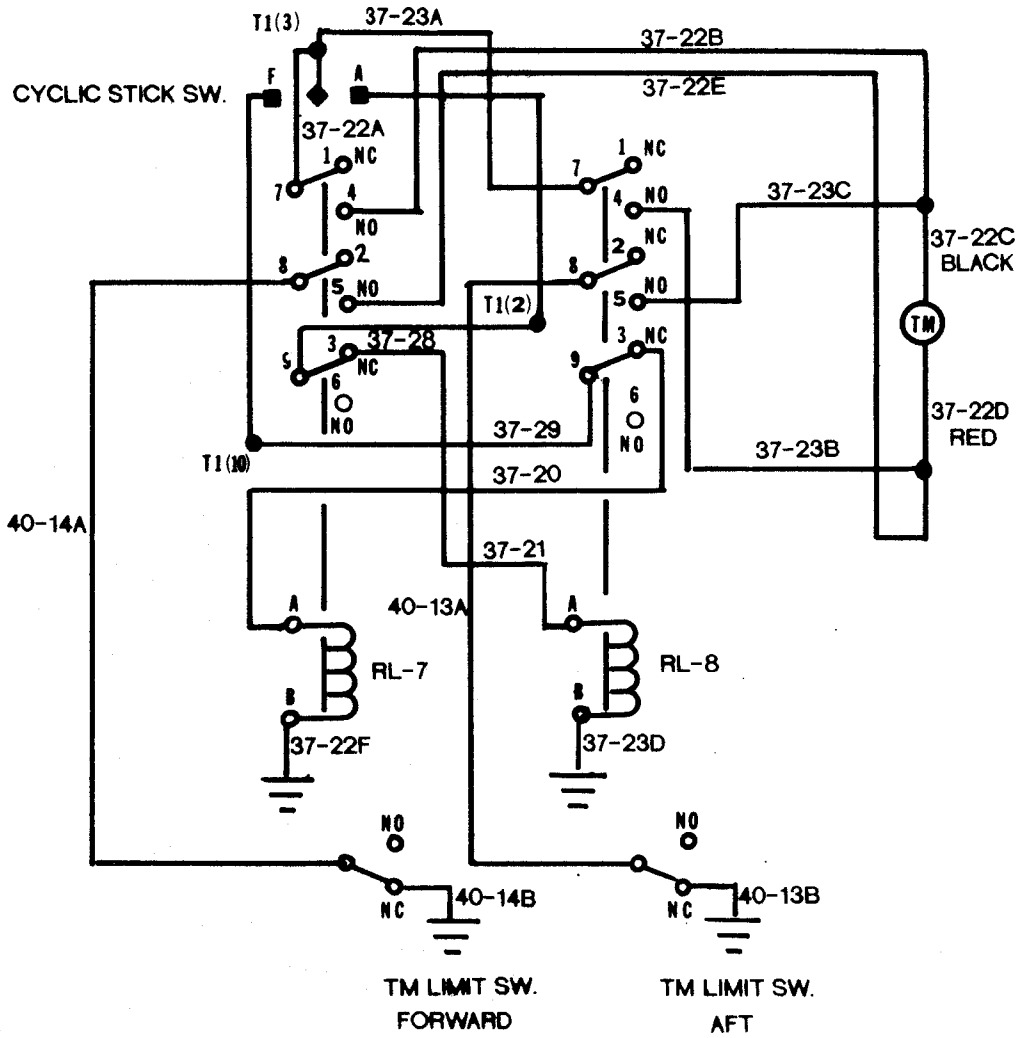
FIG. 1

LONGITUDINAL

- 5.3.2 On the longitudinal trim, relay RL-8, move wire # 40-13A from pin B to pin 8, move wire # 37-23D from pin 8 to pin B. On relay RL-7, move wire # 40-14A from pin B to pin 8, move wire # 37-22F from pin 8 to pin B.

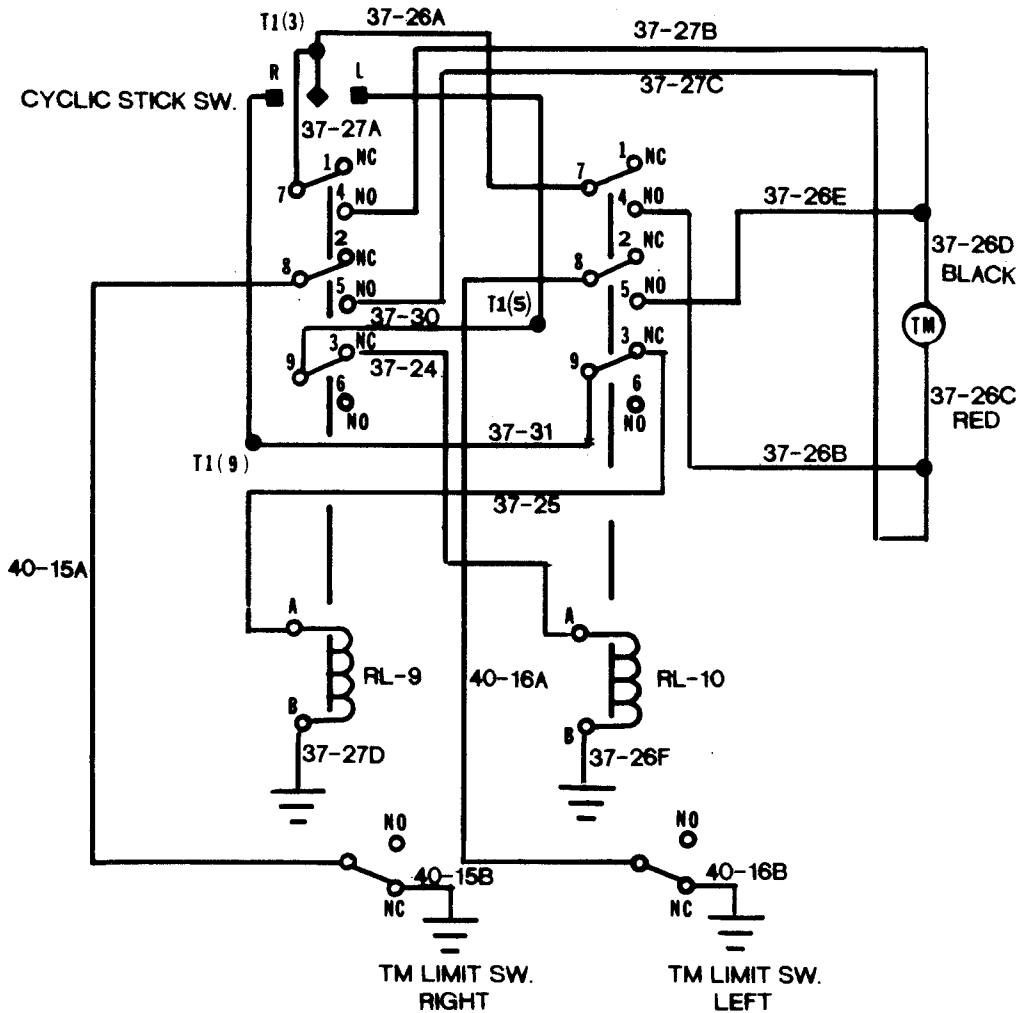
FIG. 2

LATERAL

- 5.3.1 On the lateral trim, relay RL-10, move wire # 40-16A from pin B to pin 8, move wire # 37-26F from pin 8 to pin B. On relay RL-9, move wire # 40-15A from pin B to pin 8, move wire # 37-27D from pin 8 to pin B.
