SERVICE DIRECTIVE BULLETIN NO. 0093

1. SUBJECT: Tail Rotor Control Cable Inspection
2. MODEL: F-28A, F-28C(-2), F-28F, 280, 280C, 280F, and 280FX
3. EFFECTIVITY: All serial numbers equipped with tail rotor control cable pulleys installed in the tailcone (Refer to paragraph 4)
4. BACKGROUND:

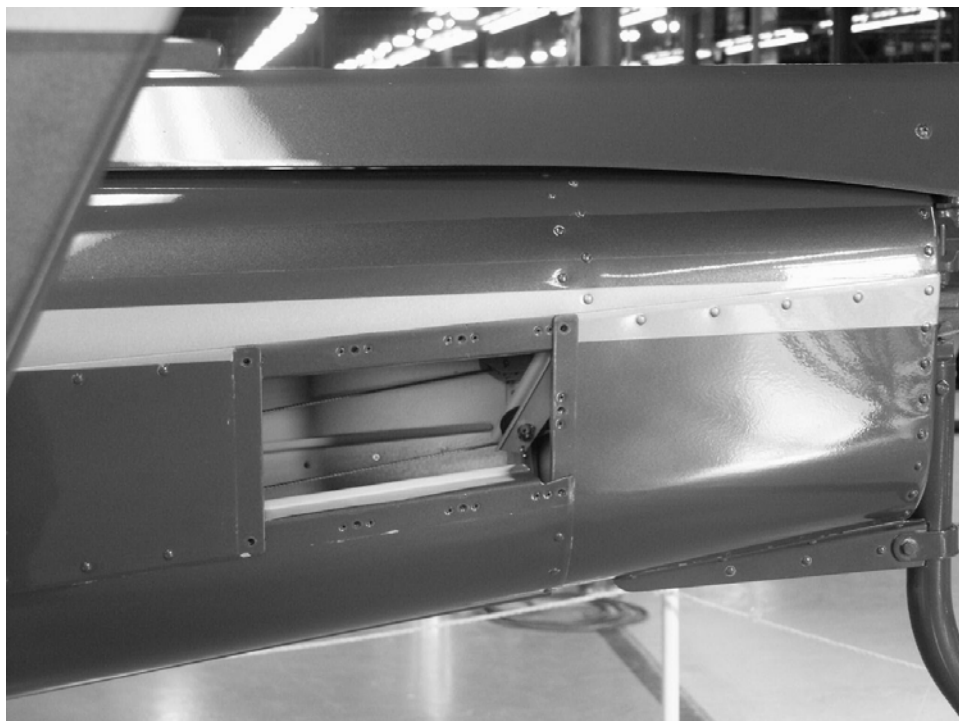
Figure 2. Access Panel Location

1. Remove the access panel located aft of the horizontal stabilizer on the left side of the tailcone (See Figure 2) and determine if the tailcone is equipped with the pulleys.
