SERVICE DIRECTIVE BULLETIN NO. 0107

DATE: November 7, 2008

1. SUBJECT: Wastegate Linkage Assembly
2. MODEL: F-28F, 280F, and 280FX
3. EFFECTIVITY: All
4. BACKGROUND:

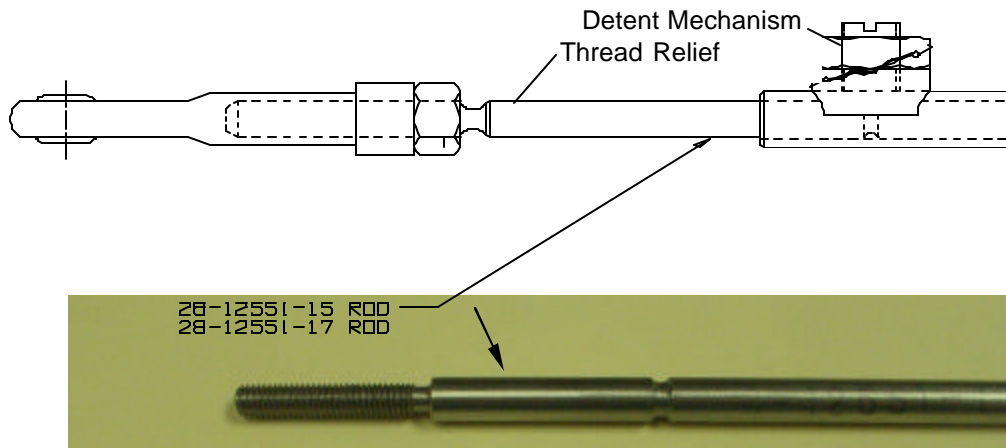
Enstrom received a field report of impaired throttle control due to the restrictor coming loose from the turbocharger bypass and jamming the wastegate. In the event of a jammed wastegate, the detent in the wastegate linkage is designed to break free and permit the linkage to telescope and allow the pilot to maintain throttle control. However, due to tolerance stack-up and the resulting wastegate rigging, after the linkage broke out of the detent, the detent locked into the thread relief near the end of the linkage rod and caused the throttle to lock in position. A change to the thread relief to prevent the detent from locking into the thread relief has been incorporated into the wastegate linkage assembly.

Figure 2. Former Wastegate Rod Assembly

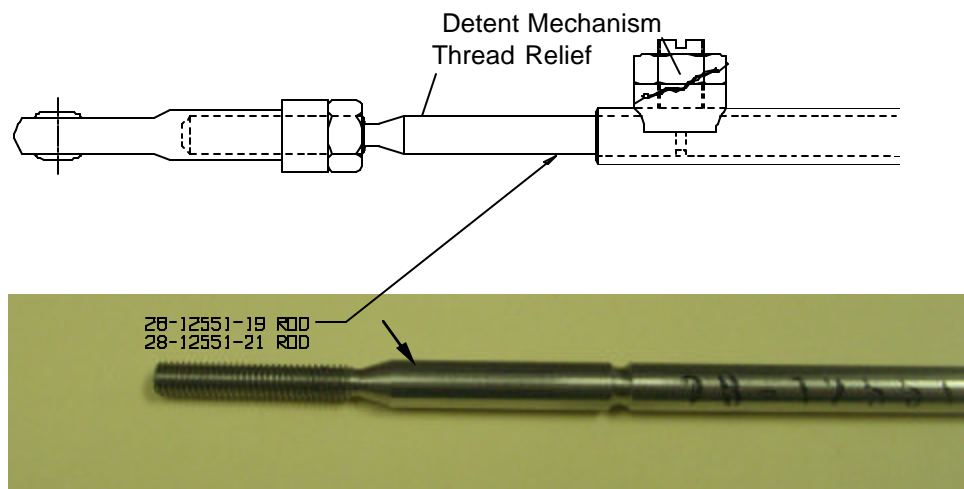
Figure 3. New Wastegate Rod Assembly

While no further action is required, Enstrom strongly recommends modifying or replacing the P/N 28-12551-15/-17 rod with a P/N 28-12551-19/-21 to eliminate any potential interference in the future.

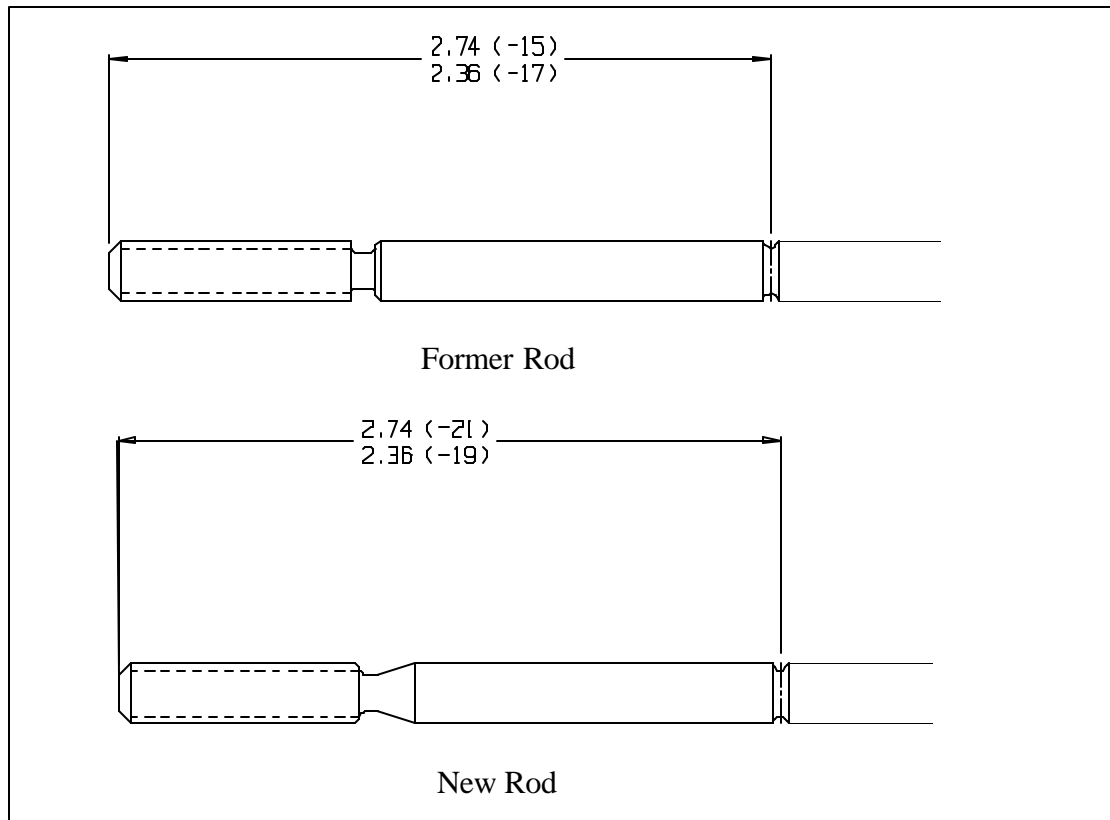
Figure 4. Wastegate Rod Part Number Determination

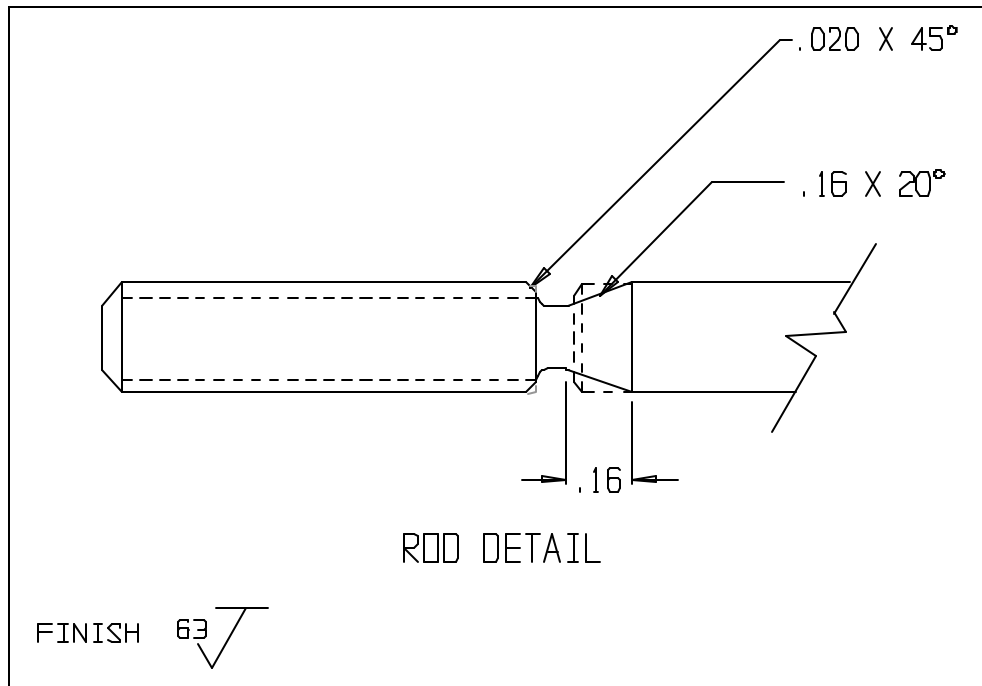
Figure 5. Existing Rod Modification to the New Rod Dimensions

- A. Disassemble the wastegate linkage assembly. To modify the existing rod, proceed to Step B. To replace the rod, proceed to Step C.
- B. Modify the existing rod in accordance with Figure 5 and proceed to Step D.
 - (1) Use a manual or CNC lathe.
 - (2) Turn a 0.16" by 20° chamfer as shown.
 - (3) Turn a 0.02" by 45° chamfer as shown. Break sharp corners.
 - (4) Minimum 63 surface finish required.
- C. Determine whether to install P/N 28-12551-19 or P/N 28-12551-21 by measuring the section of the old rod at the location shown in Figure 4. For 2.74", install the -21 rod. For 2.36", install the -19 rod.
- D. Reassemble the wastegate linkage assembly with the modified or new rod (Figure 2). Do not overtorque the spring plunger nut. Torque the nut 12-15 in-lbs/1.4-1.7 N-m.
