SERVICE DIRECTIVE BULLETIN NO. 0108

1. SUBJECT: Cracked Pylons
2. MODEL: F-28F, 280F, and 280FX
3. EFFECTIVITY: All Serial Numbers
4. BACKGROUND:

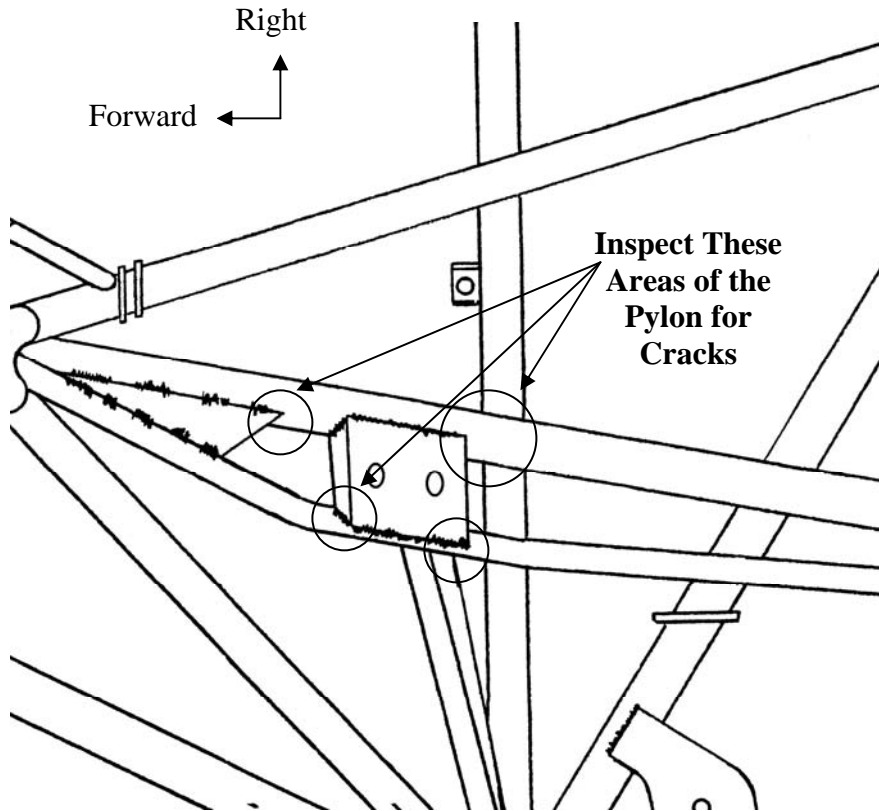
Figure 1. Pylon (Viewed from Top)

Enstrom recently received reports of 4 cracked pylons. The failures occurred in the area adjacent to the mounting bracket for the belt tension assembly bracket (Refer to Figures 1 and 2). Refer to Enstrom Service Information Letter SIL 0152 for additional information.

- A. Remove the cowling to gain access to the pylon in the area of the belt tension assembly.
- B. Using a 10-power glass, inspect the pylon area adjacent to the belt tensioning assembly mounting bracket and the gusset for cracks and other damage. (Refer to Figures 1 and 2).

- 1.) If no damage is found, continue to Step C.
 - 2.) If damage is found, contact Enstrom Customer Service for repair instructions and to report the aircraft serial number and time in service, and the serial number, part number, and manufacturer of the drive belt.

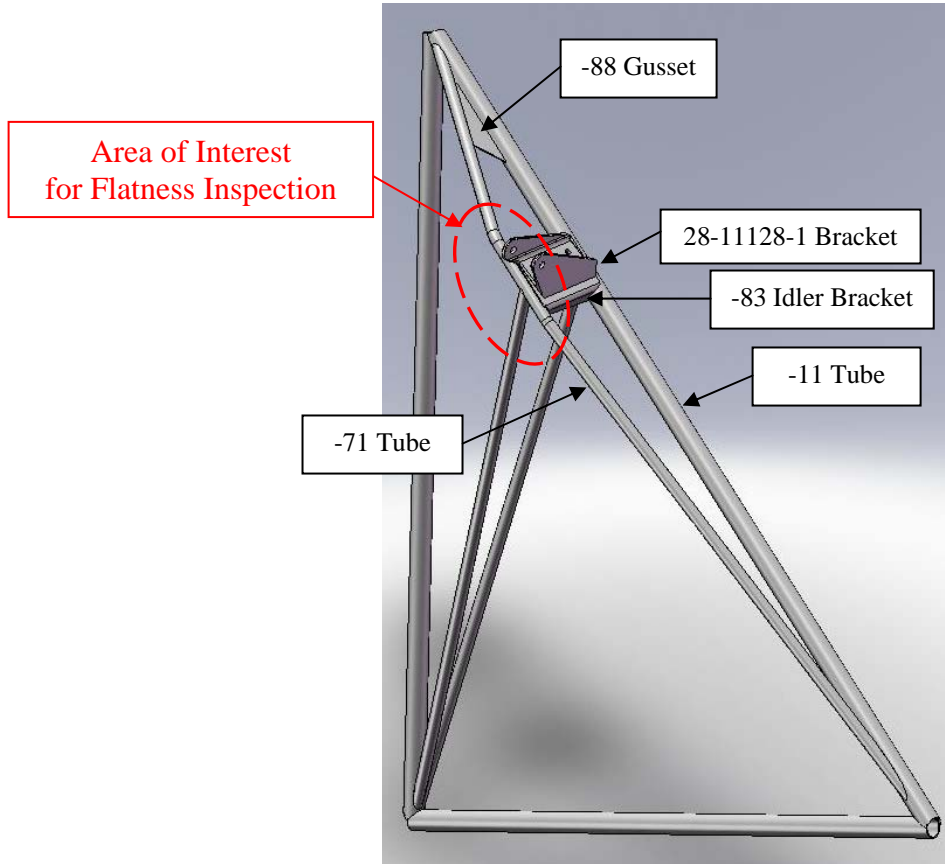
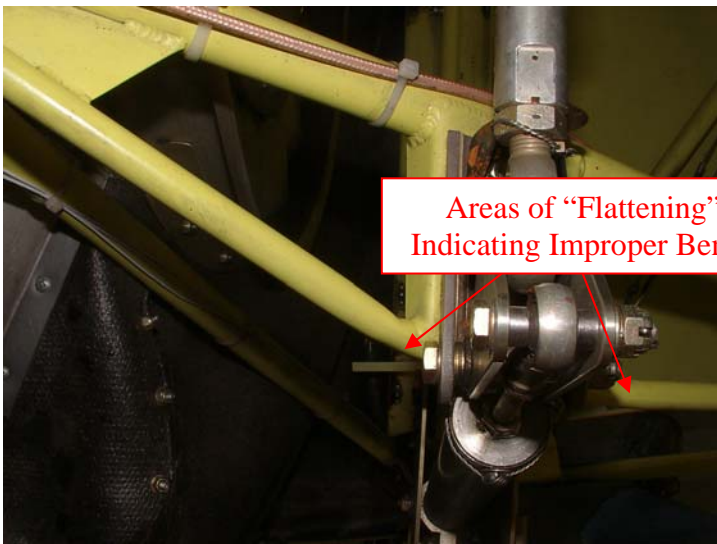
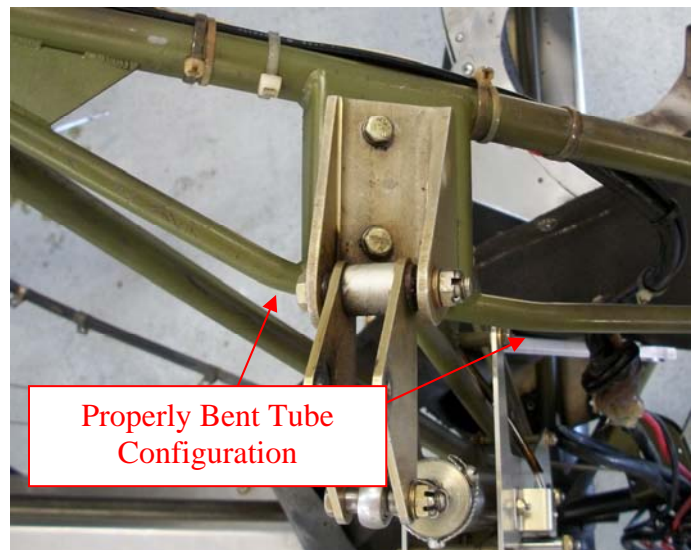
Figure 3. Flatness Inspection Criteria

Enstrom has determined the cracked pylon tubes were assembled with improperly bent pylon tubes in two places. Figure 3 depicts improperly bent and properly bent tubes for reference. Flattening of the smaller tube is evident in both bends on the tube in the improperly bent configuration.

- C. Inspect the pylon tube in the area adjacent to the belt tensioning assembly mounting bracket for flattening in the bend (Refer to Figures 3 and 4).

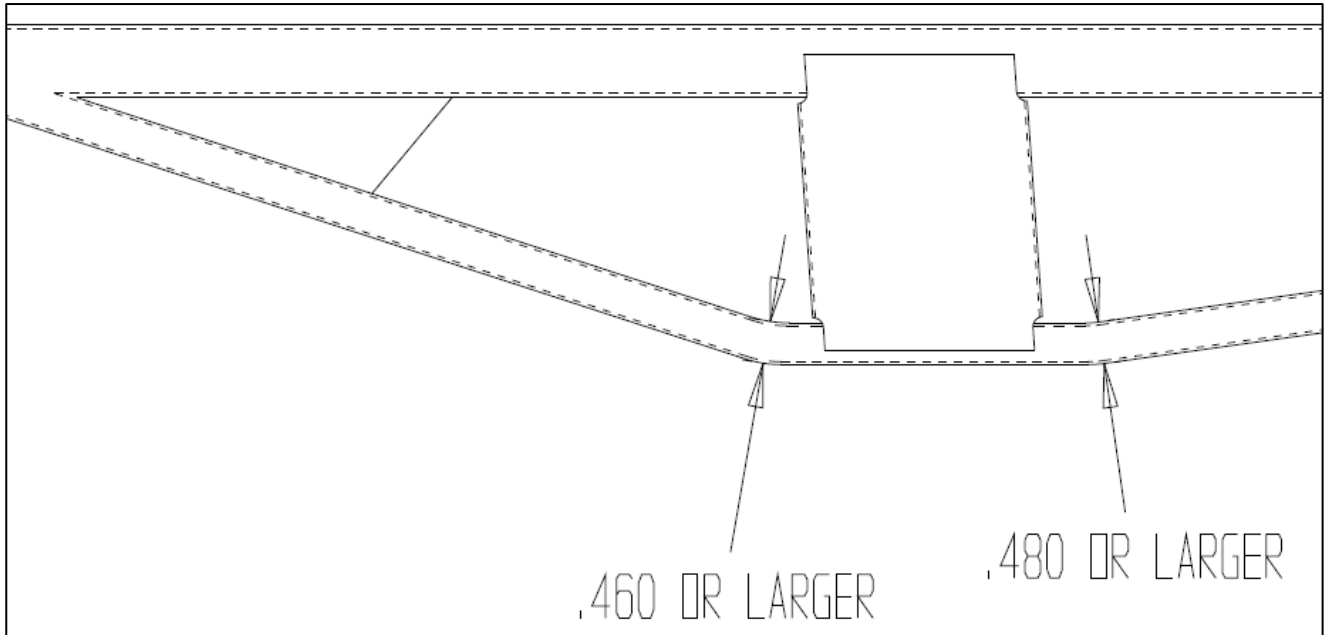
Figure 4. Minimum Dimensions for Tube in the Bend Areas

- 1.) If the width of the tube in the areas shown is greater than the dimensions shown in Figure 4, return the aircraft to service.
 - 2.) If deformation or flattening of the bends in the tube is found, and the resulting tube thickness is less than that shown in Figure 4, contact Enstrom Customer Service to report the aircraft serial number and time in service and conduct 25 hour repetitive inspections as detailed in Paragraph 11.

- A. If no flattening of the bends in the tube was found in Step 5.1(C), inspect the pylon for cracks in accordance with paragraph 5.1.B at each 50-hour (per SIL 152) inspection.
- B. If flattening of the bends in the tube is present, inspect the pylon for cracks in accordance with paragraph 5.1.B every 25 hours in service.
