SERVICE DIRECTIVE BULLETIN NO. 0110

1. SUBJECT: Cyclic Trim System – Cyclic Trim Assembly Kit for the Lateral and

Longitudinal Trim Actuator Assemblies

2. MODEL: All F-28F, 280F, and 280FX models equipped with 24 volt D.C. system;

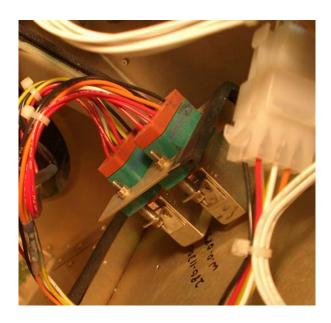
Figure 1: Trim Relay (M83536/10-024M Relay Shown)

This condition can only occur on aircraft equipped with P/N KUP14D55-24, KUP14D55-472, M83536/10-015M, or M83536/10-024M trim relays (Figure 1). Aircraft equipped with solid state trim switch units P/N 4199059-1 or 4192102-() (Figure 2) are not at risk because those units do not have a failure mode that could cause a runaway. Aircraft equipped with a reversible trim motor, P/N 28-16621 (Ford Motor Co. C1AZ-14553A) or P/N AD1R-10 (Signal Electric), are not at risk because the trim system does not use relays or solid state trim switch units. NOTE: If the electric motor on the trim actuator has three wires, it is not affected. All motors in systems with relays or solid state trim switch units have only two wires.

Compliance with this SDB must be completed within the next 5 hours or at the next annual or 100 hour inspection, whichever occurs first, for aircraft equipped with P/N KUP14D55-24, KUP14D55-472, M83536/10-015M, or M83536/10-024M trim relays. See Figure 1 for a pictorial example of a relay. Note: This includes aircraft modified per SIL 0164.

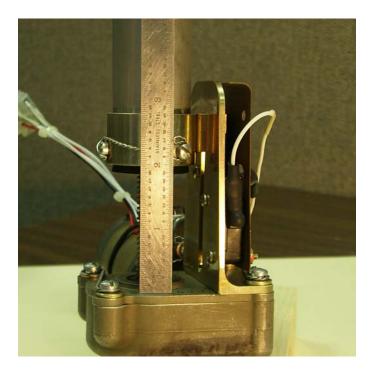
Figure 3: Maximum Stroke Limit at 1.95"

- L. Apply power to the trim actuator assembly to check and adjust the travel of the spring housing.
 - 1. Install the electrical connectors.
 - 2. Both trim actuator assemblies can be electrically tested from either the left or right hand side of the aircraft, whichever location is more convenient. Set the trim actuator assembly on a portable bench or suitable stable surface to perform the check and adjustments.
- M. Check the spring housing travel and adjust the switch positions to ensure that the retracted and extended spring housing travel are within the limits specified on the drawing or as determined in the note below. Enlist a second person to assist with the cyclic operation while conducting measurements and adjustments (Figure 3).

The retracted travel or minimum stroke limit is 0.125" +0.075"/-0.00". The extended travel or maximum stroke limit is 1.95" +0.00"/-0.05".

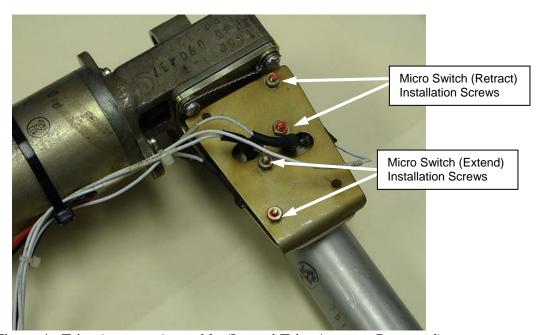
Figure 4: Trim Actuator Assembly (Lateral Trim Actuator Retracted)

- 1. To adjust the spring housing travel, loosen the switch mounting hardware to set the switch position(s) as necessary to bring the spring housing travel within limits. For example, to shorten the spring housing extension, loosen the switch mounting hardware for the extending switch and adjust the switch position inward (Figure 4).
- 2. Check spring housing travel to verify that proper adjustment was made.
