## SERVICE DIRECTIVE BULLETIN NO. 0121

DATE: March 21, 2016

SUBJECT: 1. Mixture Adjustment Rod Assembly

2. MODEL: F-28C, F-28F, 280C, 280F, and 280FX

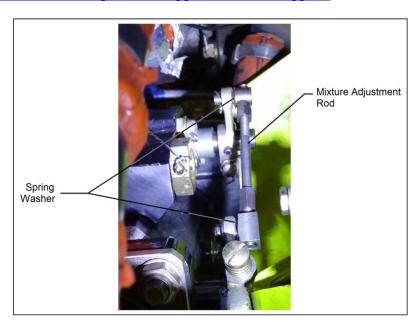
- Inspect that the two spring washers are installed in the proper location (Figure 1 and Figure 2). The spring washer should not be installed adjacent to the flat washer (cotter pin side, Figure 3).
  - 6.1.1 Open the pilot side engine access panel.
  - Locate the mixture adjustment rod assembly on the engine side of the fuel 6.1.2 injection servo.
  - 6.1.3 Using a bright light source, check that a spring washer is installed between the mixture control arm and the mixture adjustment rod and between the throttle control arm and the mixture adjustment rod. Twist the throttle grip to move the throttle for a better view of both ends of the mixture adjustment rod assembly.

Figure 1 - Mixture Adjustment Rod Assembly (as viewed through the left engine access panel) (See Figure 2 for additional detail)

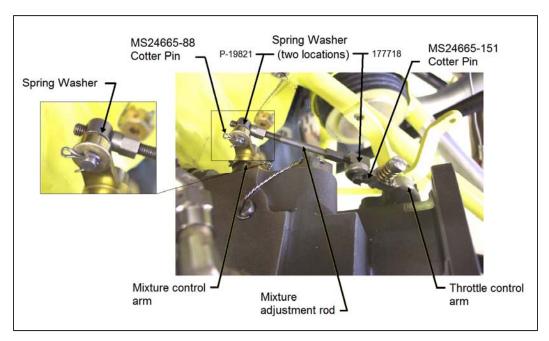
Figure 2 – Mixture Adjustment Rod Assembly (close-up of spring washer installation for the mixture control arm shown on left side, as viewed through the cabin engine access window)

- 6.3.4 Install the spring washer between the mixture adjustment rod and the mixture control arm and/or between the throttle control arm and the mixture adjustment rod, as applicable.
- 6.3.5 Install the mixture adjustment rod.
- 6.3.6 Install the flat washer.
- 6.3.7 Install cotter pin (see Parts).
- 6.3.8 Reinstall the firewall access panel in the cabin firewall, the back access panel, and the seat cushions.
- 7. PARTS: MS24665-88 Cotter Pin (mixture control arm); MS24665-151 Cotter Pin (throttle control arm)
- 8. SPECIAL TOOLS: None
- 9. MAN-HOURS: Inspection 5 minutes
- 10. WARRANTY: Per Enstrom New Helicopter Warranty policy
- 11. WEIGHT CHANGE: None
- 12. LOG BOOK ENTRY: Enter compliance with this SDB in the aircraft maintenance records.
- 13. REPETITIVE ACTION:

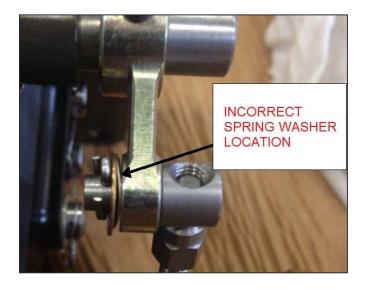
During a recent installation of a fuel injection servo at the Enstrom factory, it was discovered that spring washers were installed on the wrong side of the mixture control arm and the throttle control arm (at both ends of the mixture adjustment rod assembly).

Figure 3 – Incorrect Spring Washer Installation (assembly removed for clarity)

- 6.2 If the spring washers are installed correctly, no further action is necessary.
- 6.3 If a spring washer is not installed correctly, proceed as follows:
  - 6.3.1 Remove the seat cushions, remove the back access panel in the fiberglass seat deck, and remove the firewall access panel from the cabin firewall.
  - 6.3.2 Remove the cotter pin (Figure 2).
  - 6.3.3 Remove the mixture adjustment rod from the mixture control arm and/or the throttle control arm, as applicable. Retain the flat washer and the spring washer.
