SERVICE INFORMATION LETTER NO. T-041

1. SUBJECT: Blade Tape Repair
2. MODEL: TH-28, 480 and 480B
3. EFFECTIVITY: All
4. BACKGROUND:

This SIL (Service Information Letter) defines the procedures for making small repairs to the 3M 8681HS tape when installed on Enstrom 28-14100 series main rotor blades.

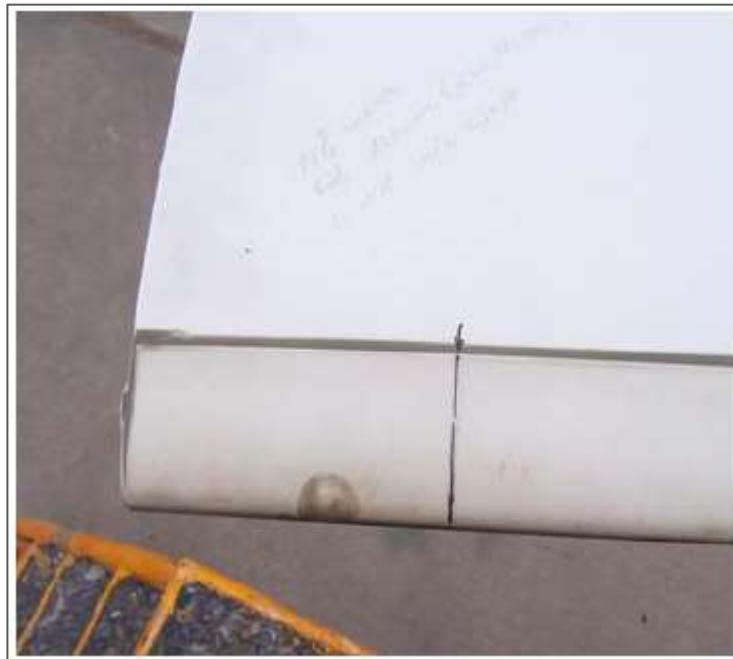
Figure 1. Area marked for blade tape repair

- 6.1 Mark a line on the blade on either side of the damaged section at right angles to the edge of the tape line (Figure 1).
- 6.2 Use a razor blade to cut the tape along this line.

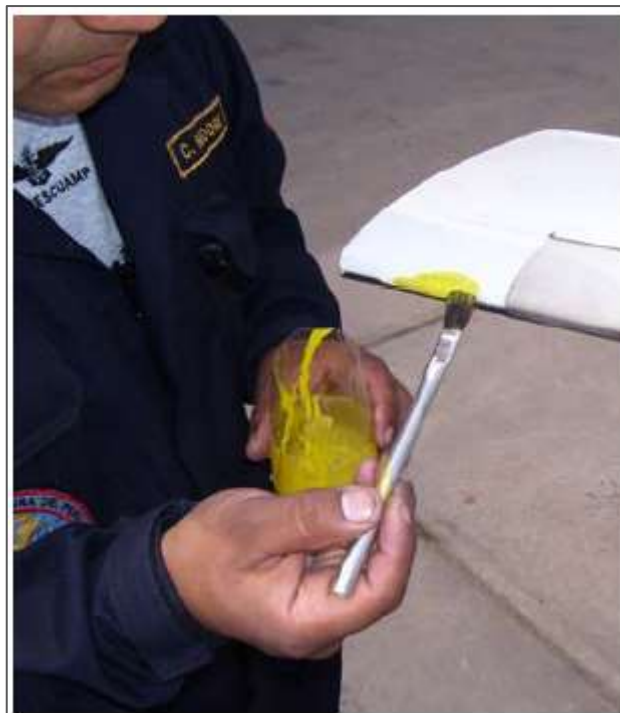
Figure 2. Primer applied to exposed area

- 6.3 Carefully remove the section of tape between the cut lines.
- 6.4 Use a sharp blade or knife to scrape the gray epoxy edge sealer from the top and the bottom of the blade tape line. Take care not to damage the paint on the blade.
- 6.5 Use sandpaper (400 grit) to remove any corrosion on the blade and treat as follows:
 - 6.5.1 The area to be taped must be coated with MIL-PRF-23377 epoxy primer or equivalent or quality top coat paint such as Axalta's Imron AF400 or similar prior to application (Figure 2).
- 6.6 Stretch a piece of masking tape along the forward edge of the epoxy tape sealer on the top of the blade.
- 6.7 Cut a repair piece of tape from the 8681HS tape that is a total of 1/8 inch (3.2 mm) shorter than the area of the tape that has been cut out for repair.

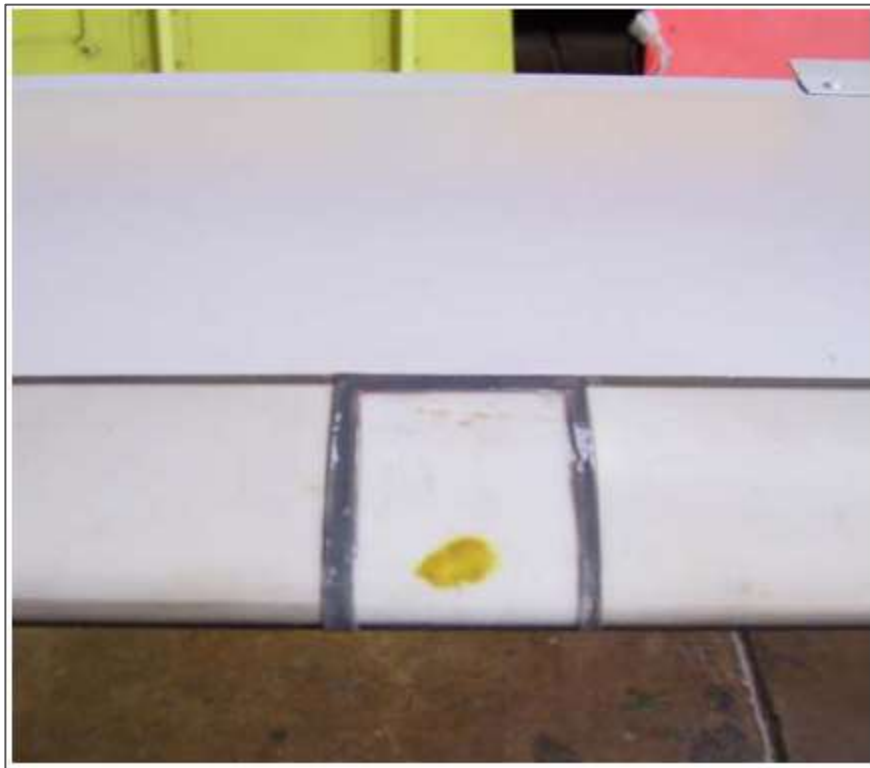
Figure 3. Sealant applied to blade tape repair edges

- 6.16 Apply sealant between the masked off area and use a stiff applicator, or your finger, to screed off the excess sealant. Immediately remove the strips of masking tape to allow the sealant to flow to a nice tapered edge. DP190 will gel in 90 minutes at 72 °F (22 °C) and full cure will be achieved in about 8 hours. It will cure faster in warmer temperatures and slower in colder temperatures (Figure 3).
