THE ENSTROM HELICOPTER CORPORATION
TWIN COUNTY AIRPORT, P.O. BOX 490, MENOMINEE, MICHIGAN 49858

SERVICE INFORMATION LETTER

SERVICE LETTER NO. 0031

Date: May 31, 1973
Subject: Collective Friction Lock Assembly
Model: F-28A
Serial No: As Noted

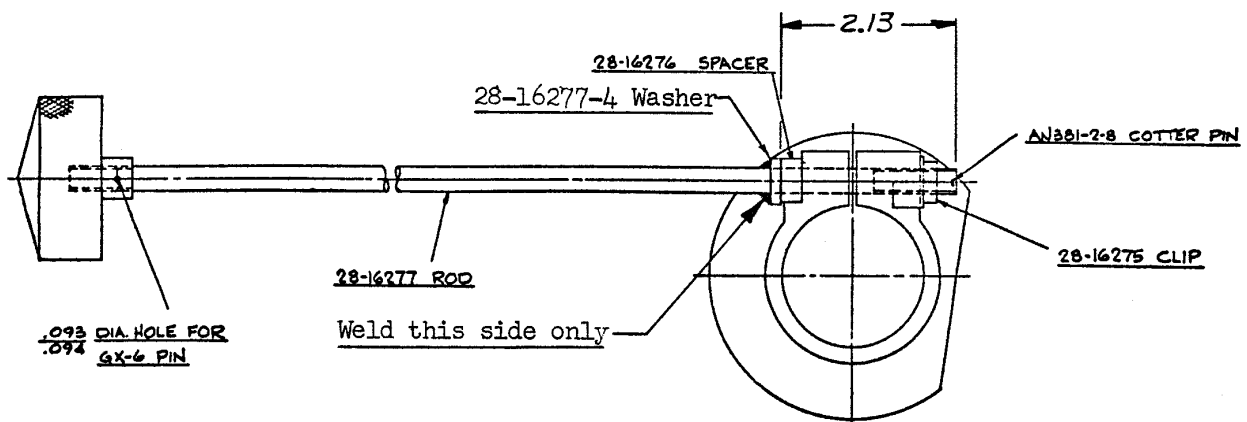
Two instances have been reported in which the 28-16277-4 washer separated from the 28-16277-3 rod because of faulty brazing. To preclude the possibility of failure, these two parts are now welded.

This modification may be accomplished in the field by polishing off all traces of brazing from the friction rod and welding a new 28-16277-4 washer to the rod, in accordance with accepted aircraft welding practice.

New washers are immediately available in stock and may be ordered at your convenience. Modified rods are also immediately available if replacement is preferred.
