THE ENSTROM HELICOPTER CORPORATION
TWIN COUNTY AIRPORT, P.O. BOX 490, MENOMINEE, MICHIGAN 49858

SERVICE INFORMATION LETTER NO. 0106

Date: November 13, 1980
Subject: Cockpit Mixture Control Friction Adjustment
Model: F-28C and 280C
Effectivity: Prior to S/N 495 and 1201

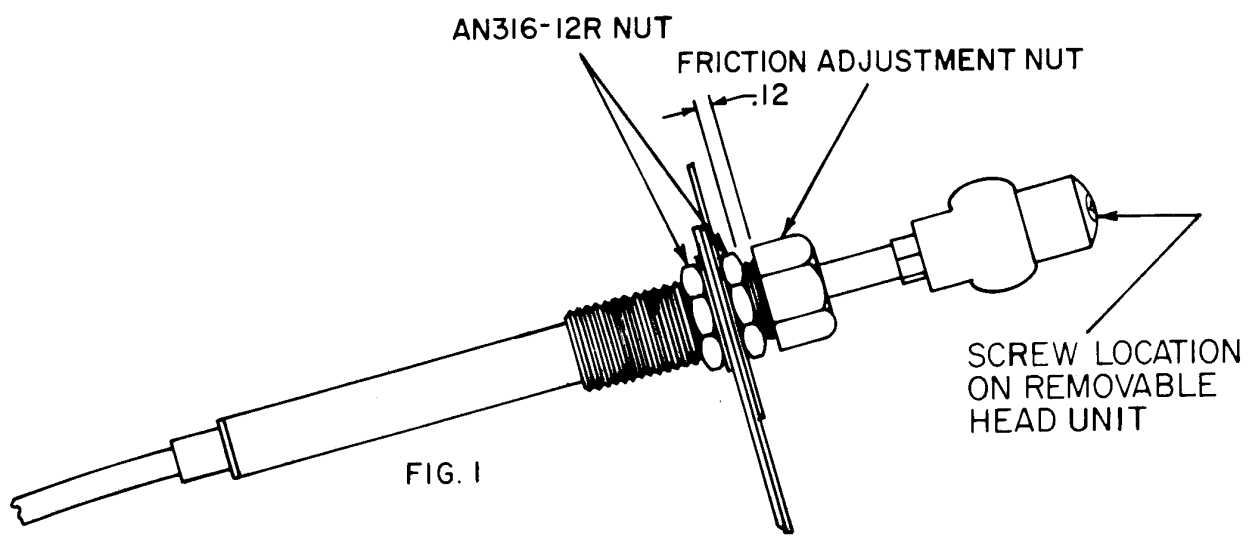
There have been reports that a decrease in friction on the mixture control shaft may occur with time. With reduced friction, normal ship vibration might cause the mixture control to rotate, changing the mixture setting. If unobserved, cylinder head temperatures and exhaust gas temperature could exceed limits, causing engine and/or turbocharger damage. Mixture control friction on all "C" model aircraft should be adjusted to provide sufficient "drag" to prevent rotation due to vibration, yet allow normal mixture adjustment without binding.

To provide a cockpit adjustable friction, the current installation must be modified by the addition of another AN 316-12R nut to the configuration shown in Figure 1. It is recommended that this change be made at the owner's earliest convenience, or at the next 100 hour inspection.

Remove the console cover to gain access to the AN 316-12R nut to loosen the #57-3255- 2113 vernier mixture control on the back side of the console. Loosen the AN 316-12R nut to allow movement of the mixture control outward or into the cabin for approximately 1/4 inch. Remove the screw from the button on the mixture control handle. Remove the button, spring and knob. Remove the large hex nut and packing from the control shaft and adjust it on the threaded portion as shown in Figure 1. Reassemble the large hex nut and packing, knob, spring, button and screw.

Readjust the position of the control by loosening the AN 316-12R nut inside the console and readjusting the AN 316-12R nut on the face of the console to allow clearance for rotation of the large hex nut and packing. With the friction adjusted properly, the AN 316-12R nut on the face of the console should be located to allow .120 inch of thread between it and the large hex nut as shown in Figure 1. Future friction adjustments can be made by varying the torque on the large hex nut by finger pressure without disturbing the mounting position of the control.
