SERVICE DIRECTIVE BULLETIN

SERVICE DIRECTIVE BULLETIN NO. 0126

DATE: July 6, 2023

1. SUBJECT: Cabin Bellcrank Mounts and Bellcrank Attachment Inspection
2. MODEL: F-28A, 280, F-28C, F-28C-2, F-28C-2R, 280C, F-28F, F-28F-R, 280F, and 280FX
3. EFFECTIVITY: All S/N (Note special exclusion in paragraph 5.3.)

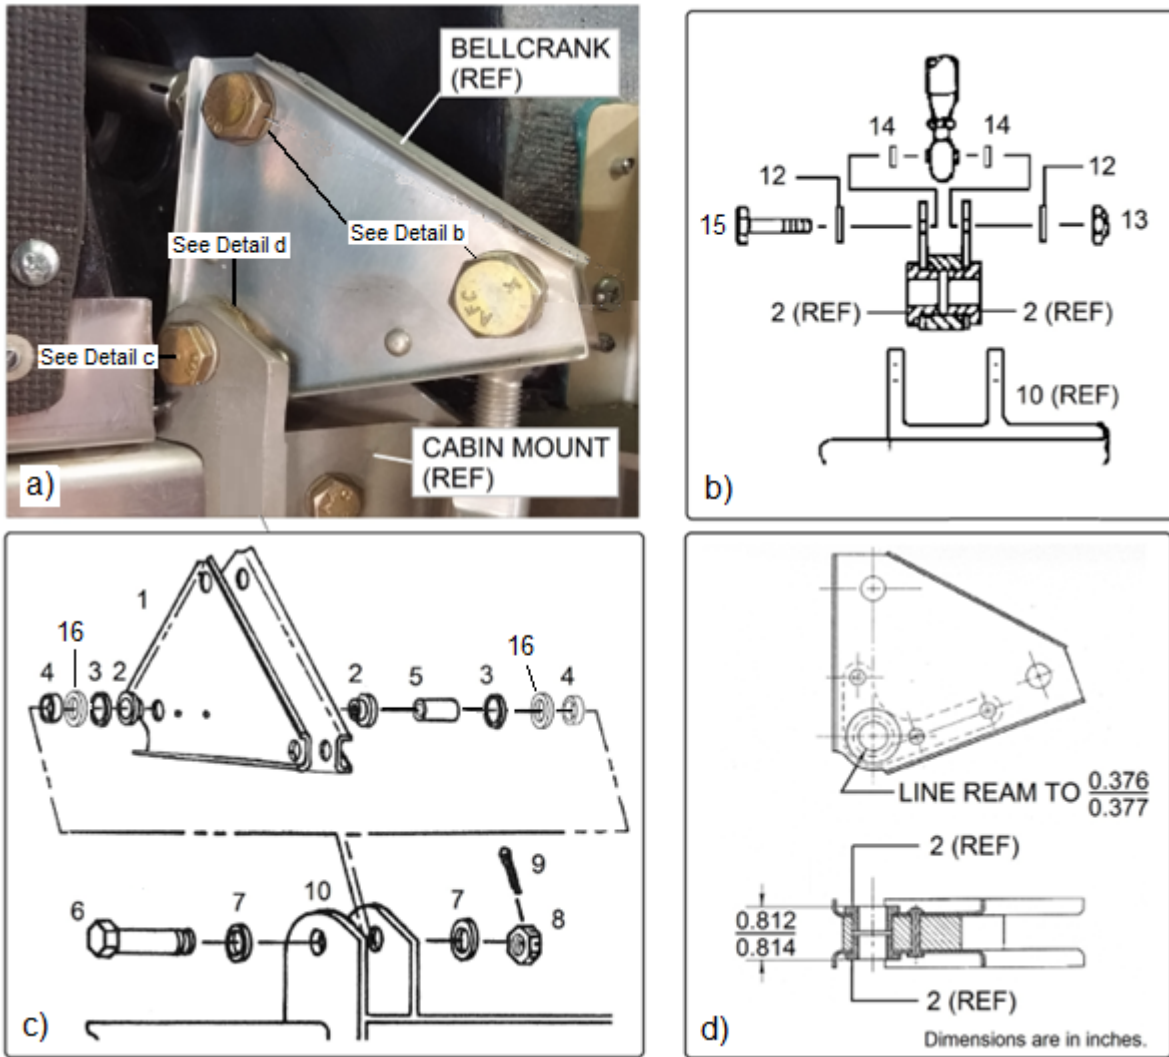
Figure 3. Cabin Mount, Control Tube, and Bellcrank Installation Detail

Looseness (side-to-side movement) in the bellcrank installation is attributed to worn bearings, loose hardware, or improper stack-up, whereas binding is attributed to interference caused by constriction in the joint. This occurs when the torque load is carried through the bearings and the cabin mount rather than through the internal spacer.

- 6.3.2.2 If the looseness is detected (deflection, audible clicking, slack between the bearings and washer, etc. is observed), the bearings and spacers (Figure 3-c, Items 2, 4, and 5) must be replaced.

- 6.3.2.2.1 Remove the control tube and bellcrank hardware (Figure 3-b, -c). Remove the bellcrank and press out the bearings (Figure 3-c, Item 2) from the bellcrank.

- 6.3.2.2.2 Install the new bearings.
- 6.3.2.2.3 Ream the bearings in accordance with Figure 3-d.
- 6.3.2.2.4 Install the bellcrank with new spacers (Figure 3-c, Items 4 and 5) and shims (Figure 3-c, Item 16), as required, and complete the installation (torque 50-70 in-lb/5.6-7.9 Nm).

- 6.3.3.2 If the binding is detected, remove the nut, spacers, shims (if present), washers, and bolt. Verify the length of the spacer (Figure 3-c, Item 5) (0.817/0.819"). File the hat-end of the bearing to reduce the thickness or protrusion. Deburr and remove any debris from the assembly.

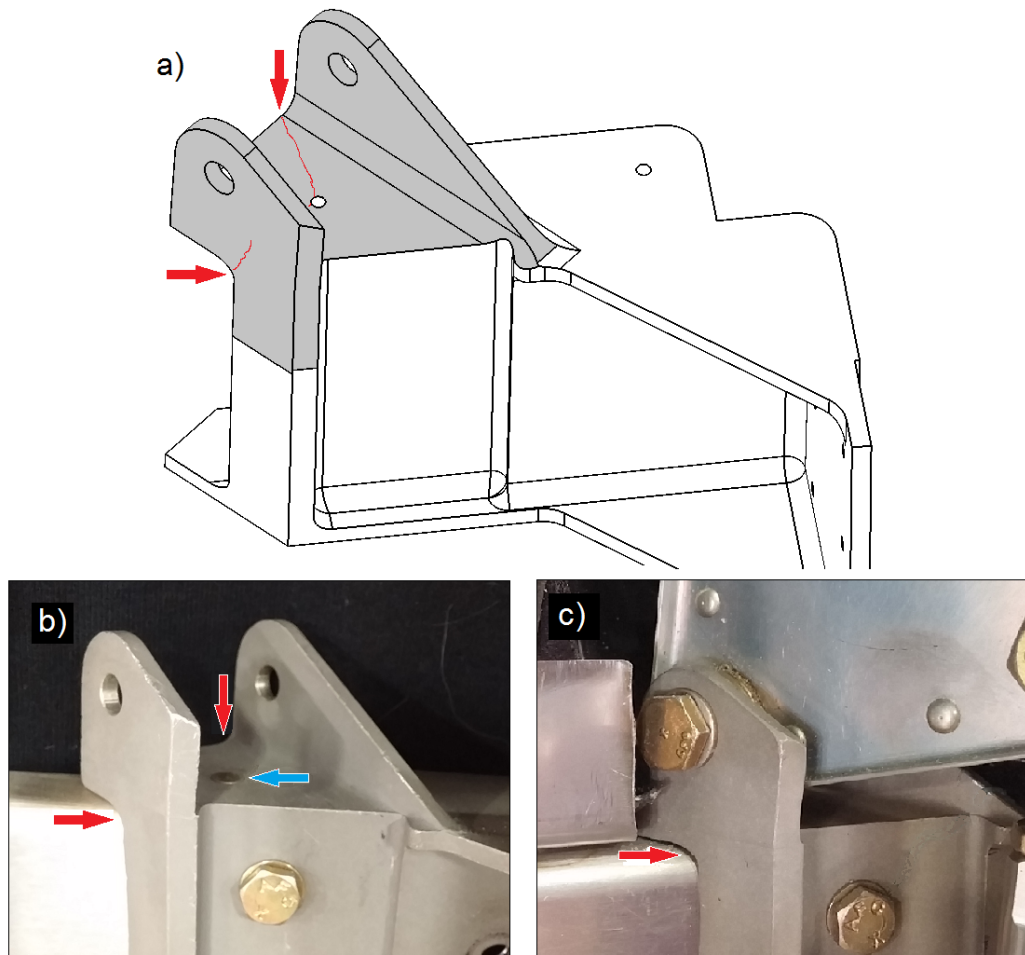
Figure 4. Upper Cabin Mount Inspection (LH Shown)

Enstrom has received a report of an in-flight separation of a P/N 28-11307-1 upper cabin mount. The upper cabin mount is also the cyclic bellcrank pivot bracket. This failure made lateral control nearly impossible. Analysis of the mount determined the separation was a result of metal fatigue initiated by corrosion and/or surface wear near the bellcrank pivot bolt. Damage on the bellcrank pivot hardware indicated relative movement between the components, which indicates that the joint was loose at one time.

All Views – Red Arrow Points to the Area for a Possible Crack

a) NDT Inspection Area (Shaded)

b) Actual Part (Incomplete Installation Shown); Blue Arrow – Rivet Inspection (Countersunk Rivet Shown)

c) Actual Part for Visual Inspection (Complete Installation Shown)

- 6.2.3 Use a solvent (denatured alcohol, mineral spirits, or equivalent) to remove grease or oil residue from the cabin mount.
- 6.2.4 With a bright light source and inspection mirror, visually inspect the cabin mounts for cracks, particularly in the area indicated in Figure 4-c.

- 6.1.7 Inspect the cabin mount for cracks using dye penetrant method. Follow the manufacturer's instructions. Refer to Figure 4 for the area to inspect.
- 6.1.7.1 Positive indication – Reject the cabin mount and replace with an airworthy cabin mount. Contact Enstrom Product Support for the replacement procedure.
- 6.1.8 If no indication, remove the dye products from the area per the manufacturer's instructions and inspect all visible rivets (countersunk and universal head) for condition and looseness. Replace loose rivets, as necessary.
- 6.1.9 Repeat 6.1.3 through 6.1.8 for the opposite side cabin mount or proceed to step 6.3.

- 6.2.4.1 If a crack is detected, reject the cabin mount and replace with an airworthy cabin mount. Contact Enstrom Product Support for the replacement procedure.

- 6.2.5 If no crack is detected, inspect all visible rivets (countersunk and universal head) for condition and looseness. Replace loose rivets, as necessary.

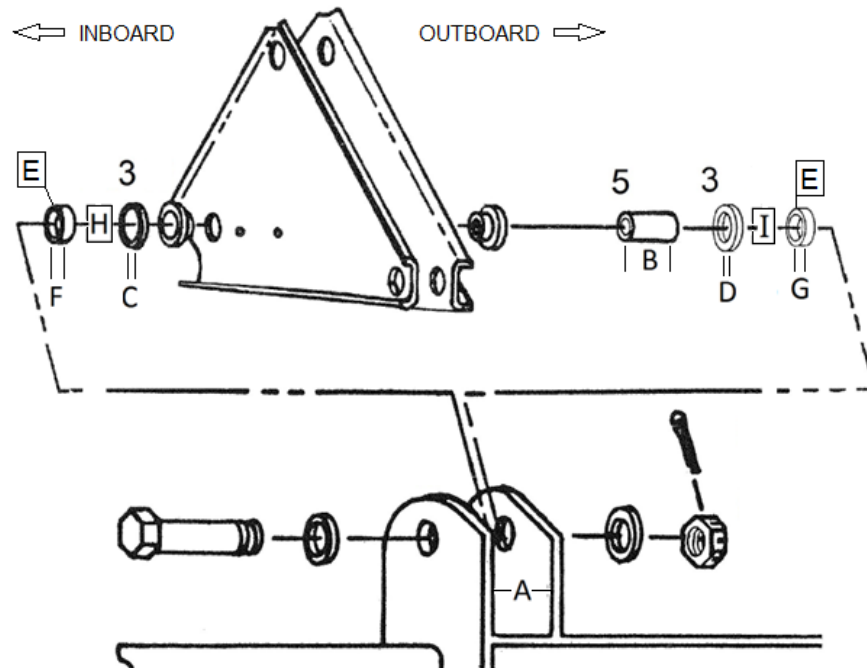
Figure 5. Hardware Stack-up Calculation

This procedure compares the measurement between the cabin mount ears and the calculated length of the hardware stack-up. Any deficiency in hardware stack-up is corrected by installing spacer P/N 28-16209-x (if required) and shim P/N 28-16217-x as required.

- 6.4 Hardware stack-up for the LH cabin mount. See Figure 5.
- 6.4.1 Measure the distance between the 0.250 inch diameter holes of P/N 28-11307-1 mount. This is Measurement A.

- 6.4.5 Solve for Δ using this formula: $A - (B + C + D) = \Delta$
- 6.4.6 Determine spacer (Item 4) selection from this formula: $\Delta / 2 = E$
- 6.4.6.1 Select spacer P/N 28-16209-1 if E value is ≥ 0.101 inch.

- 6.4.12 Install P/N 28-16217-x (Item 16) shims, as required, between Item 3 and Item 4, inboard and outboard, respectively.
- 6.5 Torque (50-70 in-lb/5.6-7.9 Nm) and safety the nut.
- 6.6 Repeat steps 6.4 and 6.5 for the RH cabin mount.
- 6.7 Reinstall the control tube covers, if installed.
- 6.7.1 Reinstall the four cover fasteners.
- 6.7.2 Reposition the boot and secure with cable ties.
- 6.7.3 Seal the cover edge with RTV sealant (Dow Corning 732, or equivalent).
- 6.8 Reinstall the fuel tanks.
- 6.9 Reinstall the seat structure cover.
7. PARTS:
