# SERVICE DIRECTIVE BULLETIN

SERVICE DIRECTIVE BULLETIN NO. 0077

Revision C

1. SUBJECT: Tail Rotor Spindle, Enstrom P/N 28-150064-11 and -13 Life Limit Addition
2. MODEL:    F-28F, 280F and 280FX Models, and any F-28C, F-28C-2 or 280C Models that have been converted to use the 28-150064-11 or -13 spindle
3. EFFECTIVITY: As addressed in Paragraph 2, Model, and in Paragraph 5, Compliance
4. BACKGROUND:

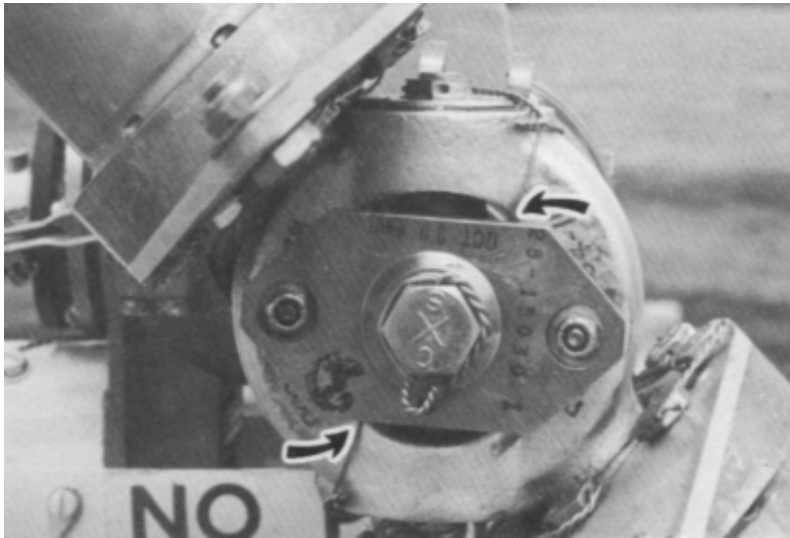
There had been reported incidents of cracked tail rotor spindles associated with spindles configured with tapered roller trunnion bearings. The majority were found by visual preflight inspection. One instance resulted in an emergency landing due to unbalance and high vibration as a result of the cracked spindle. In order to prevent any further such occurrences, Enstrom has established a service life limit of 1,200 hours on tail rotor spindles P/N 28-150064-11 and -13.

Conduct a close visual inspection for cracks in the area around the teeter bearing bores (see Figure 1). Any spindles found cracked must be removed and replaced with an airworthy component prior to the flight.

Figure 1: Areas of tail rotor spindle which require particular attention during pre-flight inspection.

5.3.6 Thoroughly clean spindle in the suspect area to the dye penetrant manufacturer's recommendations. See Figure 1.

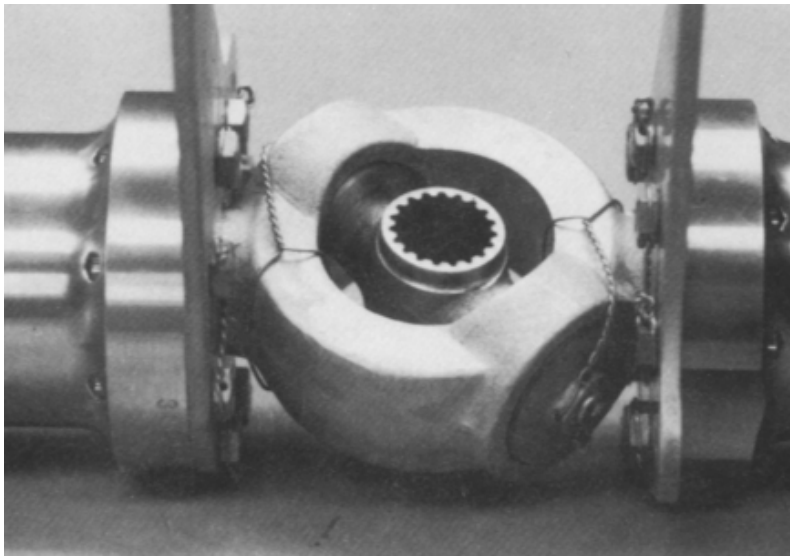
Figure 2: New safety wire method for teeter bearing cap retention.

5.3.9 After completion of the inspection, the bearing caps on the 28-150064-11 spindles must be re-safetied as illustrated in Figure 2. This illustration indicates the repositioning of the safety wire on the spindle which will allow an unobstructed view of the area to be inspected.

5.4 The tail rotor can now be reassembled and the teeter bearing caps safetied per Figure 2 (28-150064-11 spindles only).

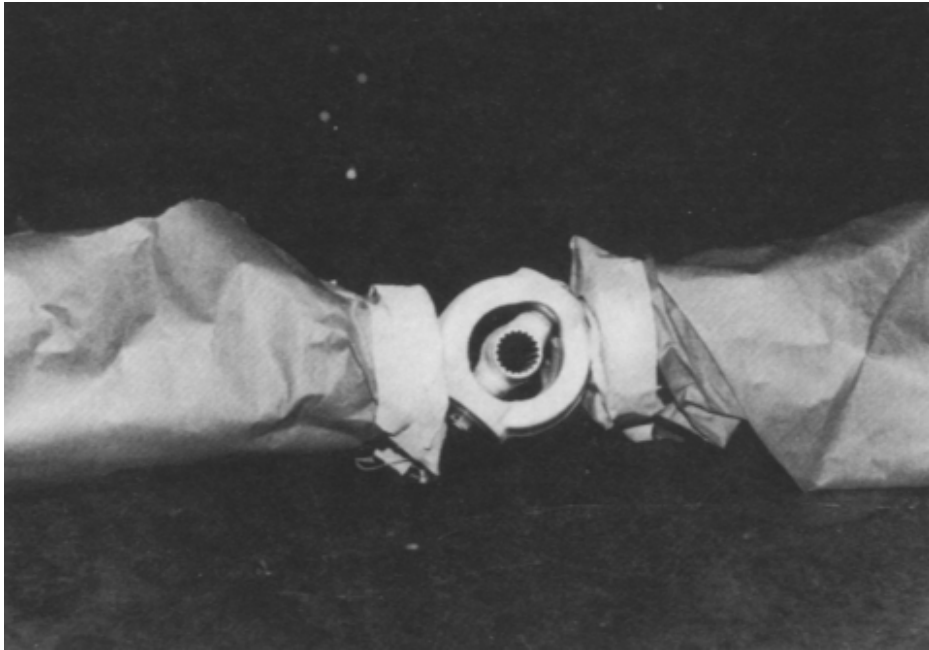
Figure 3: Tail rotor masked for dye penetrant inspection

5.3.7 Mask off blades and grips to prevent staining and proceed with the dye penetrant inspection per manufacturer's recommendations. See Figure 3.
