SERVICE DIRECTIVE BULLETIN

SERVICE DIRECTIVE BULLETIN NO. 0090

1. SUBJECT: 12 Vdc Voltage Control System Modification

2. MODELS: F-28A, 280, F-28C, and 280C Models

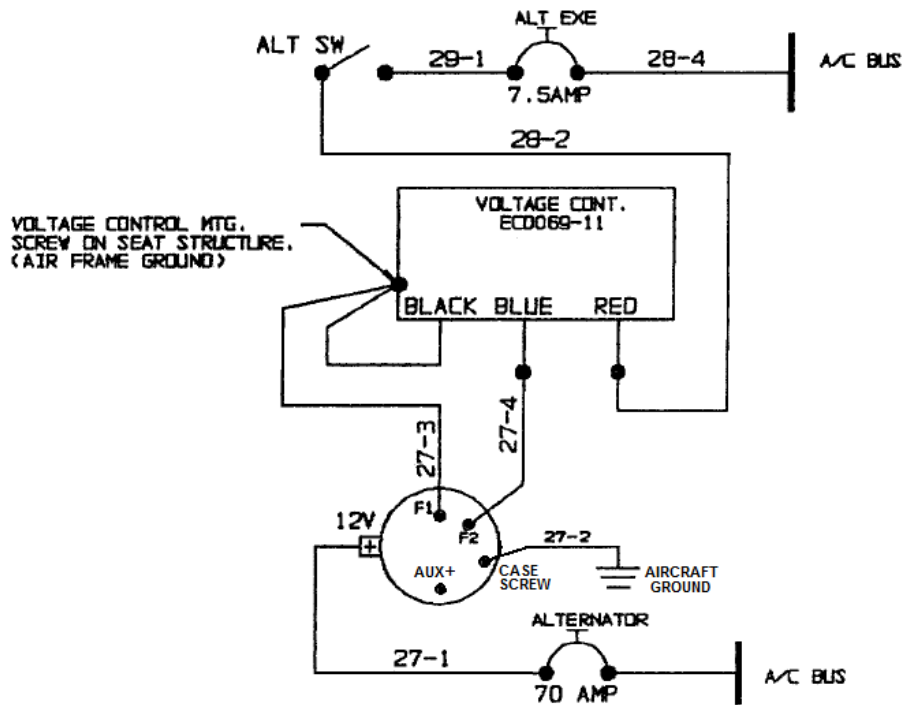
FIGURE 2. VOLTAGE CONTROL INSTALLATION

Revision 1 corrects the depiction of the alternator wiring connections and adds a step to the NOTES section to clarify the alternator ground wiring connection in Figure 2.

- 5.2.3.4. Refer to Figure 2 and install the electrical wiring for the voltage control, alternate switch, and the "ALT EXC." circuit breaker.
 - 5.2.3.5. If required, reinstall the battery.

- NOTES:
1. If the "ALT EXC." circuit breaker is already installed in the aircraft, disregard note 2 and do not modify the wiring from the bus side of the "ALT SW" to the aircraft bus.
 2. Connect wire 28-4 to the aircraft bus at one of the installed circuit breaker bus terminals.
 3. Connect the "BLACK" lead of the voltage control and wire 27-3 to the case ground/seat structure.
 4. Use 16 Gauge wire as required.
 5. F1 at alternator and the black lead of voltage control must be at the same ground potential.
 6. Connect the ground wire 27-2 to case ground. Do not connect it to the AUX+ terminal
 7. All wiring to be accomplished in accordance with AC 43B-1A.
