SERVICE DIRECTIVE BULLETIN

SERVICE DIRECTIVE BULLETIN NO. T-006

DATE: February 13, 1997

1. SUBJECT: Cracked Isolation Mount Weldment
2. MODEL: TH-28 and 480 Helicopters
3. EFFECTIVITY: Model TH-28: Serial Numbers 3004 and 3006.
Model 480: Serial Numbers 5001 through 5017.
4. BACKGROUND:

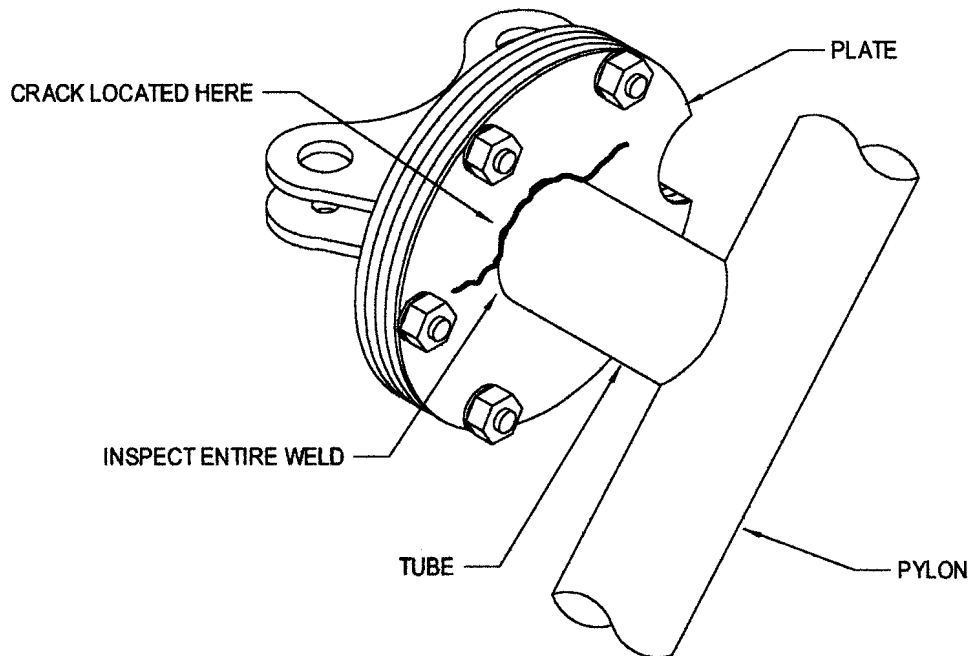
FIGURE 2

Enstrom has received two reports from the field of a cracked isolation mount weldment. The cracks occurred at the weldment between the plate and the tube (see Figure 2).

The isolation mount weldment is welded to the pylon and is the mounting structure for the lower pulley isolation mount assembly.

Within the next 5 hours time in service, visually inspect the isolation mount weldment for cracks between the plate and the tube.

1. Open the right side engine access panel and remove the access panel covering the steps and oil cooler heat exchanger (see Figure 1).
2. Clean the isolation mount as required.
3. Visually inspect the weld between the plate, the tube, and the surrounding area for cracks using a flashlight and mirror (see Figure 2).
4. If cracks are found, repair the isolation mount weldment in accordance with the repair procedure in Appendix A of this Service Directive Bulletin.
