SERVICE DIRECTIVE BULLETIN NO. T-033

Revision 1

1. SUBJECT: Inspection of Tailcone Skins, Flanges, and Longerons
2. MODEL: TH-28, 480, and 480B
3. EFFECTIVITY: All Serial Numbers
4. BACKGROUND:

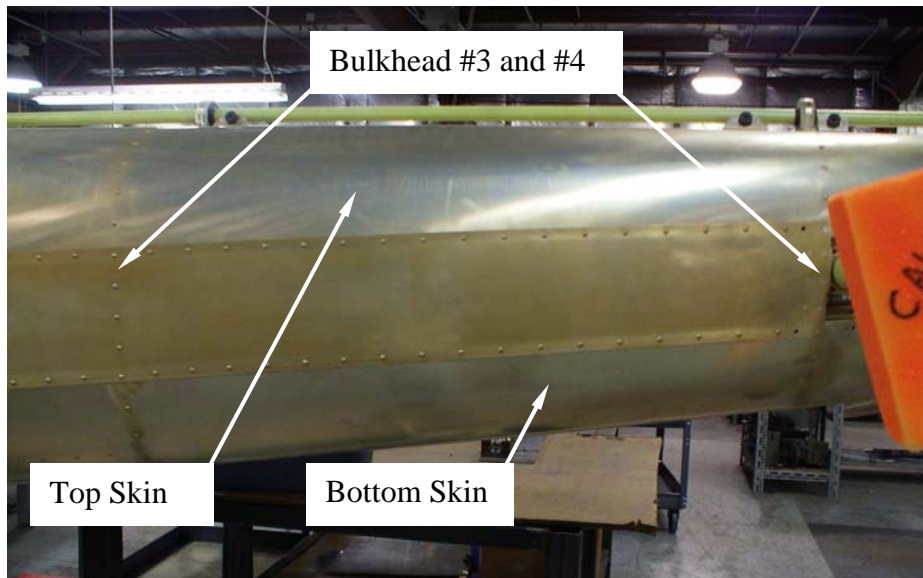
Figure 1. Tailcone Structure – Top and Bottom Skins and #3 and #4 Bulkheads

- A. Visually inspect the top and bottom skins along the entire length of the tailcone for cracks, bends or dents. Reference Figure 1.
- B. Visually inspect the V-rib along the bottom skin for any cracks, bends, or dents. Reference Figure 2.
- C. Dents that are less than 3" (76.2 mm) long and less than 3" (76.2 mm) wide and 1/8" (3.175 mm) deep or less are allowed in the areas shown in Figure 4. No dents are allowed in areas of tighter radii, rivet lines, or in the V-rib.
- D. If cracks, bends, or dents that exceed the size allowance are detected, or are outside the allowable areas, they must be repaired in accordance with paragraph 5.3.

5.3. REPAIR:

- A. Contact Enstrom Product Support for repair procedures.

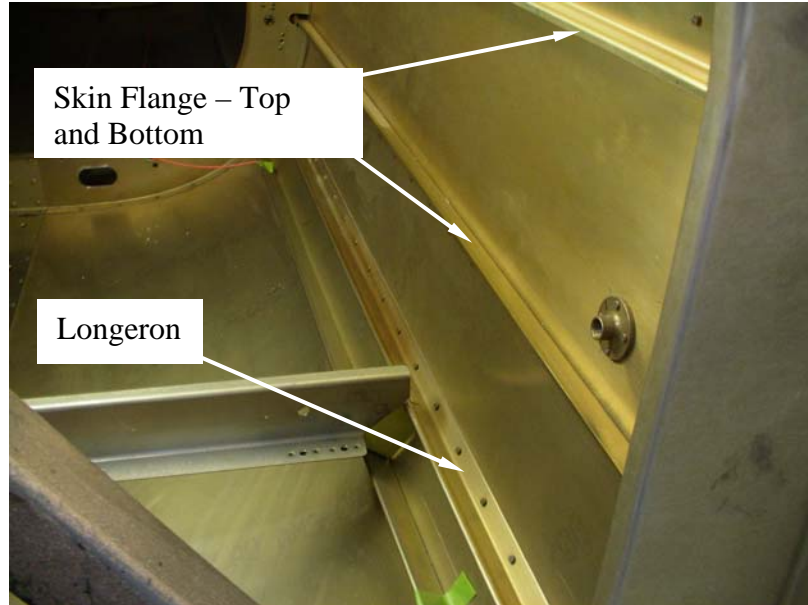
Figure 3. Tailcone Structure – Interior Skin Flanges and Longeron

- D. Visually inspect the interior top and bottom skin flanges on both the left and right side of the tailcone for any cracks, bends, or dents. Reference Figure 3.
- E. Visually inspect the interior longerons on both the left and right side of the tailcone for cracks, bends or dents. Reference Figure 3.
- F. If cracks, bends or dents are detected, proceed to paragraph 5.3

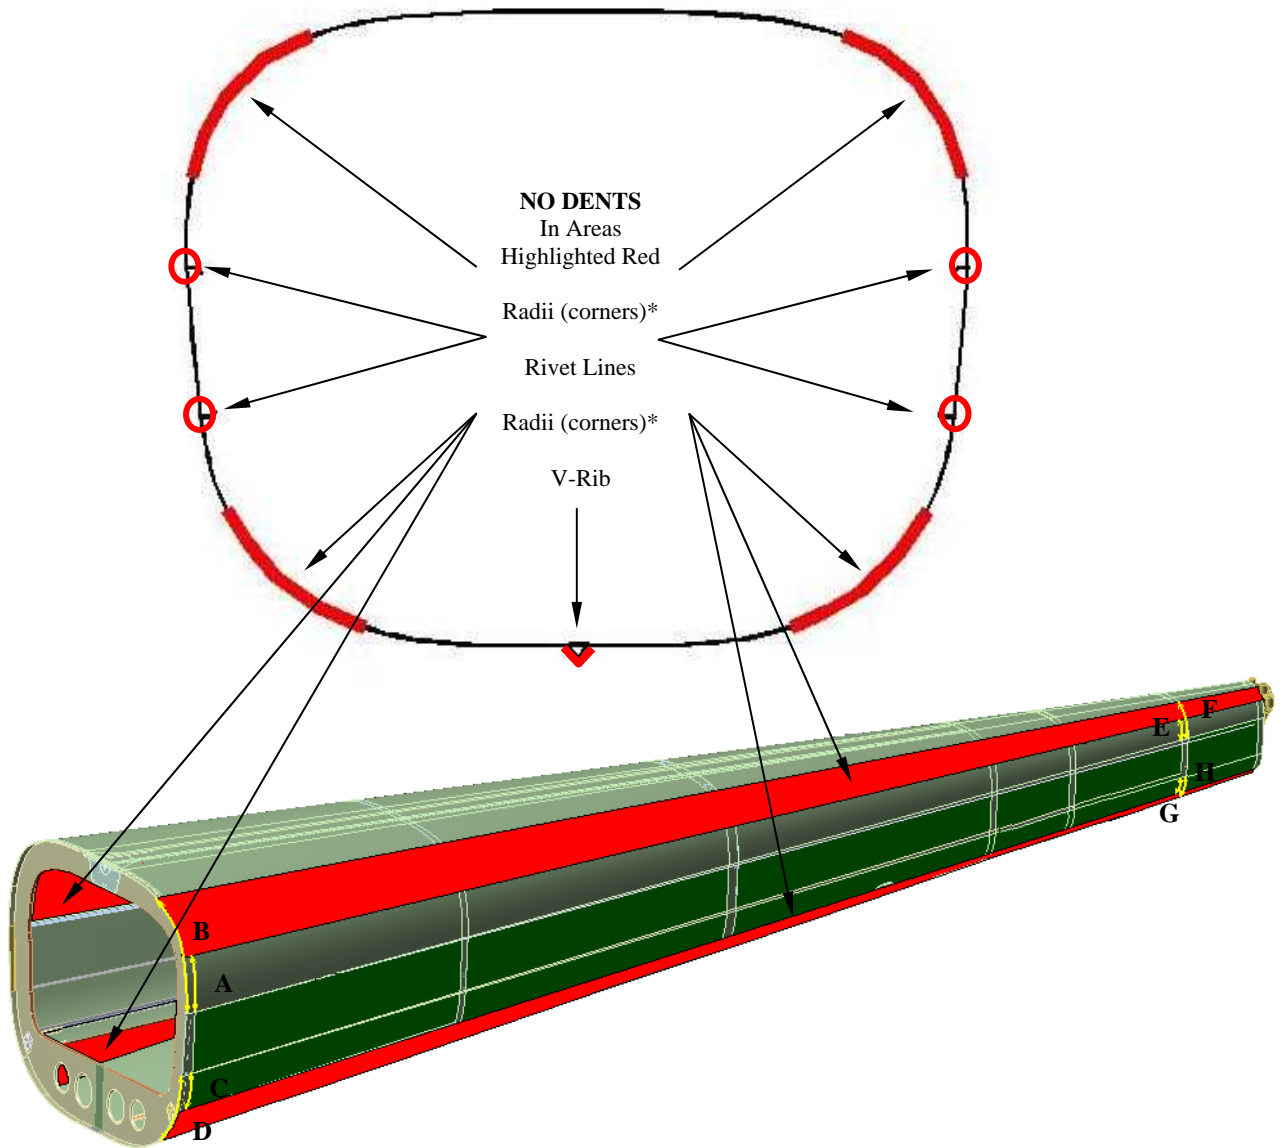
Locating Critical Radii Circumferentially in the Tailcone					
Forward End of Tailcone			Station 327.09 Approximately 10 inches (254 mm) Forward of Aft End of Tailcone		
A	Upper tailcone Rivet line to radius	4 inches (101.6 mm)	E	Upper tailcone Rivet line to radius	2 inches (50.8 mm)
B	Upper tailcone Rivet line to opposite end of radius	11 inches (279.4 mm)	F	Upper tailcone Rivet line to opposite end of radius	4 inches (101.6 mm)
C	Lower tailcone Rivet line to radius	4 inches (101.6 mm)	G	Lower tailcone Rivet line to radius	1 inch (25.4 mm)
D	Lower tailcone Rivet line to opposite end of radius	11 inches (279.4 mm)	H	Lower tailcone Rivet line to opposite end of radius	4 inches (101.6 mm)

Figure 4. Red Highlighted Tailcone Regions Indicate Where Dents are NOT Allowed. Dents within the allowable size are allowed in remaining tailcone regions.
