SERVICE DIRECTIVE BULLETIN

SERVICE DIRECTIVE BULLETIN NO. T-054

1. SUBJECT: Lamiflex Bearing Inspection (P/N 28-14320-15)
2. MODEL: 480: S/N 5001-5004, 5006
3. EFFECTIVITY: Immediately (see paragraph 5.1) or within the next five hours of service or the next 30 calendar days, whichever comes first
4. BACKGROUND:

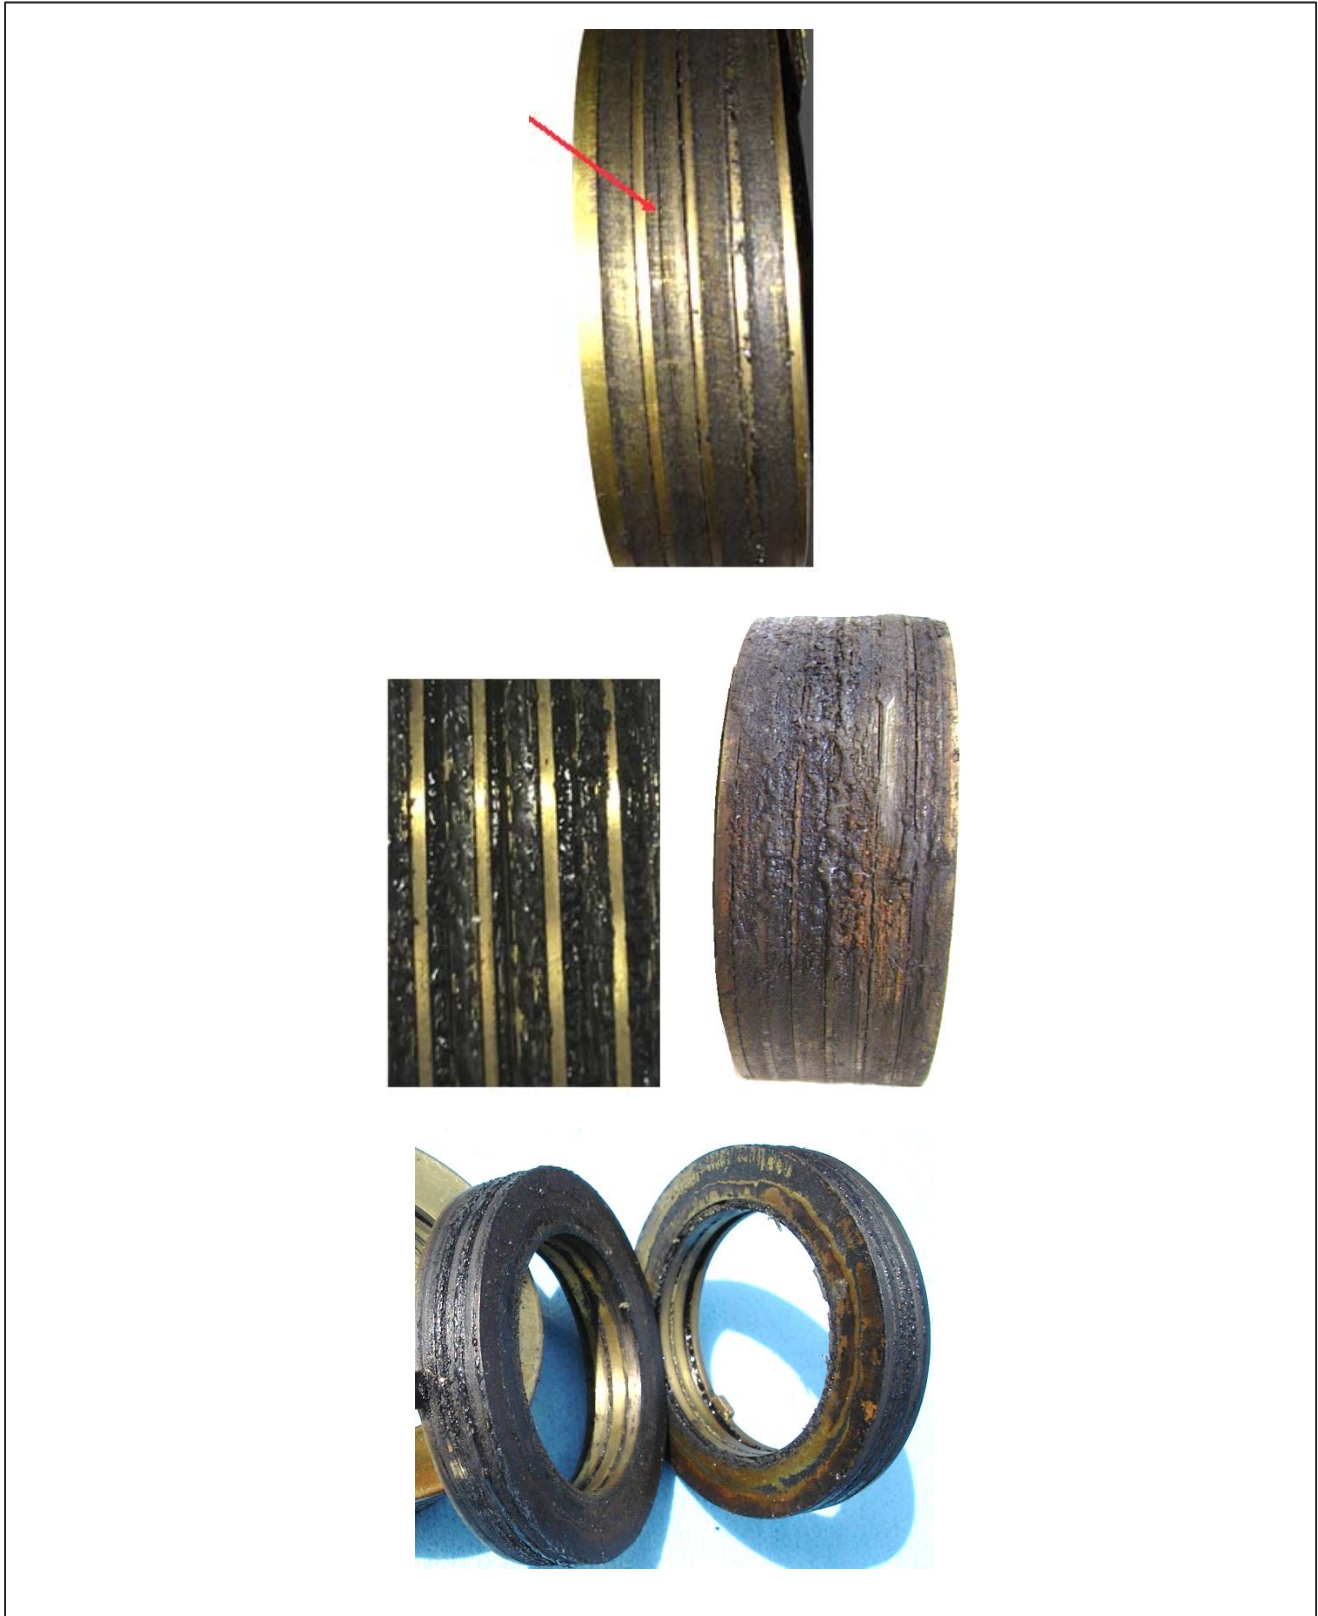
There have been several recent lamiflex bearing failures in which the bearing partially delaminated and started to extrude rubber and brass. Continued operation of the helicopter resulted in complete delamination and an extremely rough ride. The exact cause of the delaminations is under investigation, however, both grease contamination and rotor overspeed may have contributed to the premature failures.

- 5.2.4 Clean the lamiflex surface area with a clean cloth dampened with denatured alcohol. **Do not soak the bearings.**
- 5.2.5 Inspect the bearing for evidence of bulging around the outer circumference of the elastomer segments, excessive axial swelling, visual delamination of the segments or the expulsion of shim fragments on the outside diameter. (See examples in Figure 1.) Any indications are cause for immediate rejection of the lamiflex.

Figure 1. Early stage of delamination (top, at the arrow tip), rubber extrusion (middle, left and right), and rubber extrusion with shear (bottom)

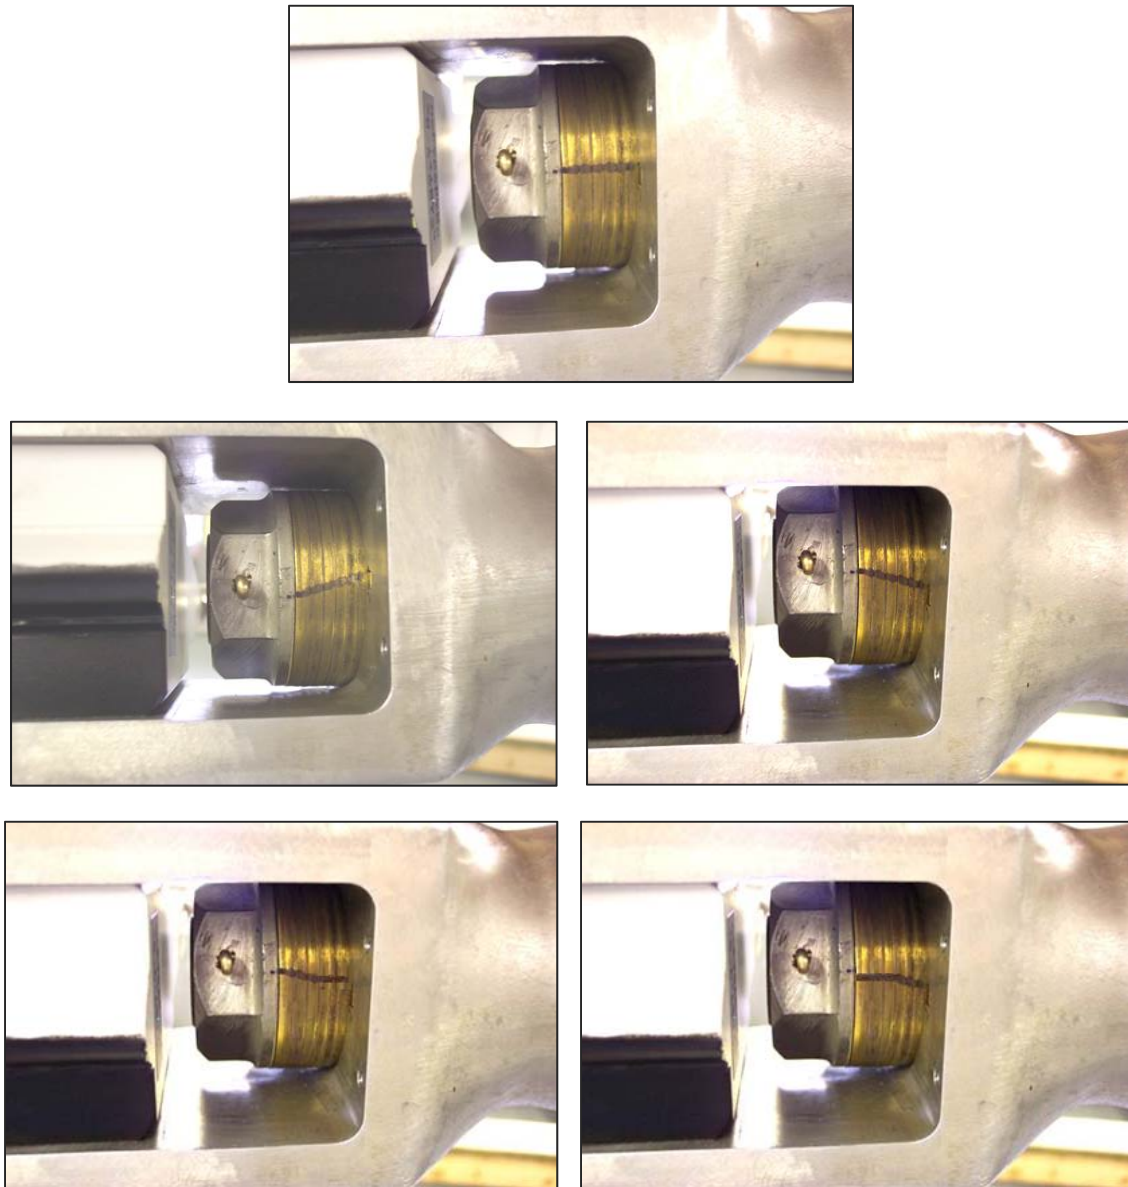
5.2.6.2 Feather the grip 1-3” at the trailing edge to check the response of the segments and to check the spring back of the lamiflex. The line should remain straight across while the grip is feathered (Figure 2). If the line doglegs at a segment, it indicates delamination in the lamiflex. Any delamination is cause for immediate rejection of the lamiflex (Figure 2).

Figure 2. An inspection line drawn across lamiflex (top); then the blade is feathered up and down. A slanted, linear indication while the blade is feathered demonstrates an acceptable lamiflex (middle, left and right).

A non-linear indication while the blade is feathered demonstrates a delaminated lamiflex and is cause for rejection (bottom, left and right).

- 5.2.6 Using a marker, draw a horizontal line across the bearing to aid inspection of the lamiflex segments and the lamiflex spring back while feathering the grip (Figure 2).
