SERVICE DIRECTIVE BULLETIN NO. T-061 Revision 1 Page 1 of 9

DATE: October 29, 2019

1. SUBJECT: Lower Air Plenum Assembly Wedge Vane

2. MODEL: 480 and 480B

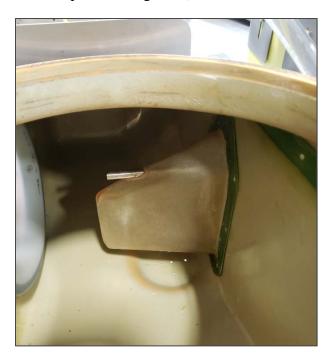
Figure 1. Lower Plenum Wedge Vane

> Enstrom has received reports of failure of the adhesive bond between the lower air plenum wedge vane and the plenum wall, causing the wedge vane to become loose or dislodged entirely during flight. Enstrom has established a preventive measure that includes applying fiberglass patches around the base of the wedge vane to ensure components and material used in the assembly of the lower plenum do not loosen and enter into the engine system. (The lower plenum wedge vane is depicted in Figure 1.)

This Service Directive Bulletin (SDB) requires inspecting the bond between the wedge vane and the plenum wall and repairing the bond as necessary as defined in Paragraph 6.

At the next 100 hr/annual inspection, check for bond failure between the wedge vane and the lower plenum wall. If the bond is sound or there are only minor voids, no further action is required. Check for voids of significance using a 0.010 inch (.25 mm) feeler gauge by attempting to insert it between the flange of the plenum wedge vane and the plenum interior wall. If there are significant voids in the adhesive, repair the wedge vane bond in accordance with Paragraph 6.4. If the bond has severely degraded, fully remove the wedge vane and reinstall in accordance with Paragraph 6.3.
