ENSTROM HELICOPTER CORPORATION

SERVICE DIRECTIVE BULLETIN

SERVICE NOTE NO. 0009
Revision A

Date: May 30, 1973
Subject: Idler Yoke Assembly - P/N 28-13292 Rev. A
Model: F-28A - All Serial Numbers
Compliance: As Noted

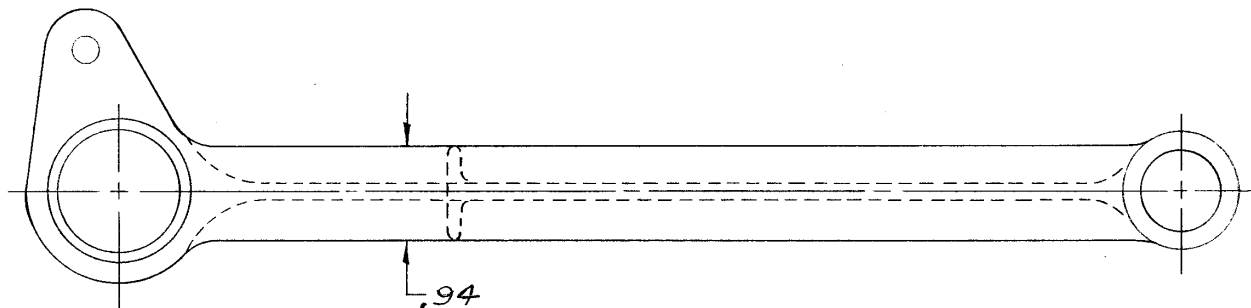
A redesigned 28-13292 yoke casting (Revision A) is now available which will eliminate this mandatory inspection. The redesigned yoke can easily be identified by the .94" width of its flanges (see attached sketch).

Any helicopter equipped with the redesigned yoke is exempt from the mandatory visual inspection imposed by the original service note.

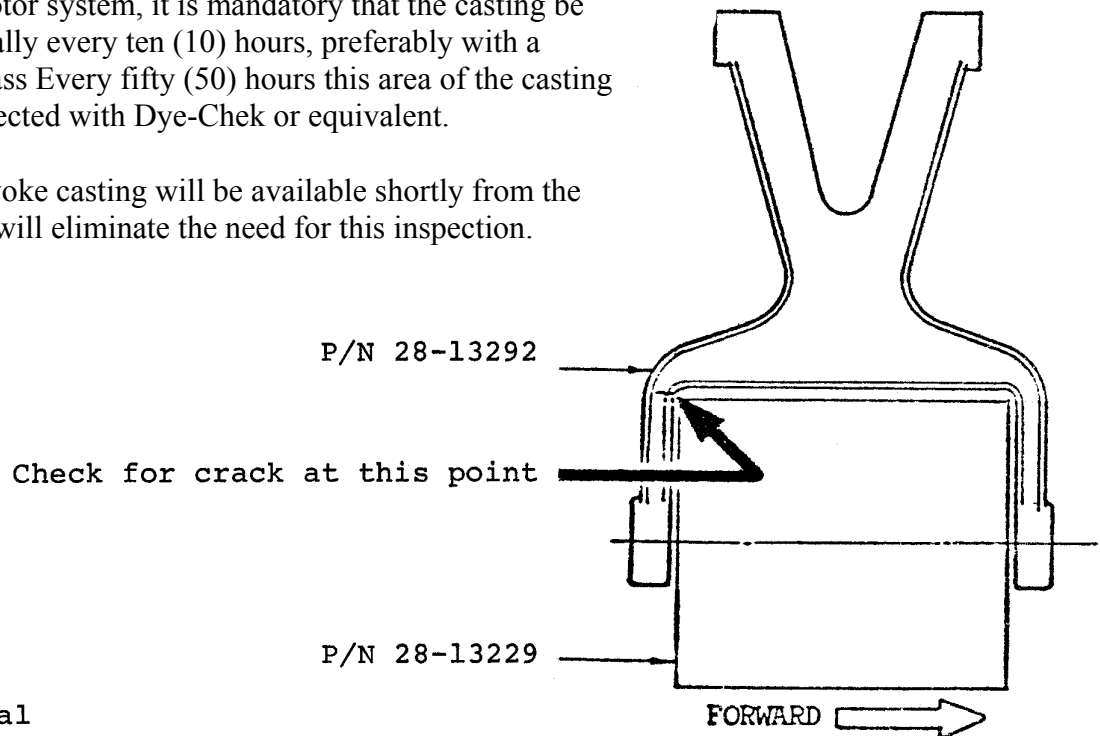
Several occurrences of cracks have been reported in the Idler Yoke Assembly, P/N 28-13292. These cracks occur at the aft portion of the casting and in the corner nearest the aft outside diameter of the idler pulley (see sketch). Two of the cracks were noted after 1300 - 1400 hours of service and one after only 100 hours.

To avoid complete failure of the casting and possible loss of power to the rotor system, it is mandatory that the casting be inspected visually every ten (10) hours, preferably with a magnifying glass. Every fifty (50) hours this area of the casting should be inspected with Dye-Chek or equivalent.

A redesigned yoke casting will be available shortly from the factory which will eliminate the need for this inspection.
