SERVICE DIRECTIVE BULLETIN

SERVICE NOTE NO. 0018

Subject: Premature Failure of Idler Yoke P/N 28-13223 (Forging)

Model Affected: F-28A Helicopters S/N 154 and Up or Any Helicopters with Replacement Forged Parts Installed

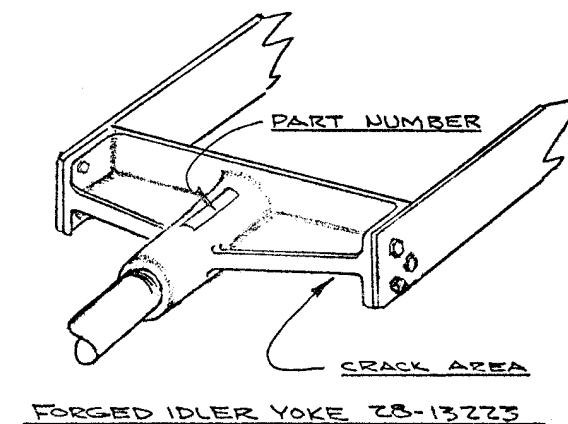
Reports of premature failures of the forged idler yoke P/N 28-13223 in the field have been received. These failures occurred at an average service time of approximately 88 hours. Identification of the forging can be accomplished by the following:

1. The part number is imprinted $\frac{1}{4}$ -inch raised numbers on the barrel portion.
2. The opposite side of the barrel has the alloy number MMT2014 in raised letters.

The illustration below shows the forged idler yoke installation.

It is mandatory that immediate dye penetrant inspection of the forged P/N 28-13223 be performed and a close visual inspection be made on preflight or daily basis. The dye penetrant inspection is to be repeated every 10 hours until further notice.
