ENSTROM HELICOPTER CORPORATION

SERVICE DIRECTIVE BULLETIN

SERVICE NOTE NO. 0030

Subject: Bellcrank P/N 28-16338 - Tail Rotor Control System

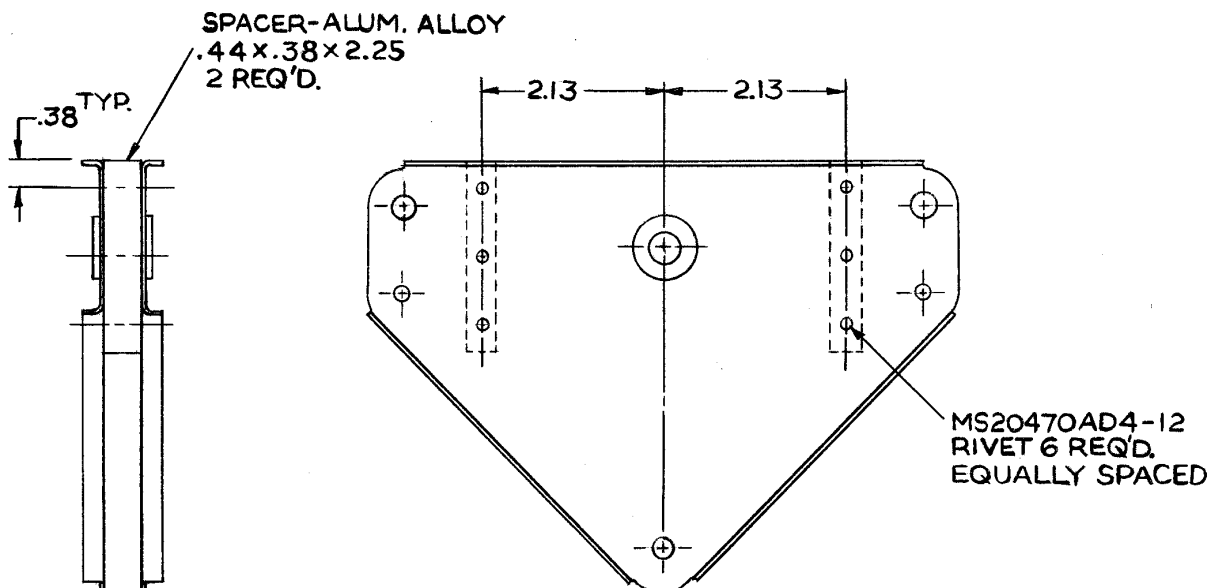
Occasionally, in student training, a heavy opposing load is applied to the tail rotor pedal system when an instructor pilot finds it necessary to overpower a pedal force applied by the student. In some cases, this opposing force has been great enough to cause buckling deformation of the bellcrank, P/N 28-16338-2, located under the floor immediately aft of the dual (R. H.) pedals.

To prevent damage when a heavy overload is applied to the bellcrank, it is necessary to reinforce it with the addition of two aluminum spacers, fastened between the top and bottom bellcrank elements with rivets (P/N 28-16338-7 and -8) as shown in the sketch below.
