ENSTROM HELICOPTER CORPORATION

SERVICE DIRECTIVE BULLETIN NO. 0049

Subject: Main Rotor Transmission Mount Bolts

Model: F-28C, S/N 451-2, 452-2, 453, 454-2, 455-2, 456-2, 457, 458, 459, 460-2, 462, 463-2 and 464-2.

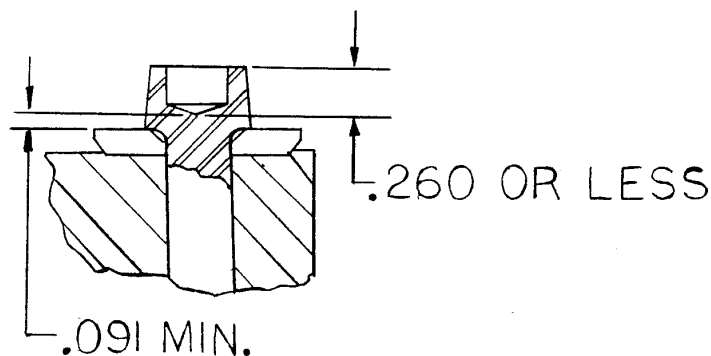
Figure 1

It has been found that several of the NAS146R-57 internal wrenching bolts to have defectively formed heads. The bolts in question are in one lot of the -57 length only and are the mounting bolts for the main rotor transmission. Therefore a strong possibility exists that some of these bolts may be in service.

The depth of the internal wrenching hole, should be measured from the top surface of the bolt, as near to center as possible. This depth should not be greater than .260 inches as indicated in Figure No. 1, if the depth measured is greater, the bolt should be removed and replaced with an airworthy bolt.
