ENSTROM HELICOPTER CORPORATION

SERVICE DIRECTIVE BULLETIN NO. 0050

Subject: Special Inspection: Collective Control Bellcrank P/N 28-16189

Models: F-28, F-28A, F-28C, F-28C-2, 280, 280C

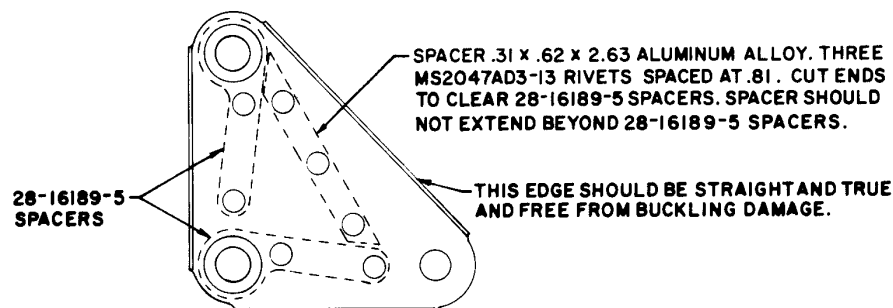
COLLECTIVE CONTROL BELLCRANK
PART NUMBER 28-16189

Sudden main rotor blade stoppage transfers loads from the collective yoke through the push-pull tube to the collective control bellcrank and transfer links causing possible damage.

To improve the damage resistance of the bellcrank P/N 28-16189, an aluminum spacer should be riveted in place as shown in the drawing below on or before the next 100 hour inspection. Installation of this spacer must not interfere with the motion of the lower end of the vertical push-pull tube.
