SERVICE DIRECTIVE BULLETIN NO. 0103

1. SUBJECT: Inspection Of Turbocharger Bypass Tube
2. MODEL: F-28C and 280C
3. EFFECTIVITY: All serial numbers
4. BACKGROUND:

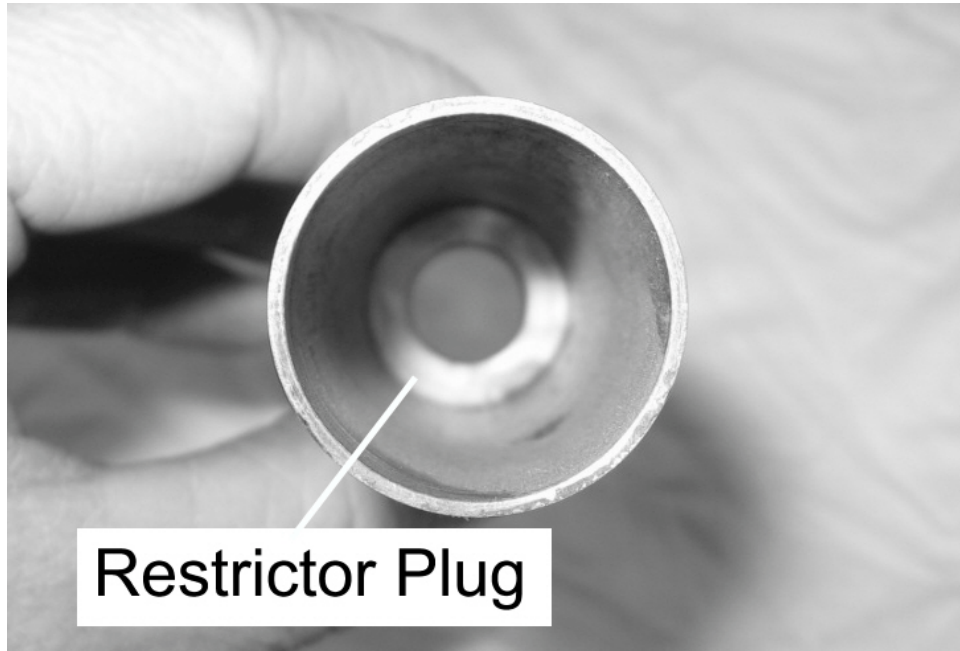
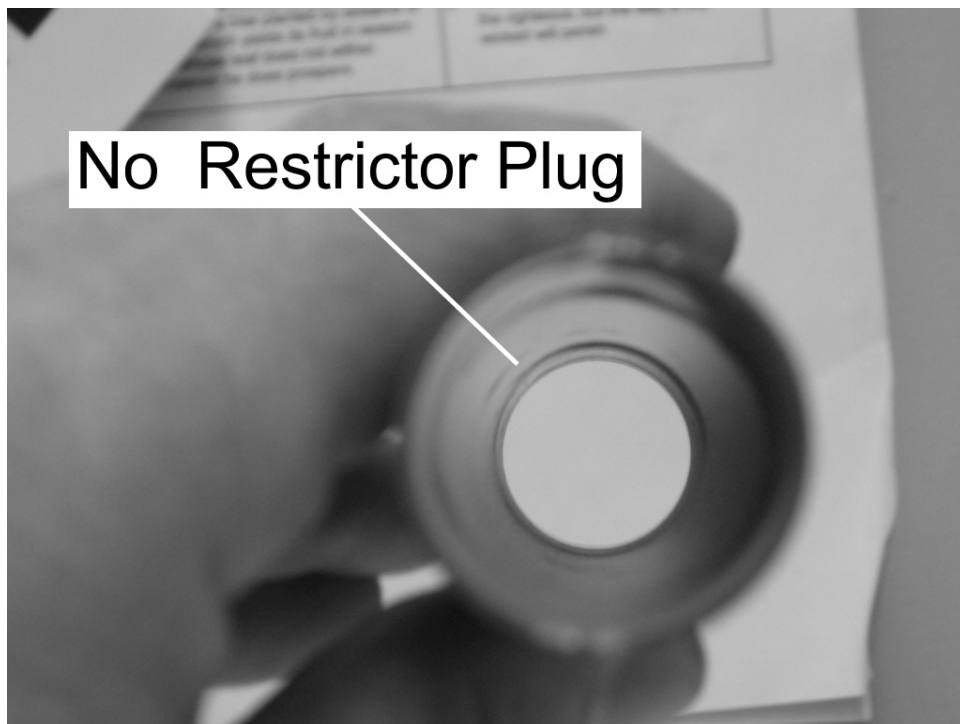
Figure 1

- A. Using an inspection mirror and suitable light source, inspect the bypass tube for the restrictor plug (Figure 1) via the exhaust tail pipe.
- B. If the bypass tube does not have the restrictor plug, replace the bypass tube with an airworthy restrictor bypass tube, P/N 28-125017-1.

At or before the next 100 hour/annual inspection, inspect the bypass tube to determine if it is equipped with a restrictor plug. If the bypass tube does not have a restrictor plug, replace the bypass tube with an airworthy restrictor bypass tube, P/N 28-125017-1.
