SERVICE DIRECTIVE BULLETIN NO. 0105

DATE: October 17, 2008

1. SUBJECT: Collective Bellcrank Inspection
2. MODEL: F-28A, F-28C, F-28F, 280, 280C, 280F, and 280FX
3. EFFECTIVITY:

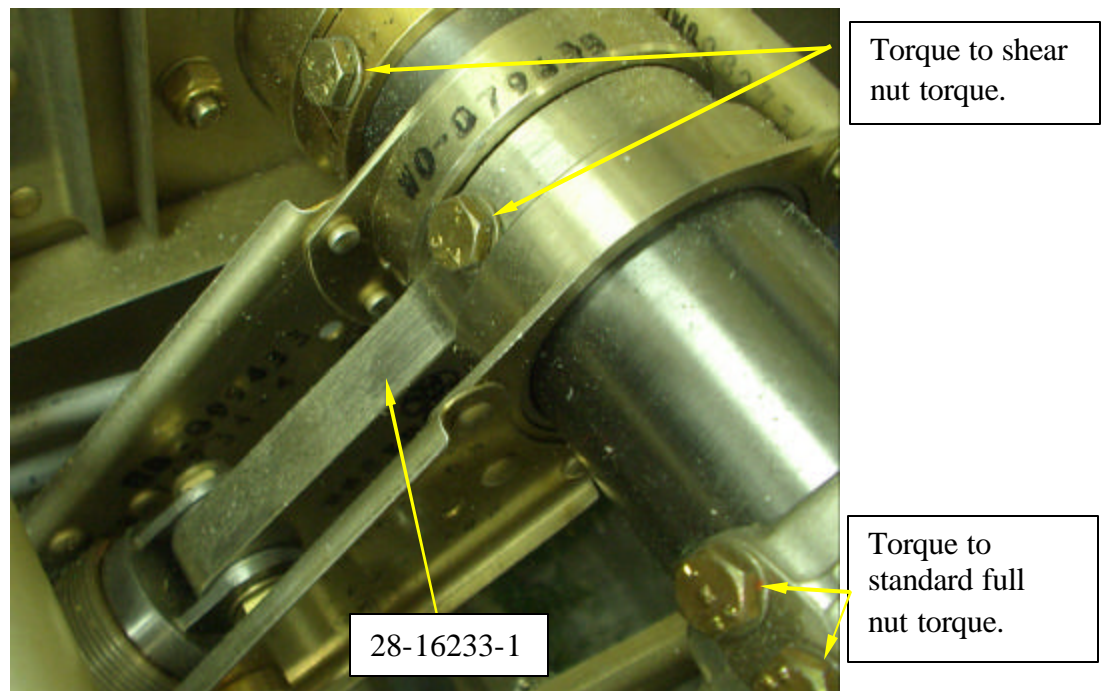
Figure 1. Collective Spring Capsule Bellcrank P/N 28-16233-1/-3

Enstrom has received four reports of failures of the P/N 28-16233-1 bellcrank that attaches the collective spring capsule to the torque tube. In 2005, Enstrom changed the design of the bellcrank to strengthen it. All of the failures were of the old design bellcrank. This Service Directive Bulletin (SDB) requires a mandatory inspection of the bellcrank and makes owner/operators aware of the redesigned bellcrank and recommends they replace the old design with the new design.

- E. Model F-28F, 280F, or 280FX: Disconnect the collective bellcrank from the spring capsule by following steps 1 through 9 in Section 12-5 of the F-28F/280F Series Maintenance Manual. See Figure 1
- F. Model F-28A, F-28C, 280, or 280C: Disconnect the collective bellcrank from the spring capsule by following steps a through h in Section 11 of the F-28A/F-28C or 280/280C Series Maintenance Manual (pages MM-11-4 and MM-11-5). See Figure 1.
- G. Remove the bolt through the collective bellcrank and torque tube. The collective bellcrank may now be rotated freely on the torque tube to inspect the opposite radius on the bellcrank.
- H. Report any failed or cracked bellcranks to Enstrom Customer Service.

- K. Do not overtorque the bolts in the torque tube. Torque to shear nut torque. Use full torque on all bolts connecting the collective stick fitting to the torque tube. See Figure 1.
- L. Verify collective trim rigging IAW Section 12, Paragraph E of the F-28F/280F Series Maintenance Manual.

- J. Do not overtorque the bolts in the torque tube. Torque to shear nut torque. Use full torque on all bolts connecting the collective stick fitting to the torque tube. See Figure 1.
- K. Verify collective trim rigging IAW Section 11 "Rigging", page MM-11-6, of the F-28A/F-28C/280/280C Maintenance Manual.
- L. Patch the hole in the cabin side wall per AC 43.13-1B, Chapter 3.

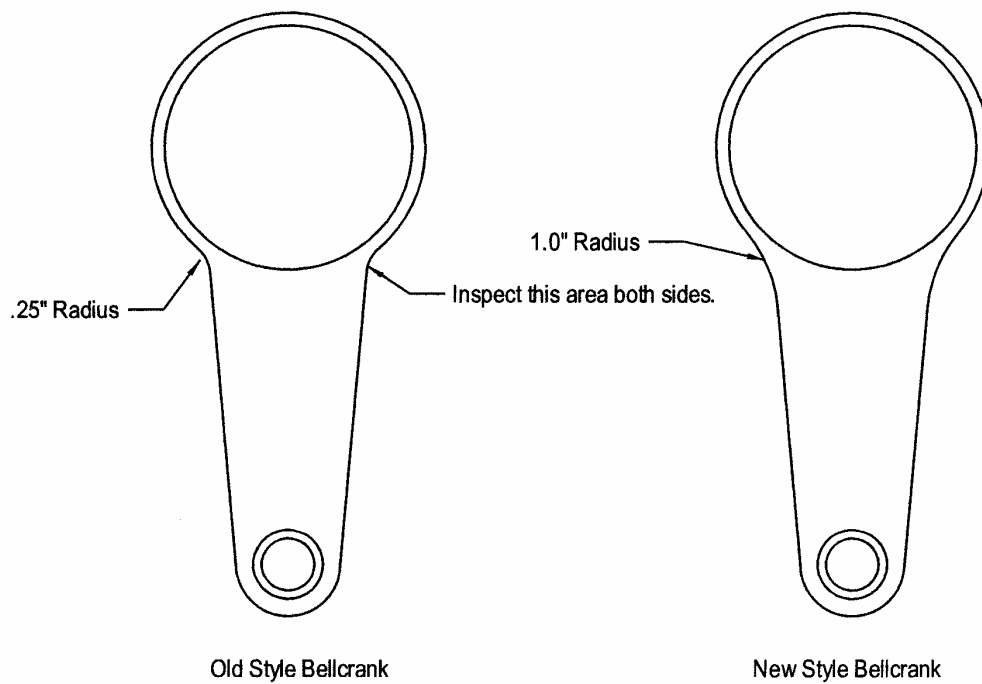
Figure 2. Radius Measurement Location for Bellcrank P/N 28-16233-1

- A. Measure the radius between the arm and the strap of the bellcrank. See Figure 2.
- B. Visually inspect the bellcranks for toolmarks, scratches, nicks, or damage. Use a mirror and suitable light source as required. Blend and polish out any toolmarks, scratches, and nicks to a maximum 0.040" / 1.01mm in depth.
- C. If the radius measures 1.00-inch, this is the new design bellcrank and no further action is necessary.
- D. If the radius measures .25-inch, this is the old design bellcrank and the radius area must be inspected by dye penetrant. Follow steps E through G below for access to the bottom side radius. If a dye penetrant inspection reveals a crack, replace the bellcrank with an airworthy, new design bellcrank. Proceed to paragraph 5.2.
