### SERVICE DIRECTIVE BULLETIN NO. 0124

DATE: February 3, 2017

1. SUBJECT: Landing Gear Assembly - Clamp Inspection

2. MODEL: F-28A, F-28C, F-28C2, F-28F, 280, 280C, 280F, 280FX

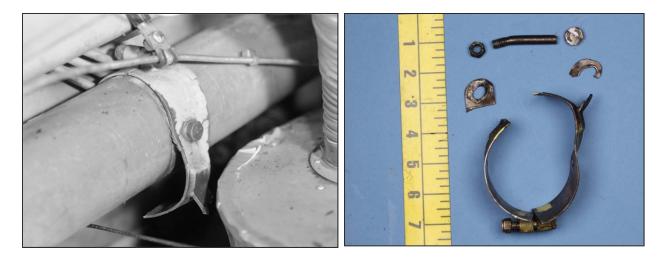
The drag strut (pivot) and pylon attachment clamps of the landing gear assembly will be subject to fatigue caused by corrosion, cracks due to stress and vibration, and wear or damage from the landing gear use.

Figure 2. Failed clamp as-installed (left); clamp assembly and installation hardware removed (right).

- 6.1 Perform a close, visual inspection of the drag strut and pylon attachment clamps for elongated bolt holes, cracked weldments, corrosion, and security of attaching hardware.
  - 6.1.1 Replace clamps that exhibit any of the following: cracks, elongated bolt holes, and corrosion greater than .010 inch/0.25 mm deep.
  - 6.1.2 Corrosion equal to or less than .010 inch/0.25 mm deep may be blended and polished smooth.
  - 6.1.3 Secure loose attachment hardware (standard torque).
  - 6.1.4 Cross tubes with a bow greater than 0.5 inches/12.7 mm must be replaced.

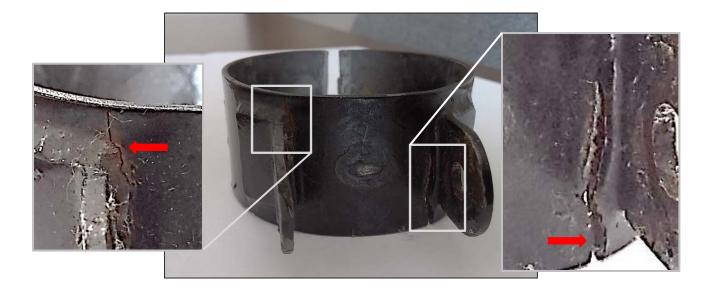
Figure 3. Crack in two locations – each inside the weldment as indicated by the arrows.

- 6.2.3 Remove the paint from the clamps and inspect for cracks using dye penetrant method or magnetic particle inspection. Follow the manufacturer's instructions.
  - 6.2.3.1 Positive indication Reject the clamp and replace with an airworthy clamp.
  - 6.2.3.2 Negative indication Clamp may be returned to service.
- 6.2.4 Apply epoxy primer to any bare metal surfaces of the clamp. (Epoxy primer may be procured locally.)
- 6.2.5 If removed from the cross tube, reinstall the clamps. Leave the pylon clamp attachment hardware loose until after the cross tube is attached to the pylon.
