SERVICE DIRECTIVE BULLETIN NO. T-045 Revision 1 Page 1 of 6

DATE: June 25, 2014

SUBJECT: Copilot Collective – Retention Pin Installation 1.

2. MODEL: 480 and 480B

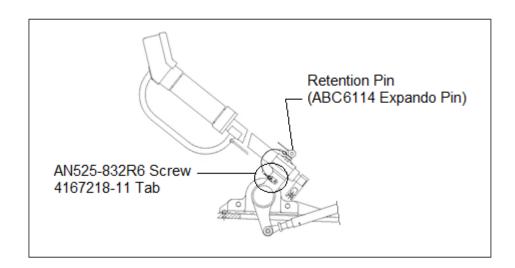
Figure 1. Former Retention Pin Lanyard Installation

> Enstrom had received a report of the copilot collective retention pin assembly disengaging from the stick fitting and dropping into the throttle controls (the copilot's collective had been removed for flight). As a result of this incident, Enstrom has relocated the retention pin lanyard mount from the stick fitting to the co-pilot collective stick.

- 6.1 Disconnect the copilot collective electrical harness from the floor connection.
- 6.2 Remove the retention pin securing the collective stick and remove the collective stick.
- 6.3 Remove the black plastic cover to access the copilot stick fitting.
- Remove the AN525-832R6 screw and P/N 4167218-11 tab. Use care when removing hardware to avoid dropping the parts into the throttle controls (see Figure 1).
- 6.5 Retain the retention pin and lanyard.

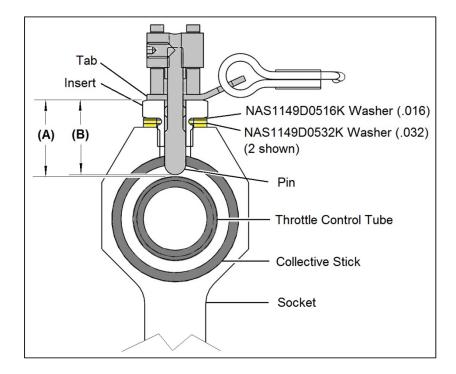
Figure 4. Washer Installation

> Revision 1 installs washers under the collective socket insert to ensure clearance between the end of the retention pin and the throttle control tube.

- 6.13 Check clearance between the retention pin and the throttle control tube (Figure 4).
  - 6.13.1 Measure the distance from the insert to the control tube (A).

- 6.13.2 Measure the length of the pin (B), bottom of tab to tip of pin (measure length with pin uninstalled).
  - 6.13.3 If (B) is longer than (A), stack appropriate combination of washers (NAS1149D0516K and/or NAS1149D0532K) between the insert and the collective socket fitting to ensure (A) is greater than (B), and provide necessary clearance. **NOTE: The maximum stack-up is 0.080" (2.03 mm).**
