R. J. Enstrom Corporation
SERVICE LETTER

SERVICE LETTER NO. 0026.....

Date: May 18, 1972
Subject: Safety Lock Washer on Damper Rod End
Model: F-28A
Compliance: As Noted

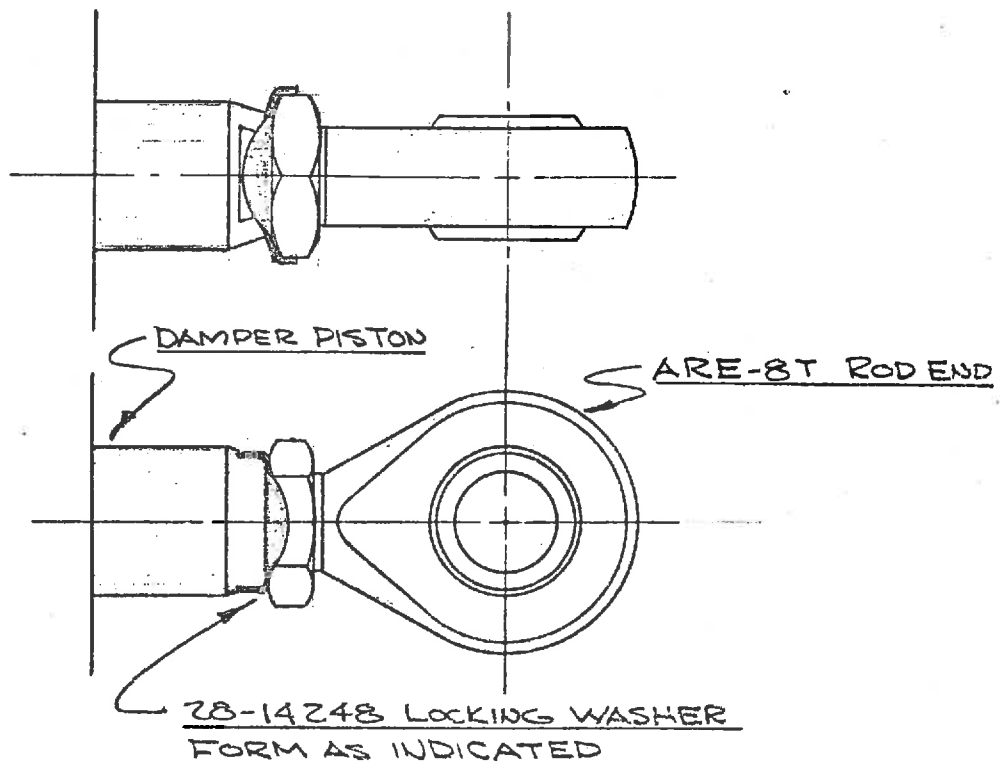
There have been two cases of the damper rod end working loose because of the jamb nut and locking washer not being properly secured.

The following method is recommended for locking the ARE-8T rod end to the damper piston. The AN316-8R should be torqued to 290 - 410 inch pounds. The thin steel washer 28-14248 behind the nut should be deformed into the flats on the piston shaft by the use of a pin punch and hammer. Note this should be accomplished on both flats. The other portions of the washer are to be deformed over the flats of the AN316-8R jamb nut. See illustration below.

A visual check should be made on the next preflight inspection. If the locking washer is not deformed as described or illustrated, it should be reworked according to the aforementioned instructions.
