SERVICE INFORMATION LETTER NO. T-014
Page 1 of 4

1. SUBJECT: Generator Control Unit Relocation
2. MODEL: 480
3. EFFECTIVITY: Serial numbers 5001 through 5036
4. BACKGROUND:

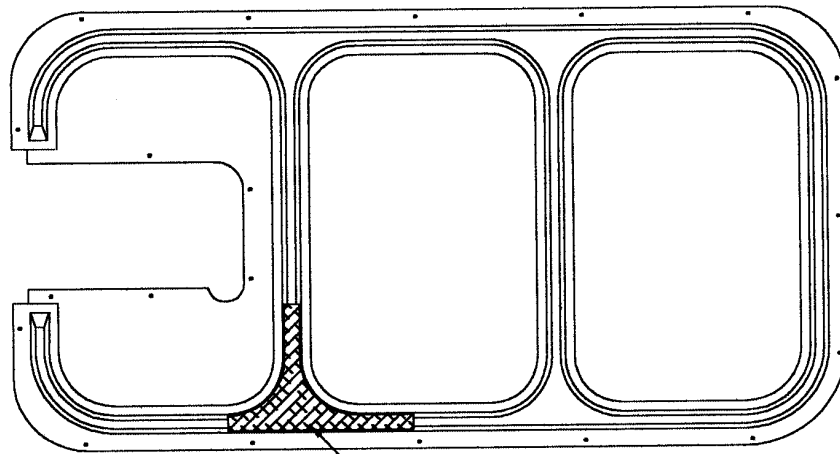
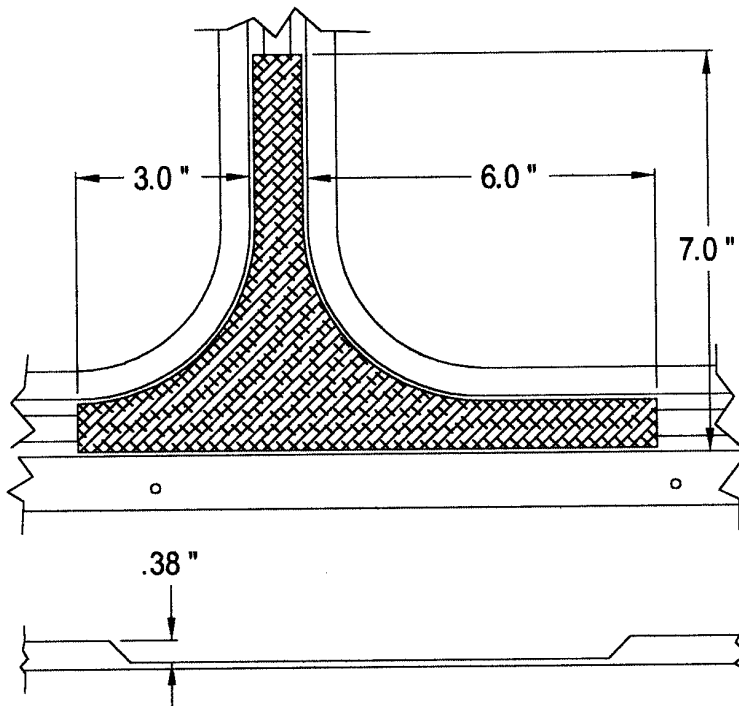
Figure 1. Keel Access Panel Modification

MODIFY THE DOUBLER ON THE RIGHT SIDE
KEEL ACCESS PANEL AS SHOWN BELOW

13. Reconnect the wiring to the T9 terminal strip.
14. Using cable ties and anchors, secure the wiring as required in accordance with AC 43.13-1B.
15. Using the fiberglass repair kit, modify the doubler on the right side keel access panel as shown in Figure 1.

1. Mark the location for modifying the doubler and using a suitable device cut out the excess material.
 2. Using either .125" balsa wood or foam sheet, fabricate a filler block for the doubler and bond into place using a suitable adhesive.

3. Apply two (2) layers of 6 ounce fiberglass cloth over the modification area using the fiberglass repair kit.
16. Connect the battery.
17. Ground run the aircraft in accordance with the Rotorcraft Flight Manual and check the operation of the GCU. Check/Adjust the voltage output of the GCU in accordance with paragraph 6-68 in the TH-28/480 Maintenance Manual.
