SERVICE INFORMATION LETTER NO. T-017

DATE: September 5, 2002

1. SUBJECT: Electrical System Pylon Grounds
2. MODEL: TH-28, 480, and 480B
3. EFFECTIVITY: All serial numbers
4. BACKGROUND:

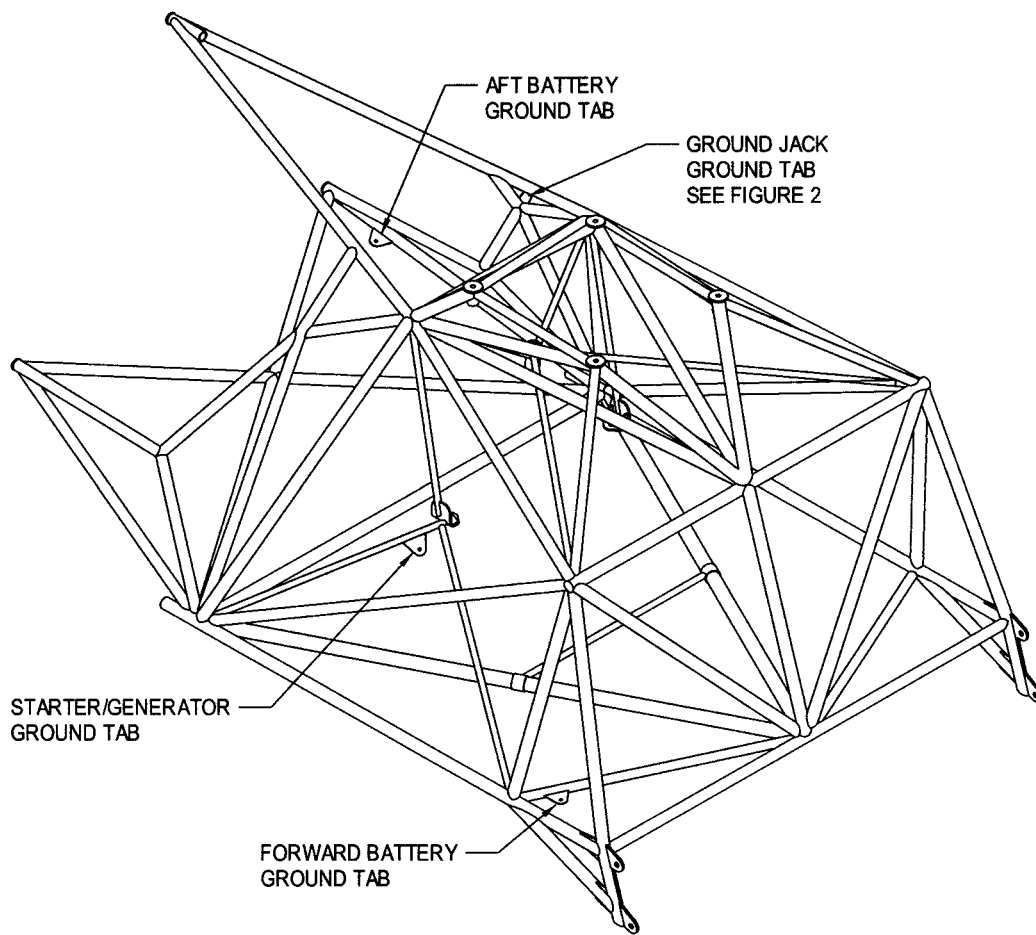
Figure 1. Ground Tab Locations

Enstrom received a report of an anomaly in the electrical system which was traced to a bad ground. Investigation revealed that touch-up paint, used to protect the exposed surface of the pylon ground tab after installation of the ground wires, had penetrated between the wire terminals and the ground tab. The touch-up paint prevented the terminals from maintaining proper contact with the ground tab.

- e. Inspect the ground tabs and wire and bond strap terminals for paint contamination or corrosion. The ground tabs should have a 0.5 inch/13mm unpainted "dot" located where the wire terminals attach.

5. COMPLIANCE:
 - a. At or before the next 100 hour/annual inspection, inspect the aircraft electrical system grounds at the pylon ground tabs in accordance with the procedures in paragraph 5.1.
- 5.1. MAINTENANCE:
 - a. Open the right side engine access panel to gain access to the ground tabs on the right side of the pylon, remove the bottom aft cowling to gain access to the ground tab located on the left side of the pylon, and remove the oil cooler air inlet access panel to gain access to the pylon tab for the ground jack bonding strap. (See Figures 1 and 2).
 - b. Disconnect the battery.

- g. Using Scotch-Brite[®], steel wool, or other suitable abrasive, remove the paint contamination or corrosion from the ground tabs and wire and bond strap terminals. Reinstall the wire and bond strap terminals on the ground tabs and torque the hardware to standard torque.

- h. Apply a corrosion inhibitor conforming to MIL-C-81309, Type III, Class 1 or 2 (Refer to Table 1), to the ground tabs and wire and bond strap terminals.
