THE ENSTROM HELICOPTER CORPORATION

SERVICE INFORMATION LETTER NO. T-049

DATE: July 7, 2011

1. SUBJECT: Special Inspections for Agricultural Aircraft
2. MODEL: 480 and 480B Helicopters
3. EFFECTIVITY: Helicopters Equipped with Ag Spray Kit
4. BACKGROUND:

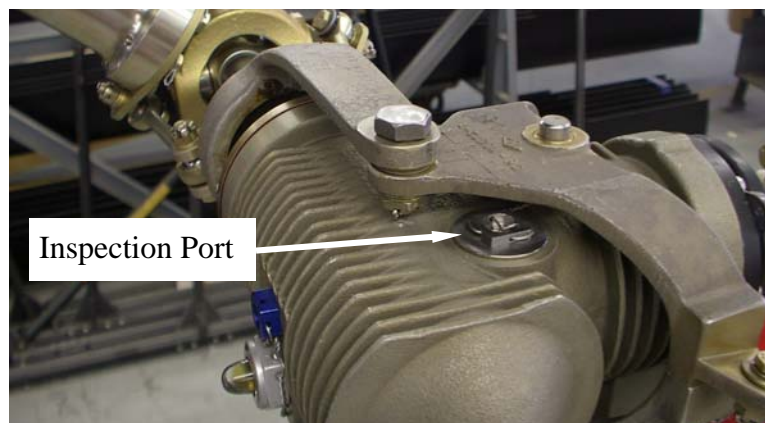
Figure 1. Tail Rotor Transmission Gearbox

- 6.1.1 Equipment Required: Small bright light source and a 10X magnifying glass
- 6.1.2 Access the tail rotor drive gear via the inspection port located on top of the transmission (Figure 1).
- 6.1.3 Cut the safety wire between the inspection port plug (5) and bolt (3). Remove the inspection port plug (5) and o-ring (4) (Figures 1, 2, and 5). Discard the safety wire.

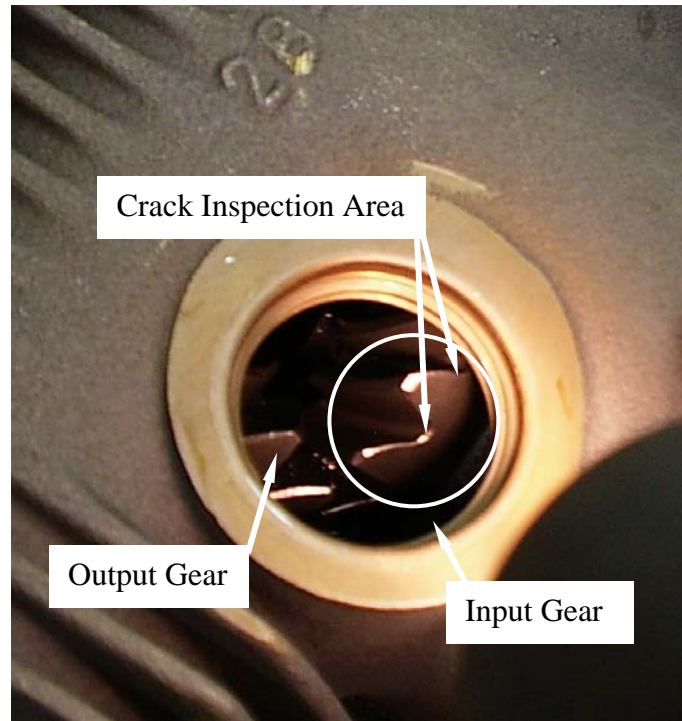
Figure 3. Gear Teeth Inspection – Input Gear Illuminated

- 6.1.4 Illuminate the drive gears with a suitable bright light. With the 10X magnifying glass visually inspect the input gear for broken or cracked gear teeth (Figure 3). See Figure 4 for an example of broken and cracked gear teeth. Slowly rotate the tail rotor to turn the gear for one complete revolution (360°) and thoroughly inspect all the input gear teeth.
- 6.1.5 Replace the tail rotor transmission if any broken or cracked gear teeth are discovered. Refer to the TH-28/480 Series Maintenance Manual, Paragraphs 11-88 through 11-92, for removal and installation instructions.

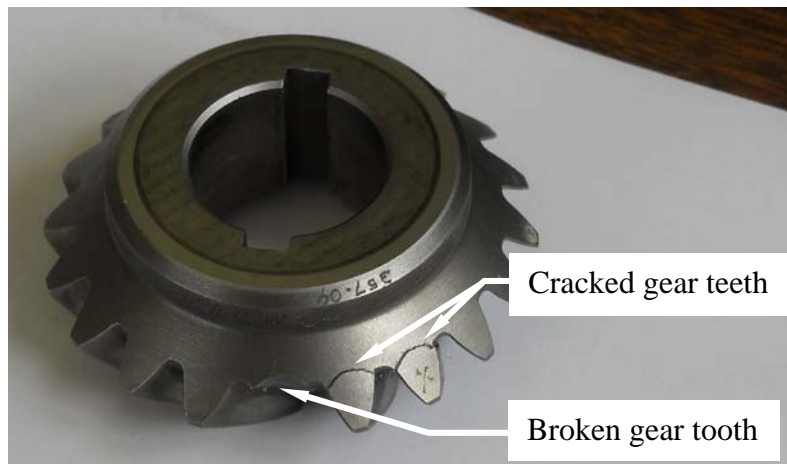
Figure 4. Example of Broken and Cracked Gear Teeth

NOTE: Cracks may not be as obvious as shown in this photo.

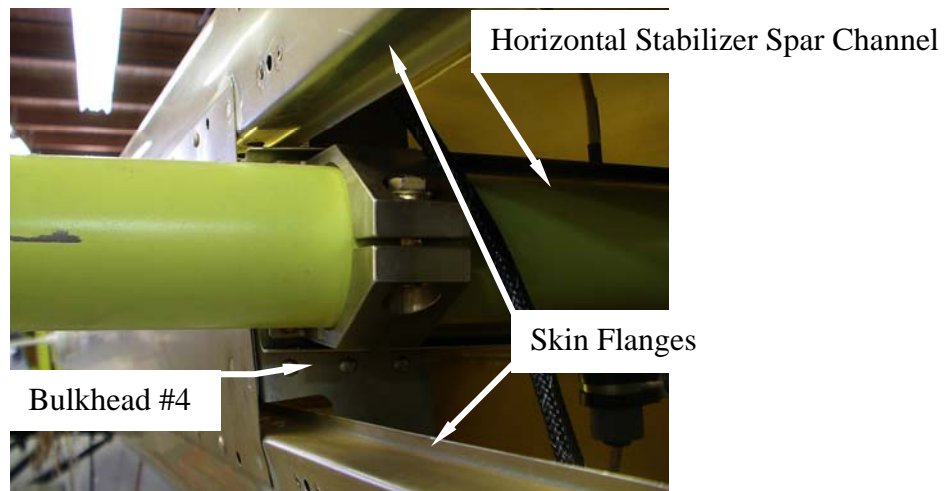
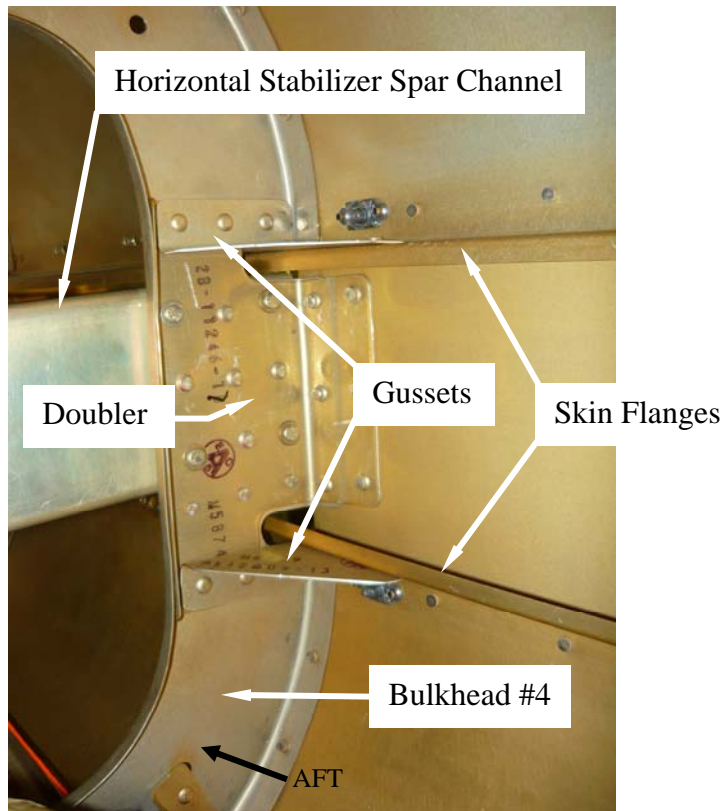
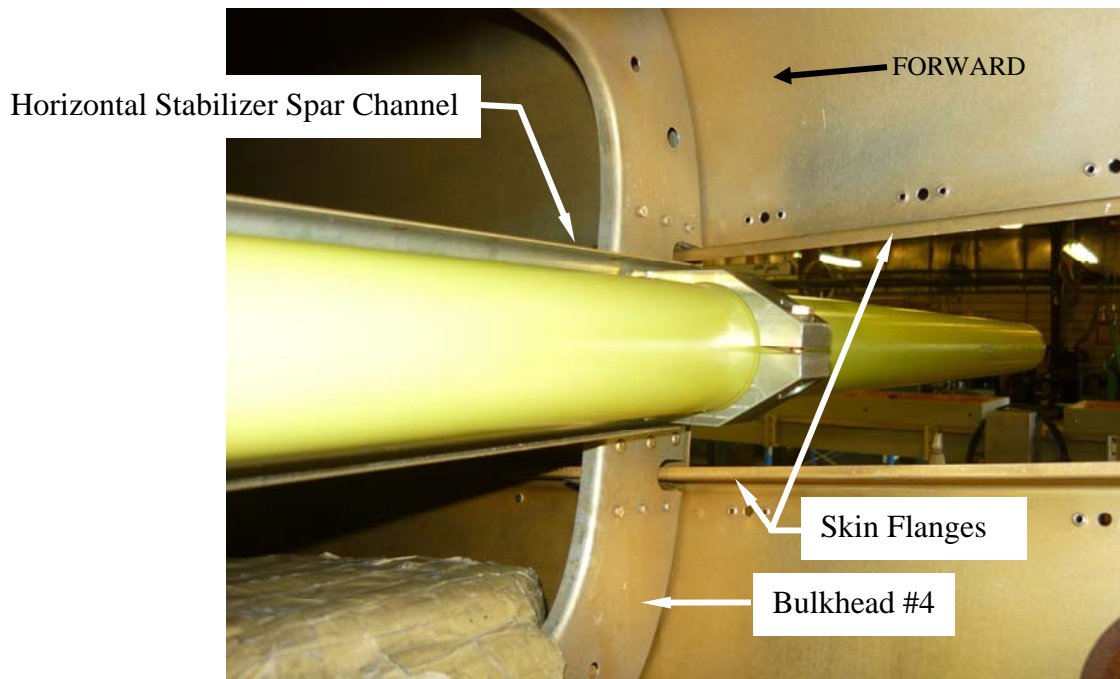
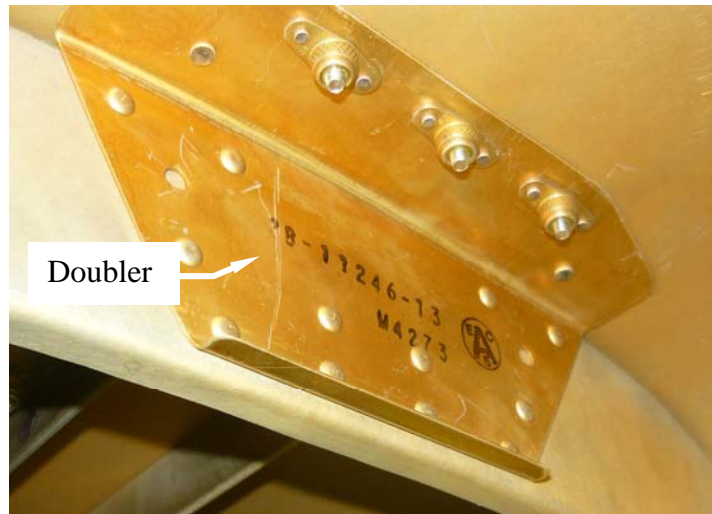
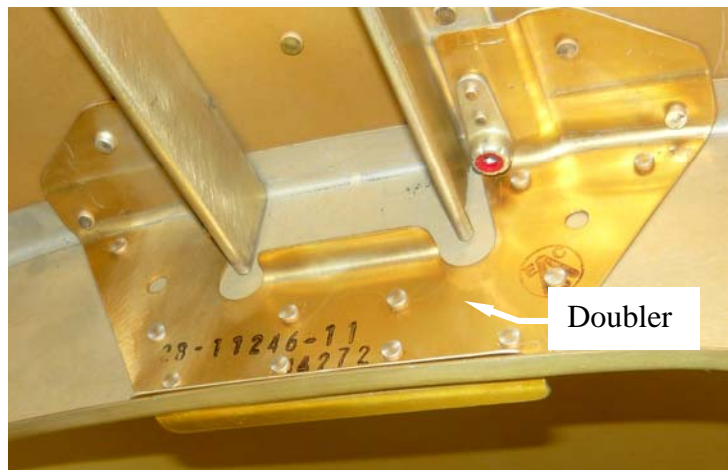
6.2 Tailcone Structure Inspection (Reference Figures 6 and 7)

- 6.2.1 Equipment Required: Bright light source, mirror, cleaning cloth, solvent, and camera (optional)
- 6.2.2 Remove the horizontal and vertical stabilizer assemblies in accordance with paragraph 8-97 of the TH-28/480 Series Maintenance Manual.
- 6.2.3 Remove the forward tailcone/horizontal spar access panels.
- 6.2.4 Wipe all exposed exterior and interior surfaces of the bulkhead #4 doublers, gussets, channels, and skin flanges on both the left and right side with a cleaning cloth wetted with solvent. Carefully inspect all the cleaned surfaces for cracks (Figures 6 and 7). Use a mirror or a digital camera to aid inspection of the interior surfaces hidden from view.

- 6.2.5 If cracks are detected contact Enstrom Product Support for repair procedures.
- 6.2.6 Reinstall the forward tailcone/horizontal spar access panels.
- 6.2.7 Reinstall the horizontal and vertical stabilizers in accordance with paragraph 8-102 of the TH-28/480 Series Maintenance Manual.

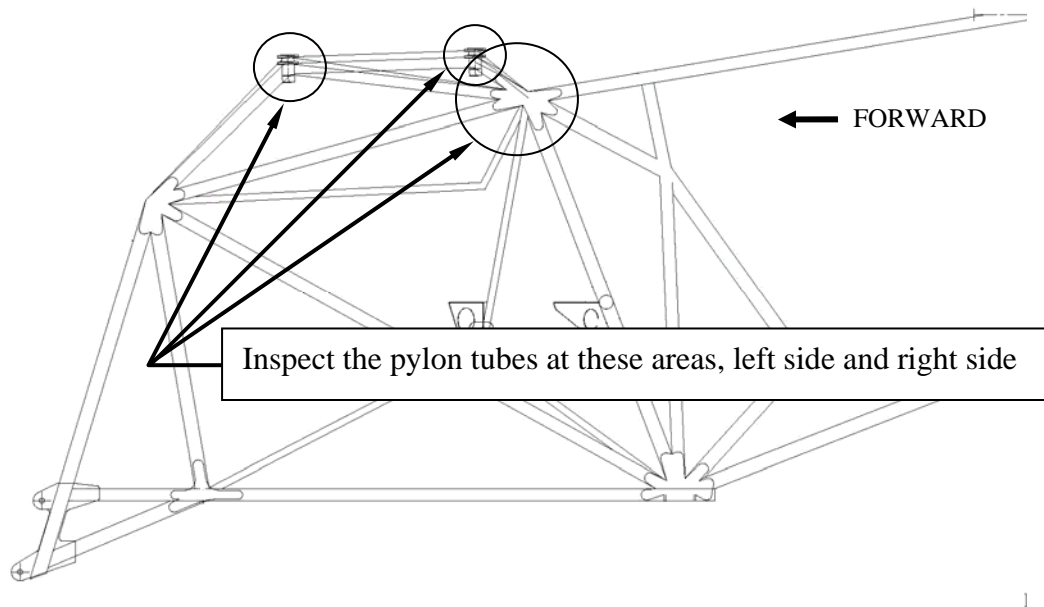
Figure 8. Pylon Structure Inspection Areas – View from the Left Side

- 6.3.1 Equipment Required: Bright light source, mirror, cleaning cloth, and solvent
- 6.3.2 Open the access panels below the left and right fuel tanks.
- 6.3.3 Wipe the surfaces of the pylon tube, gusset, and engine mount weldments (Figure 8) with a cleaning cloth wetted with solvent.
- 6.3.4 Using a light and mirror, carefully inspect the cleaned surfaces for cracks. Pay particular attention to the weldment areas.
