**THE ENSTROM HELICOPTER CORPORATION**  
**TWIN COUNTY AIRPORT, P.O. BOX 490, MENOMINEE, MICHIGAN 49858**

SERVICE INFORMATION LETTER NO. 0101

Date: August 18, 1980  
Subject: Position and Strobe Light Assembly Light Shields  
Models: 280 and 280C  
Effectivity: S/N 1172, 1192 through 1201 and as noted

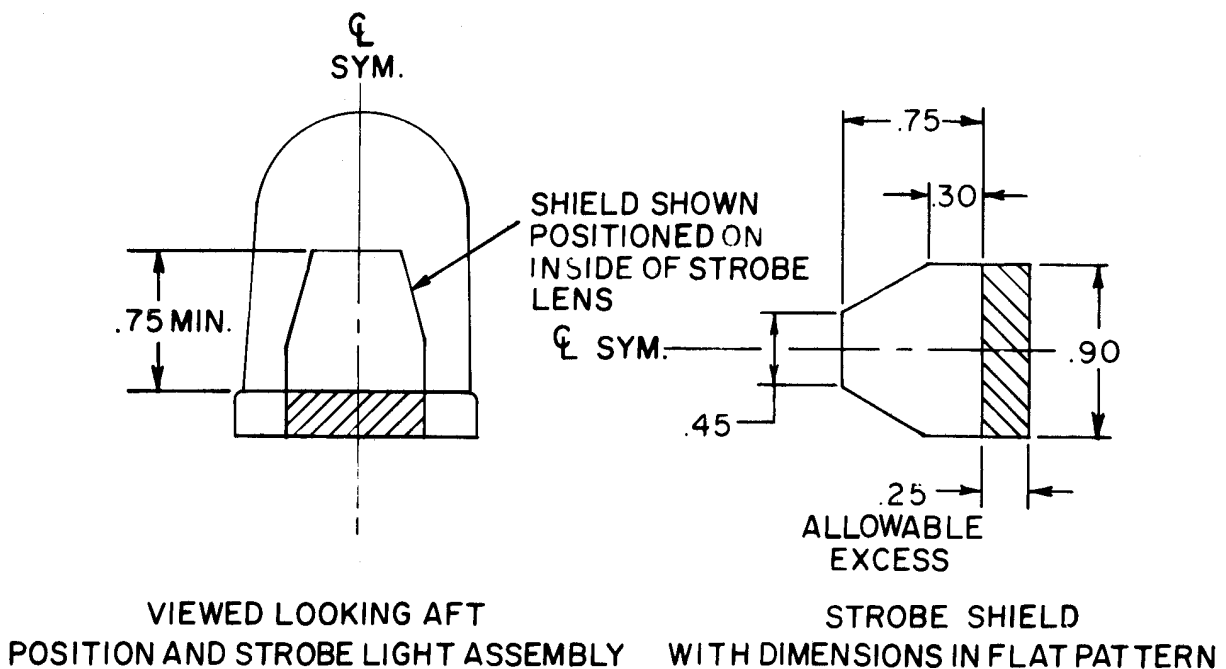
This letter is written to inform owners of the above listed helicopters and customers who have recently replaced position and strobe light assemblies that there is a possibility the internal light shield was omitted during assembly of some units.

This shield, or mask, is installed to prevent forward strobe light penetration which can cause distracting reflections in the cockpit during operation. It is suggested that all owners and operators inspect both the left and right horizontal stabilizer strobe lights to verify the installation of the light shields. Units found without the proper shielding can be repaired in the field by removing and cleaning the strobe light lens before installing an aluminum foil pressure sensitive tape as illustrated.

NOTE: Be sure the tape is installed symmetrically on the forward side of the lens.
