# THE ENSTROM HELICOPTER CORPORATION

SERVICE INFORMATION LETTER NO. 0121

Date: December 2, 1981

Subject: Troubleshooting & Tracking Enstrom Articulated Rotor System

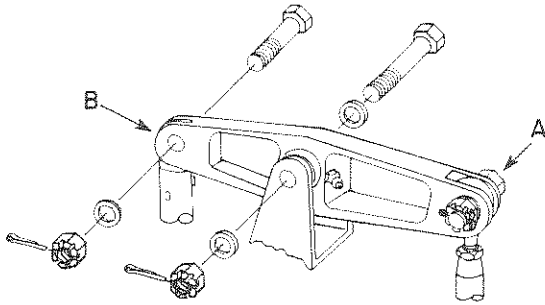
FIGURE 1

1. Lamiflex bearing failure.

Check: Disconnect the rotor pitch links at the upper walking beams (ref. Fig. 1, Item A) and flex the blade grip in no more than a  $30^\circ$  (i.e.  $\pm 15^\circ$ ) arc. Failure of the blade grip to spring back indicates a failed Lamiflex bearing.

2. Upper push rod bushing and spacers worn excessively (ref. Figure 1, Item B).

Solution: Replace Lamiflex bearing.

Solution: Replace bushings and spacers as required.

Note: Ream bushings with a 3/8" adjustable reamer, if required, to avoid looseness or binding.

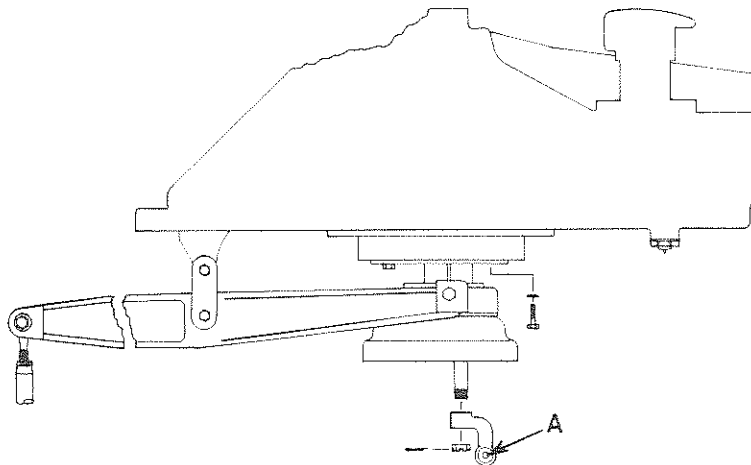
FIGURE 2

5. Dog leg uniball bearings worn excessively (ref. Figure 2, Item A).

Check: Note looseness of the bearing and insure the bearing is secure in the dog leg.

Solution: Replace bearings as required.

Note: Bearings must be swaged into the dog legs with equal preload on each.

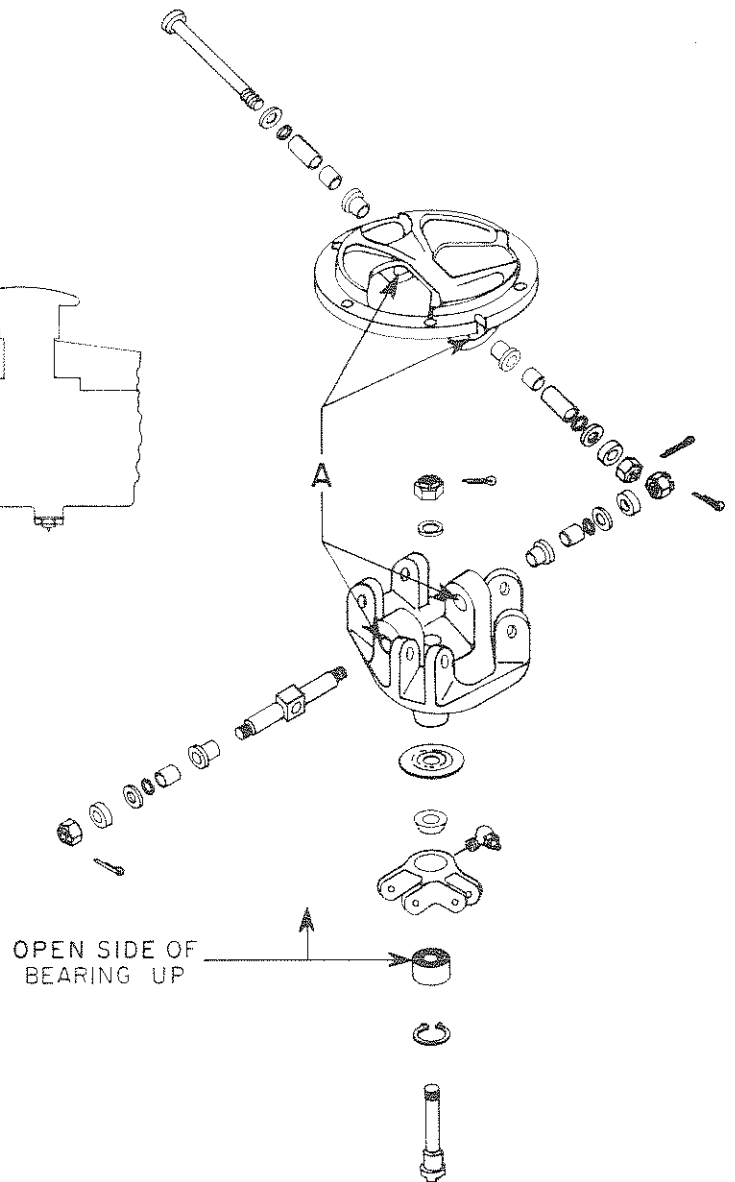
FIGURE 3

3. Lower swashplate axes worn (ref. Figure 3, Item A).

Check: Rotate main rotor hub to position each axis of the lower swashplate over the longitudinal push rod and move cyclic stick fore and aft. Note any play at the axes.

Solution: Retorque nuts to take up play or overhaul the swashplate if necessary.

Note: Preload on each axis should be equal (check after disconnecting both upper and lower controls). If unable to obtain equal preload, overhaul as necessary.

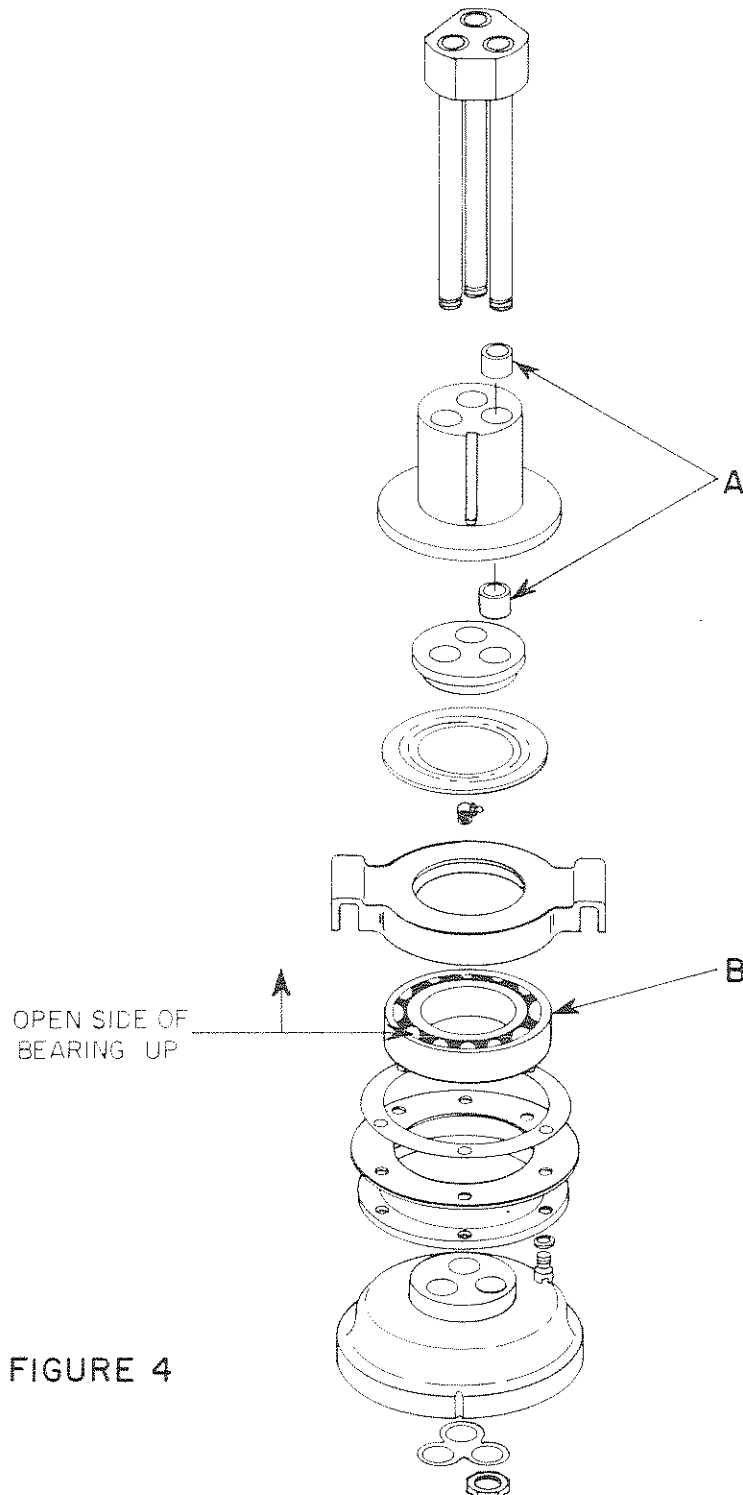
4. Upper swashplate DU bushings worn excessively (ref. Figure 4, Item A).

Check: Move bell housing from side to side to check for looseness.

6. Excessive play in the upper collective bearing (ref. Figure 4, Item B).

Check: Move collective walking beam, noting amount of play at the bearing.

Solution: Play in excess of .010" will require overhaul of the assembly.

Solution: Replace bearing if excessive play is evident.
