Repairing Main Rotor Blade Leading Edge Corrosion

Customer Support Work aid Document

Aircraft Type: ALL
Effectivity: ALL
Model (S): ALL

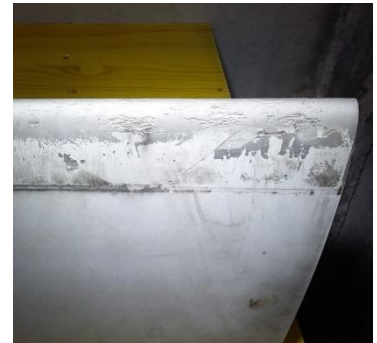
FIGURE 1

1. Determine if the corrosion is within limits for repairing the blade
 - 1.1. Pick a point on the blade that is showing severe exfoliation.

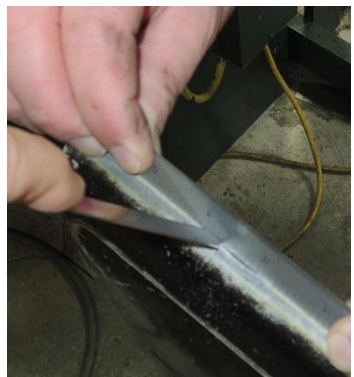
FIGURE 3

- 1.3. Use a feeler gauge, depth micrometer, or other equivalent measuring method to determine the depth of the groove that has been filed in the blade. This is the measurement that determines whether the blade meets the spar corrosion limitations shown in figure 9-79 (480 MM) and figure 9-19 (Piston MM).

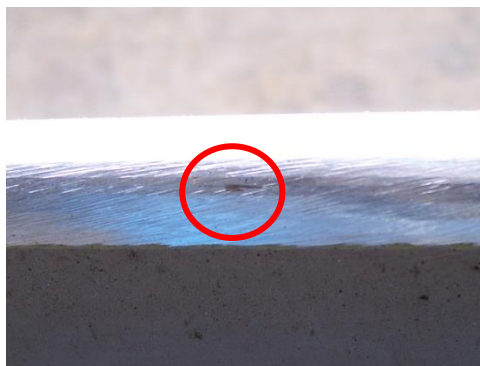
FIGURE 6

2.5. Corrosion can still be seen in figure 6.

2.4. It is necessary to completely remove the corrosion from the blade before painting the blade as any corrosion that is left in the aluminum will continue to develop.
