SERVICE DIRECTIVE BULLETIN

SDB T-026
Revision 1
Page 1 of 6

DATE: February 14, 2014

1. SUBJECT: Power Output Shaft Bearing Inspection
2. MODEL: TH-28, 480, 480B
3. EFFECTIVITY: TH-28 & 480: All serial numbers
480B: Serial numbers 5090 and prior
4. BACKGROUND:

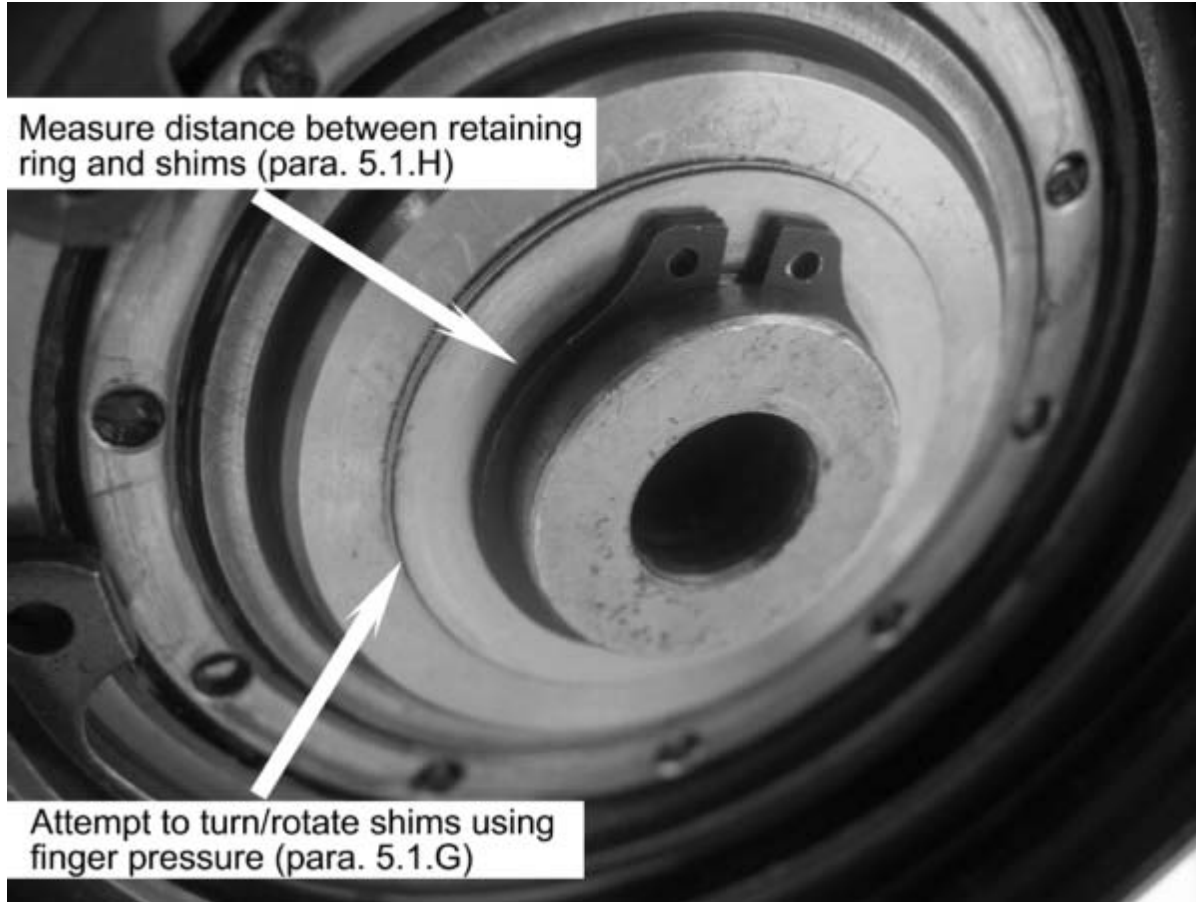
Figure 1.

- G. Using your fingers, attempt to turn/rotate the shims installed under the retaining ring on the end of the power output shaft (Refer to Figure 1).
- (1) If the shims cannot be turned/rotated using your fingers, remove the retaining ring from the end of the power output shaft and remove the shims. Separate and clean the shims. Reinstall the shims and retaining ring, and attempt to rotate the shims using your fingers.

- (3) Proceed to the next step (para. 5.1.H) if the shims can be turned/rotated using your fingers.
- H. Using a feeler gauge, determine the distance between the retaining ring on the end of the power output shaft and the shim(s) (Refer to Figure 1). Record distance on the SDB Report Sheet (Measurement 1).

- (1) If the distance between the retaining ring and the shim(s) is .004" to .006", no further action is required.
 - (2) If the distance between the retaining ring and shim(s) is greater than .006", remove the retaining ring and add shims until the distance is between .004" and .006".

- (3) If the distance between the retaining ring and shim(s) is less than .002", remove the retaining ring and shims and record the total thickness of shims on the SDB Report Sheet (Measurement 2). Recheck the aft end of the power output shaft for radial and axial play IAW para.5.1.C.; replace the bearing as required. If no radial or axial play is evident, reinstall the retaining ring and adjust the shim(s) to the .004" to .006" distance. Determine the difference between the thickness of the original shim installation verses the thickness of the adjusted installation. Record the difference on the SDB Record Sheet (Measurement 3).
